SERVICE LETTER

No. 630

Piper Aircraft Corporation

Subject: Lubrication of Fuel Valve Selector Mechanism

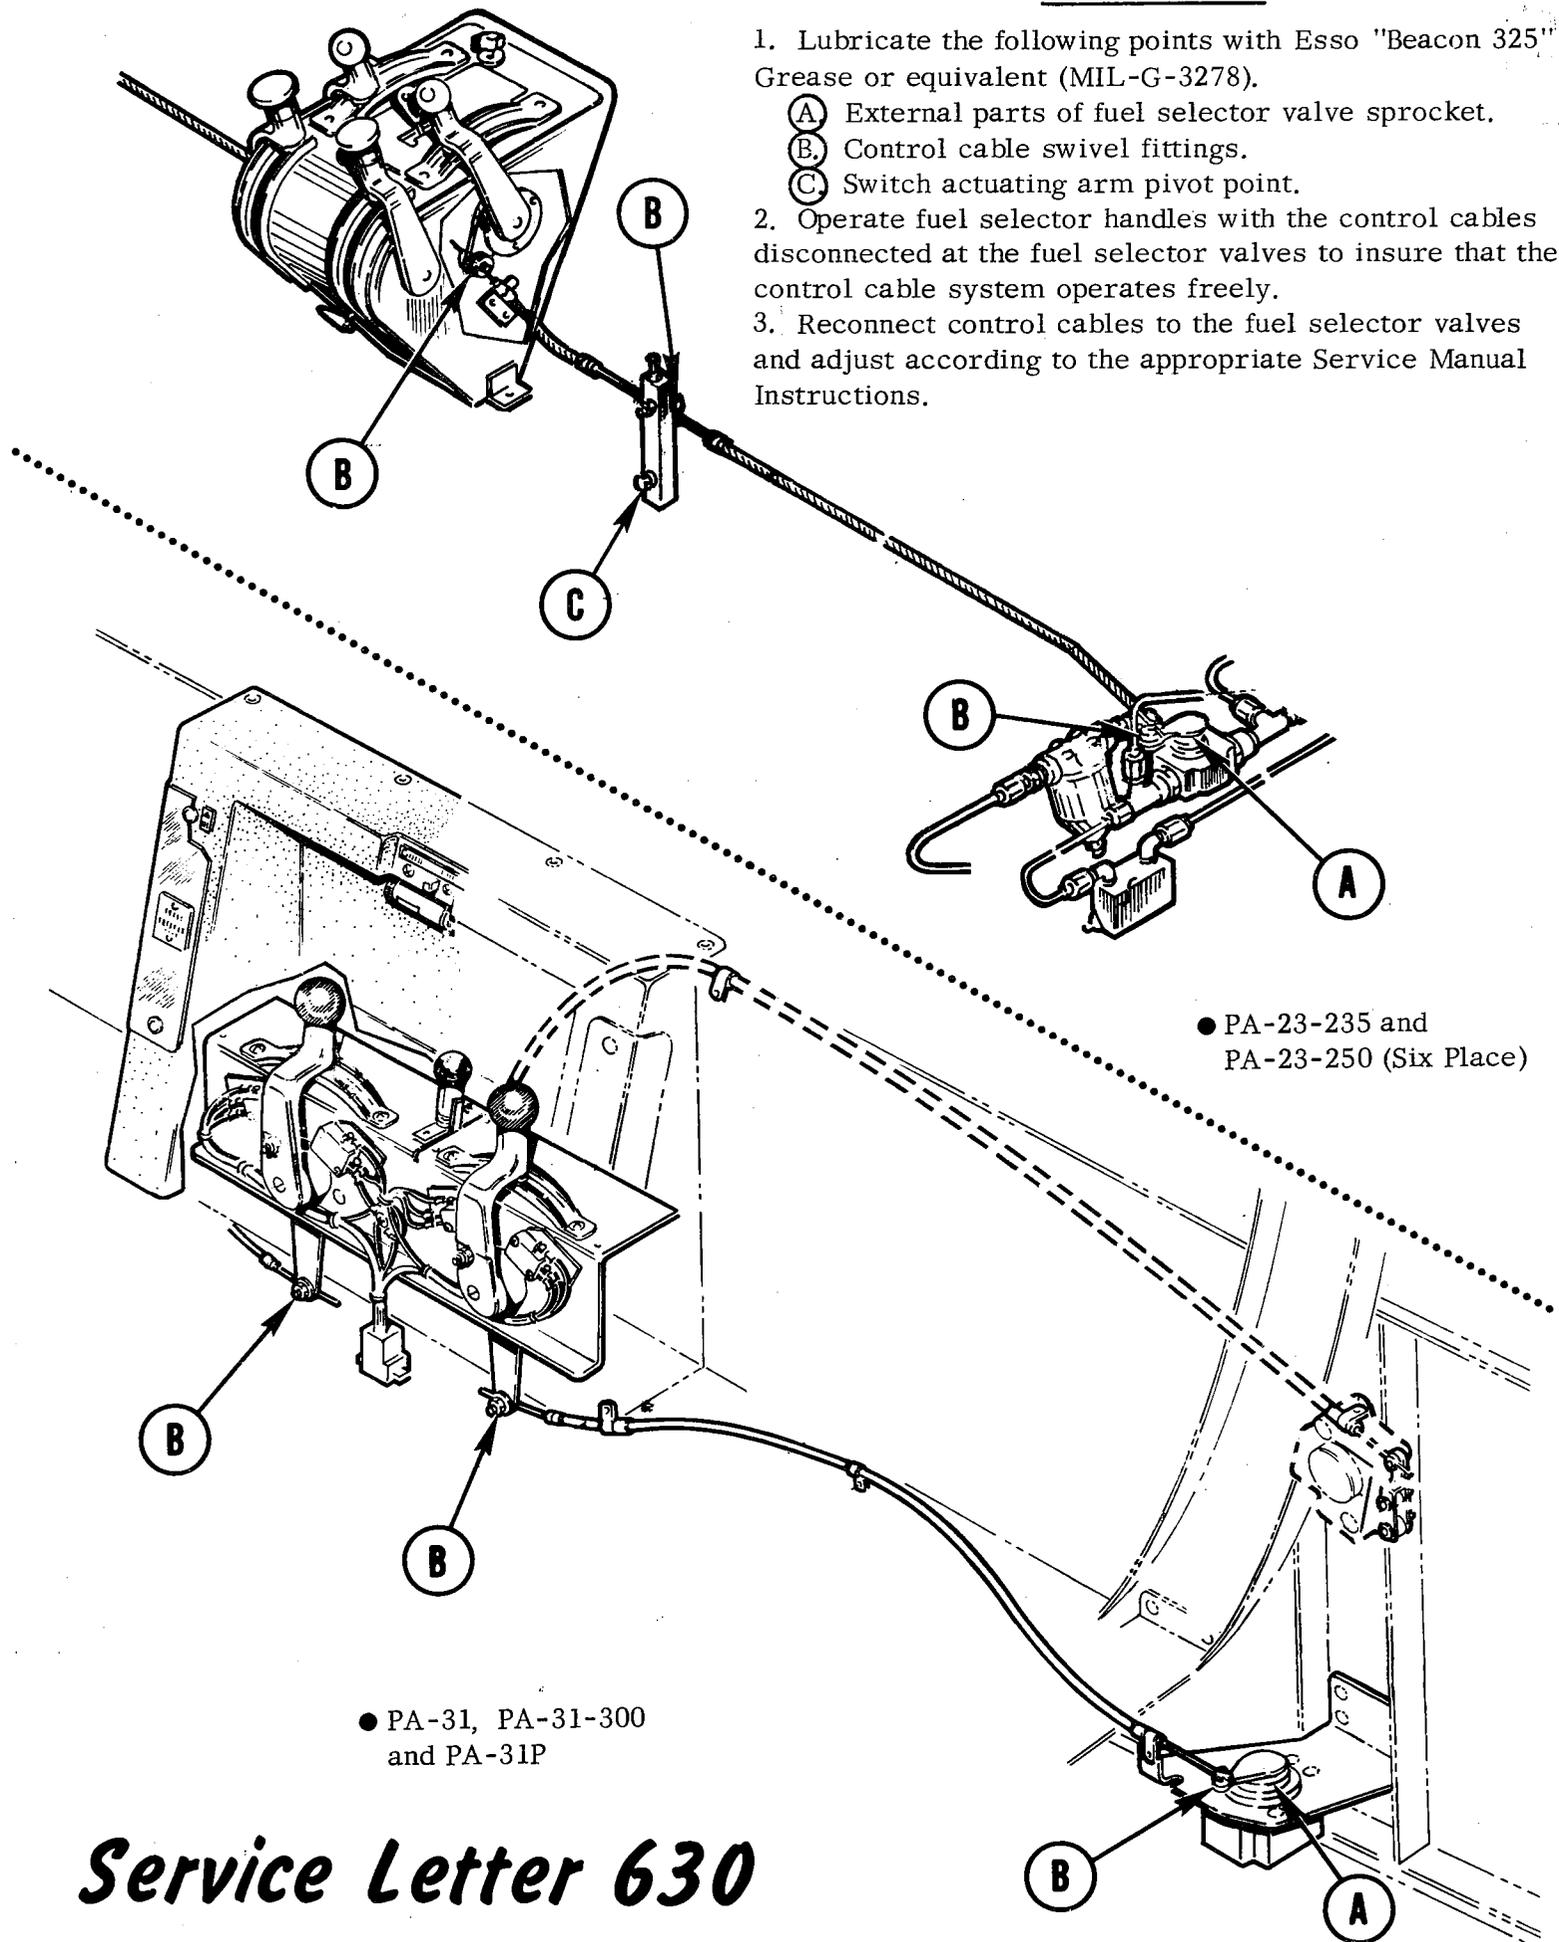
Purpose: Field feedback information received to date concerning operation of the fuel selector system external components indicates a need for additional inspection and maintenance information, particularly in the area of system lubrication.

Instructions: See sketch on reverse side of this letter for an illustration of system friction check points and lubrication directions.

1. Lubricate the following points with Esso "Beacon 325" Grease or equivalent (MIL-G-3278).

- (A) External parts of fuel selector valve sprocket.
- (B) Control cable swivel fittings.
- (C) Switch actuating arm pivot point.

2. Operate fuel selector handles with the control cables disconnected at the fuel selector valves to insure that the control cable system operates freely.

3. Reconnect control cables to the fuel selector valves and adjust according to the appropriate Service Manual Instructions.
