SERVICE BULLETIN

No. 739

Piper Aircraft Corporation

Subject: Restriction of Flap Travel and Inspection of Wing Flap Flexible Drive Shaft

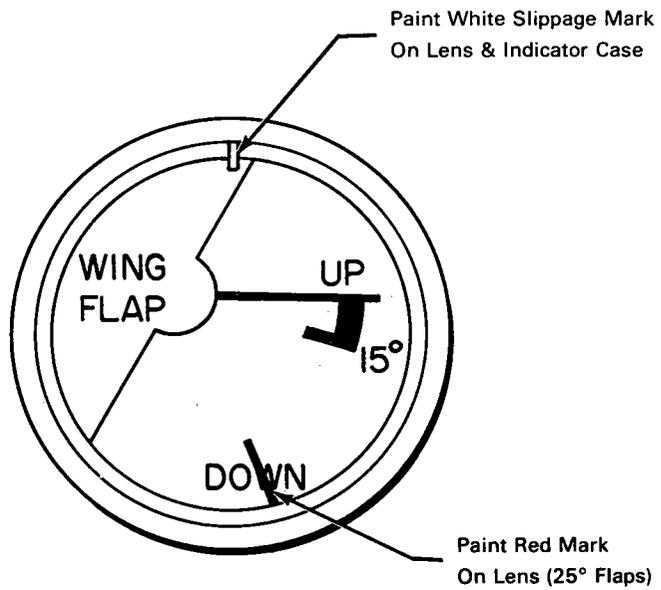
SKETCH A

TYPICAL FLAP INDICATOR

3. Paint a red full flap radial position mark to correspond with the needle position at 25° on the flap position indicator lens. Also, extend a white slippage mark from the indicator case to the lens. (Ref. Sketch A.)
4. Attach the appropriate Flap Operation Placard on the left window molding in plain view of the pilot. (Ref. Sketch B.)
5. For PA-31P aircraft attach appropriate Stall Speed Placard(s) adjacent to the airspeed indicator(s). (Ref. Sketch C.)
6. Make the necessary handwritten changes in pen and ink to the appropriate Airplane Flight Manual/Pilot's Operating Manual/Pilot's Operating Handbook as follows:
 - (a) For Piper Model PA-31-300:
 - (i) Approved Airplane Flight Manual per PAC Report No. 1470 for Model PA-31-300, Serial Nos. 31-2 through 31-511.

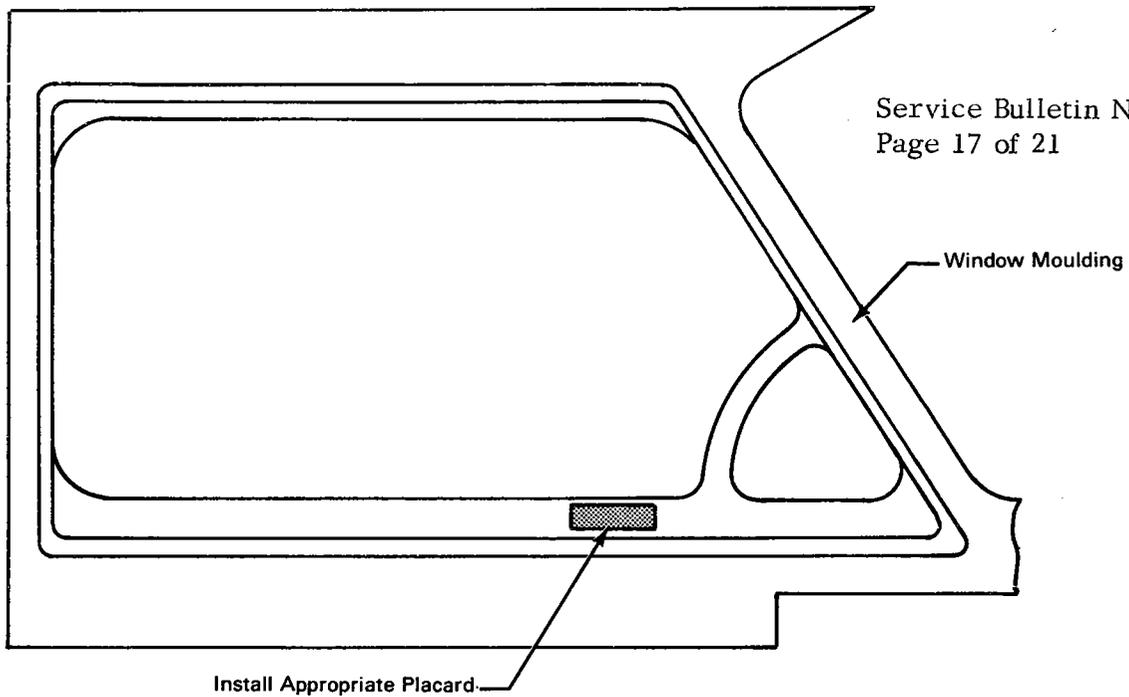
Typical Left Pilot's Window Moulding

FLAP SETTINGS IN EXCESS OF 25° ARE NOT APPROVED. DISENGAGE THE AIRCRAFT AUTOPILOT PRIOR TO OPERATING FLAPS. OPERATE FLAP CONTROL IN SMALL INCREMENTS TO ASSURE FLAP SYMMETRY.

Cut Out And Attach Placard P/N 71859-2 To Pilot's Window Moulding
As Shown In Sketch Above.

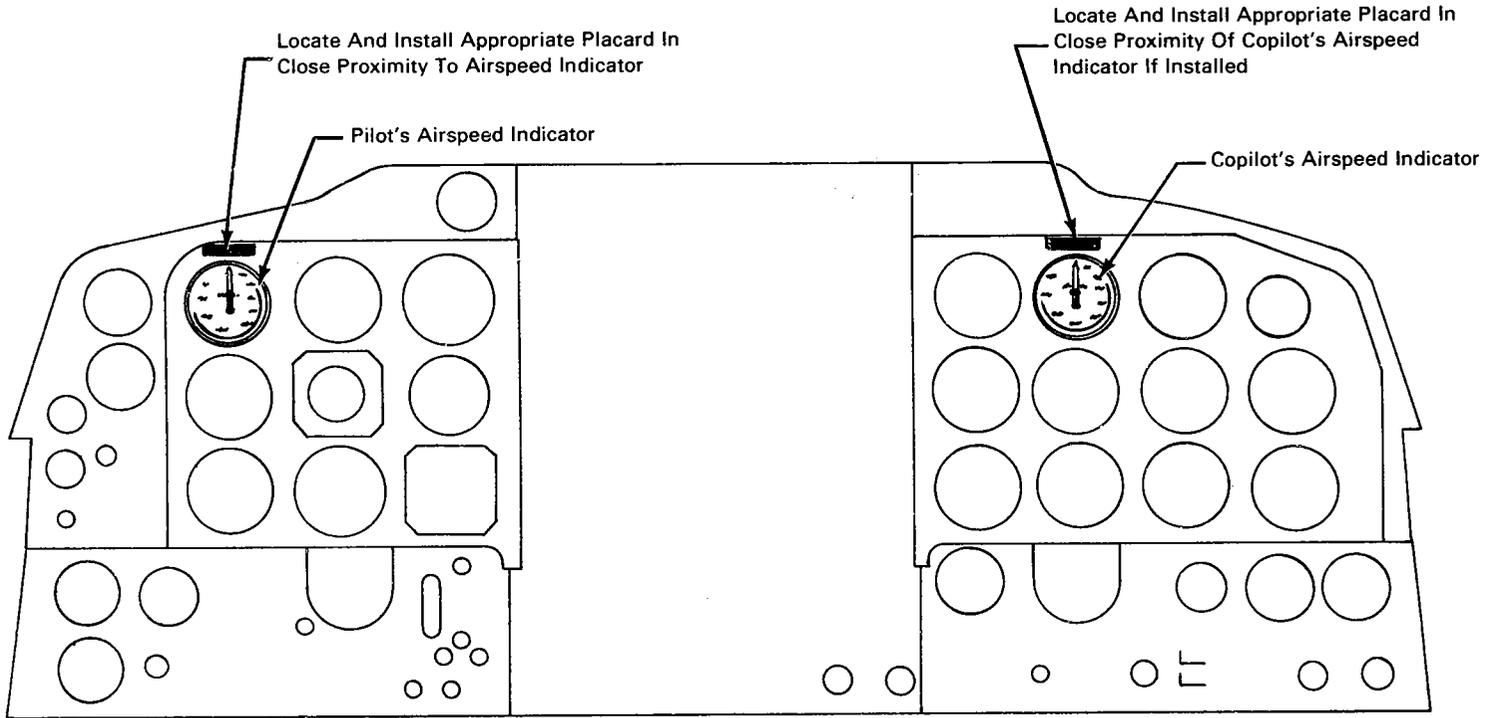
PA-31P INSTRUMENT PANEL

**STALL SPEED 86 MPH/75 KT
WITH 25° FLAPS** 81008-2

Cut Out And Attach Placard(s) P/N 81007-2 To Instrument Panel In Close Proximity To Airspeed Indicator(s) As Shown Above.

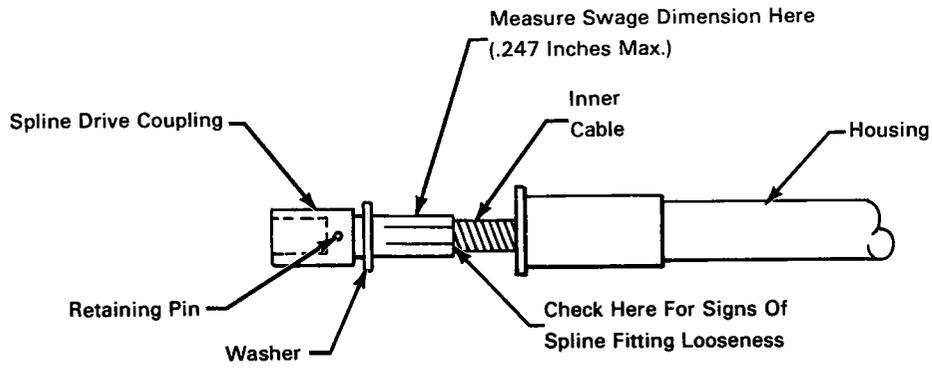
FIGURE 2

4. Visually inspect the flexible shaft splined drive coupling and retaining pin for evidence of looseness on the cable swage fitting. (Ref Sketch D, Figure 2.) If any looseness is apparent, replace the flexible shaft assembly.

5. Inspect the swaged fittings at both ends of the flexible shaft as follows:
 - a. Expose the swaged portion of the inner cable at the motor end by twisting the outer housing two (2) turns clockwise. The swaged portion of the cable should have eight (8) flats clearly visible and free from deep scratches or wear marks. (Ref Sketch D, Figure 2.)

- b. Using a micrometer, or dial caliper, measure the diameter of the swage for each of the flats at the middle of the swaged portion of the cable. A total of four (4) measurements should be taken. If any of the measurements exceed .247 inches, replace the drive shaft

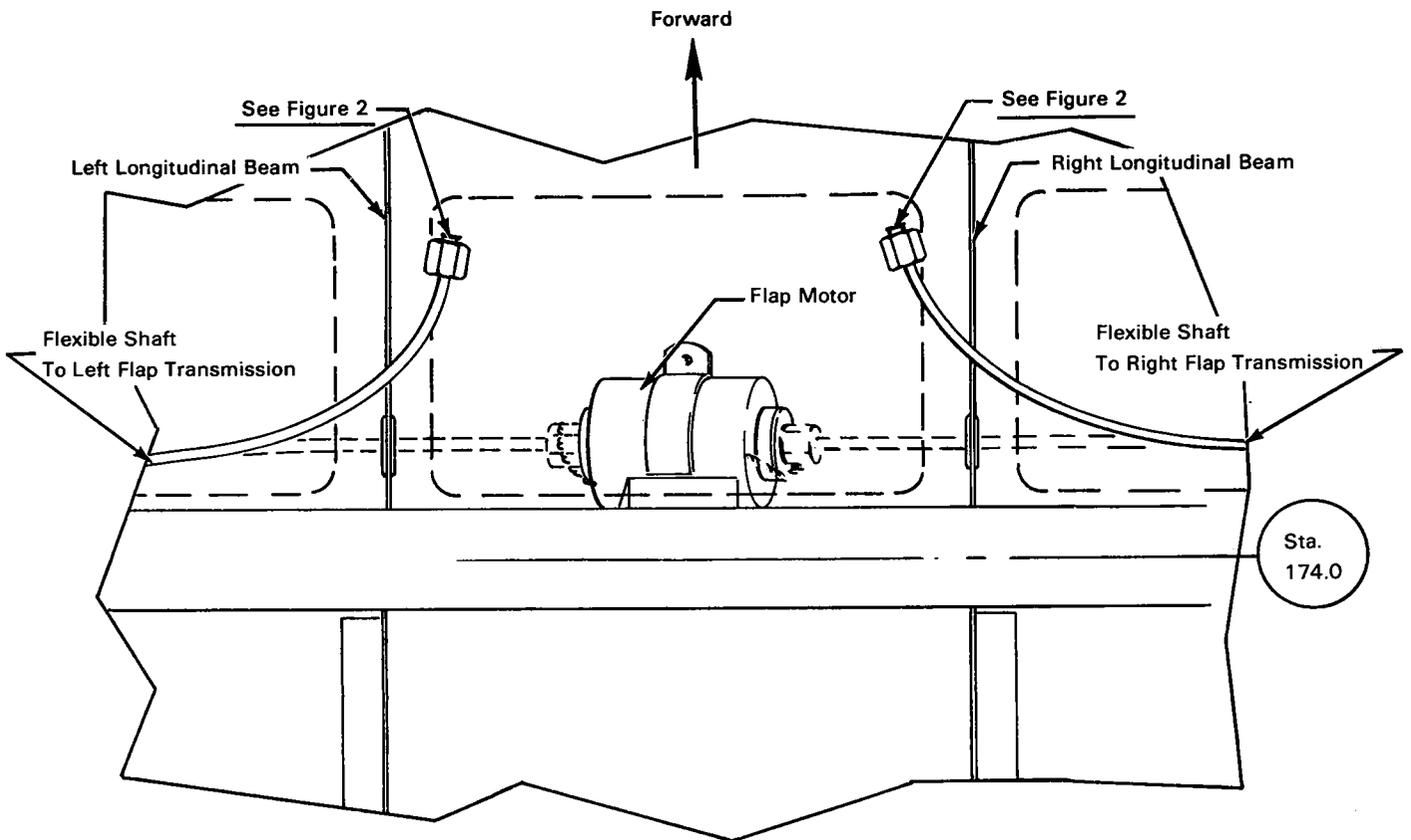
FIGURE 1

1. Gain access to flap motor, Piper Part Number 475 208 and flexible shaft assemblies, (drive shaft), Piper Part Number 486 597, as outlined in the Surface Controls section (Chapter 5) of the appropriate Navajo/Chieftain/Pressurized Navajo Service Manual.
2. Remove all Ty-Raps and support clamps along the entire length of both flexible shaft assemblies, and inspect the outer housing. If the housing is damaged, replace the flexible shaft assembly.
3. Disconnect flexible shafts and remove the flap motor. Using caution not to damage the flexible shaft housing, route the flexible shafts outboard through the longitudinal beams (Ref Sketch D).

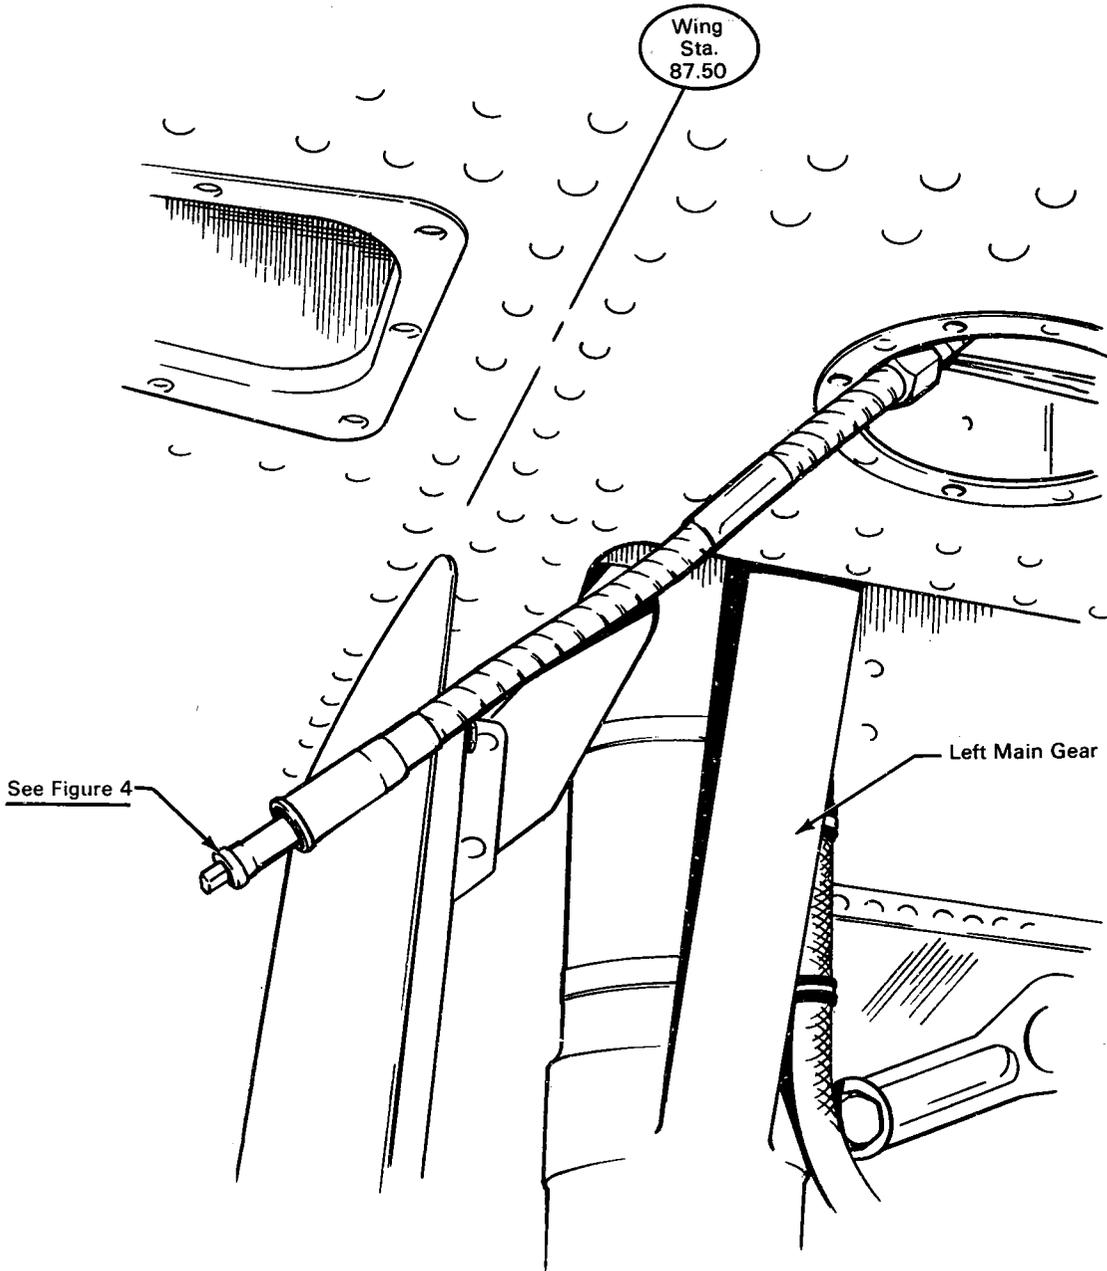
FIGURE 3

- c. Disconnect drive shaft from the flap transmission. Using caution not to damage the shaft housing, route inboard through the Sta. 87.50 bulkhead. (ref Sketch E.) Inspect the swaged portion of the drive blade fitting end as described in "a" and "b" above.

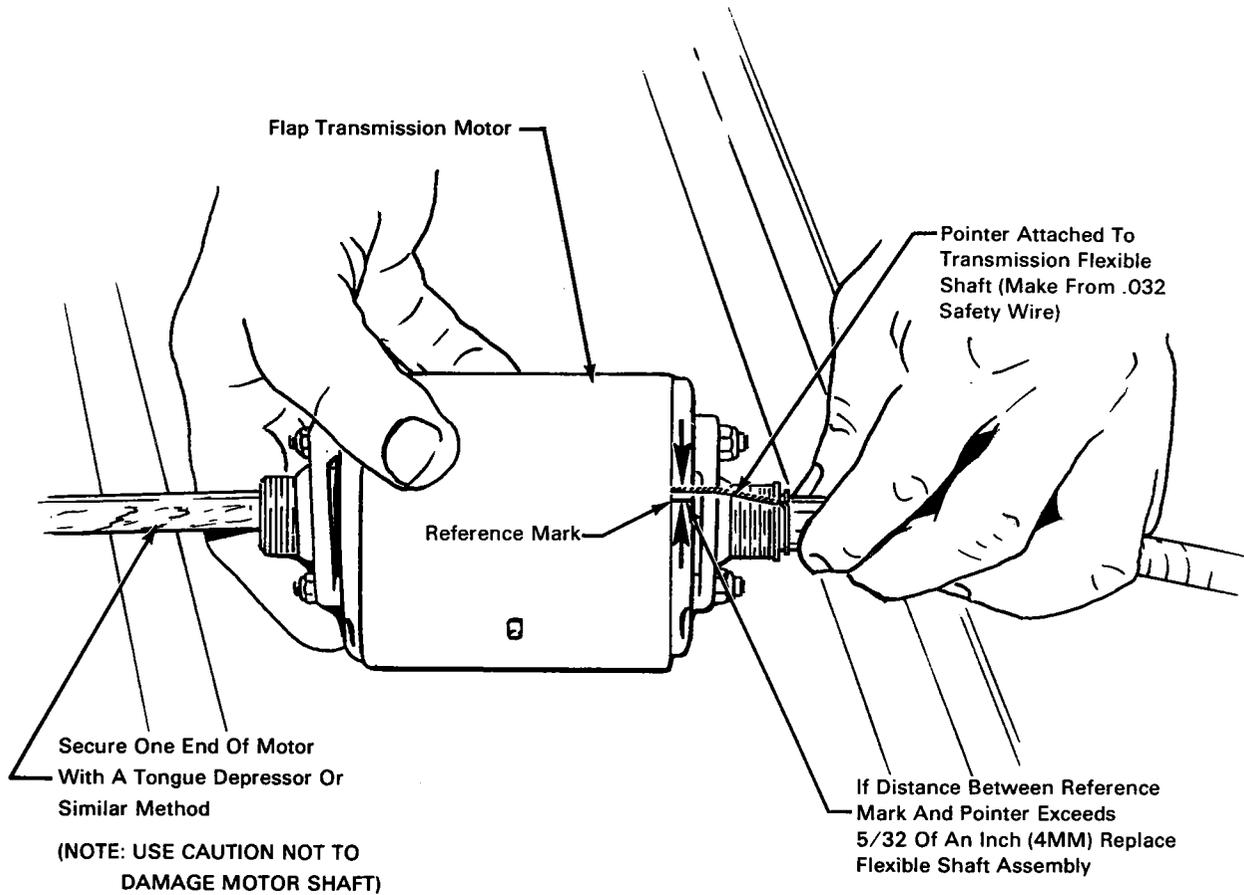
FIGURE 5

- b. Hold the spline end of the flexible shaft securely with one hand, and gently turn the flap motor to remove rotational play in the splines. Place a reference mark on the motor housing adjacent to the wire pointer (Ref Sketch F, Figure 5). Turn the flap motor gently in the opposite direction to remove rotational play and place another reference mark on the motor housing. If any distance between these two marks exceed 5/32 of an inch (4 mm) replace the flexible shaft assembly (Ref Sketch F, Figure 5).
