Piper Aircraft Corporation  
Vero Beach, Florida, U.S.A.

# SERVICE *No.* 923 BULLETIN

Date August 16, 1989 M

SUBJECT: Main Landing Gear Actuator Reinforcement Bracket Replacement

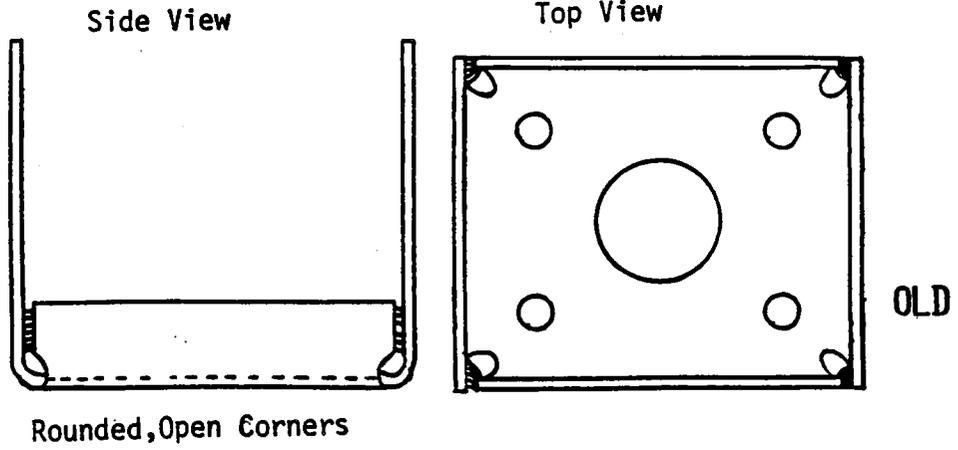
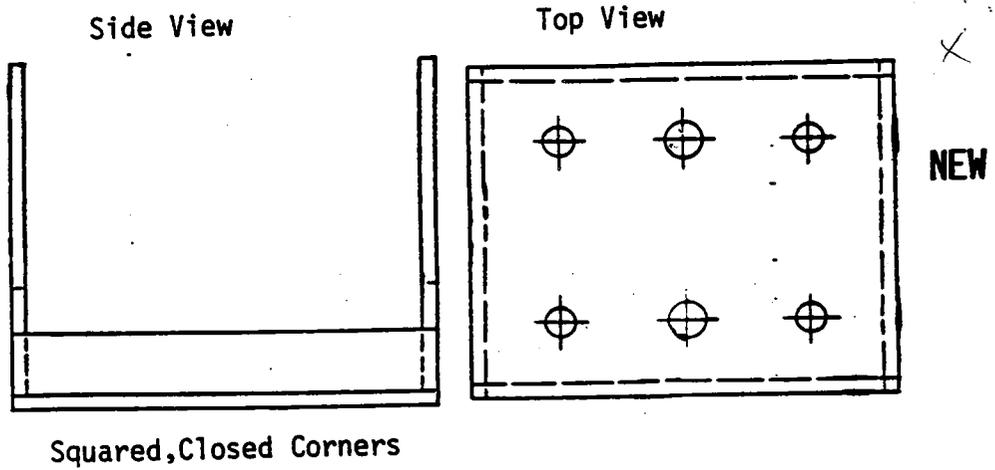
Some aircraft may have the new actuator reinforcement brackets (Piper Part Number 73786-02) installed as replacement parts. Refer to Sketch "A" for identification of Piper Part Numbers 40776-00 (old) and 73786-02 (new). Aircraft with Piper Part Number 73786-02 installed on both sides are in compliance with this Service Bulletin.
