SERVICE LETTER

No. 798

Piper Aircraft Corporation

Subject: Cabin Headliner/Oxygen Cover Panel Refinement

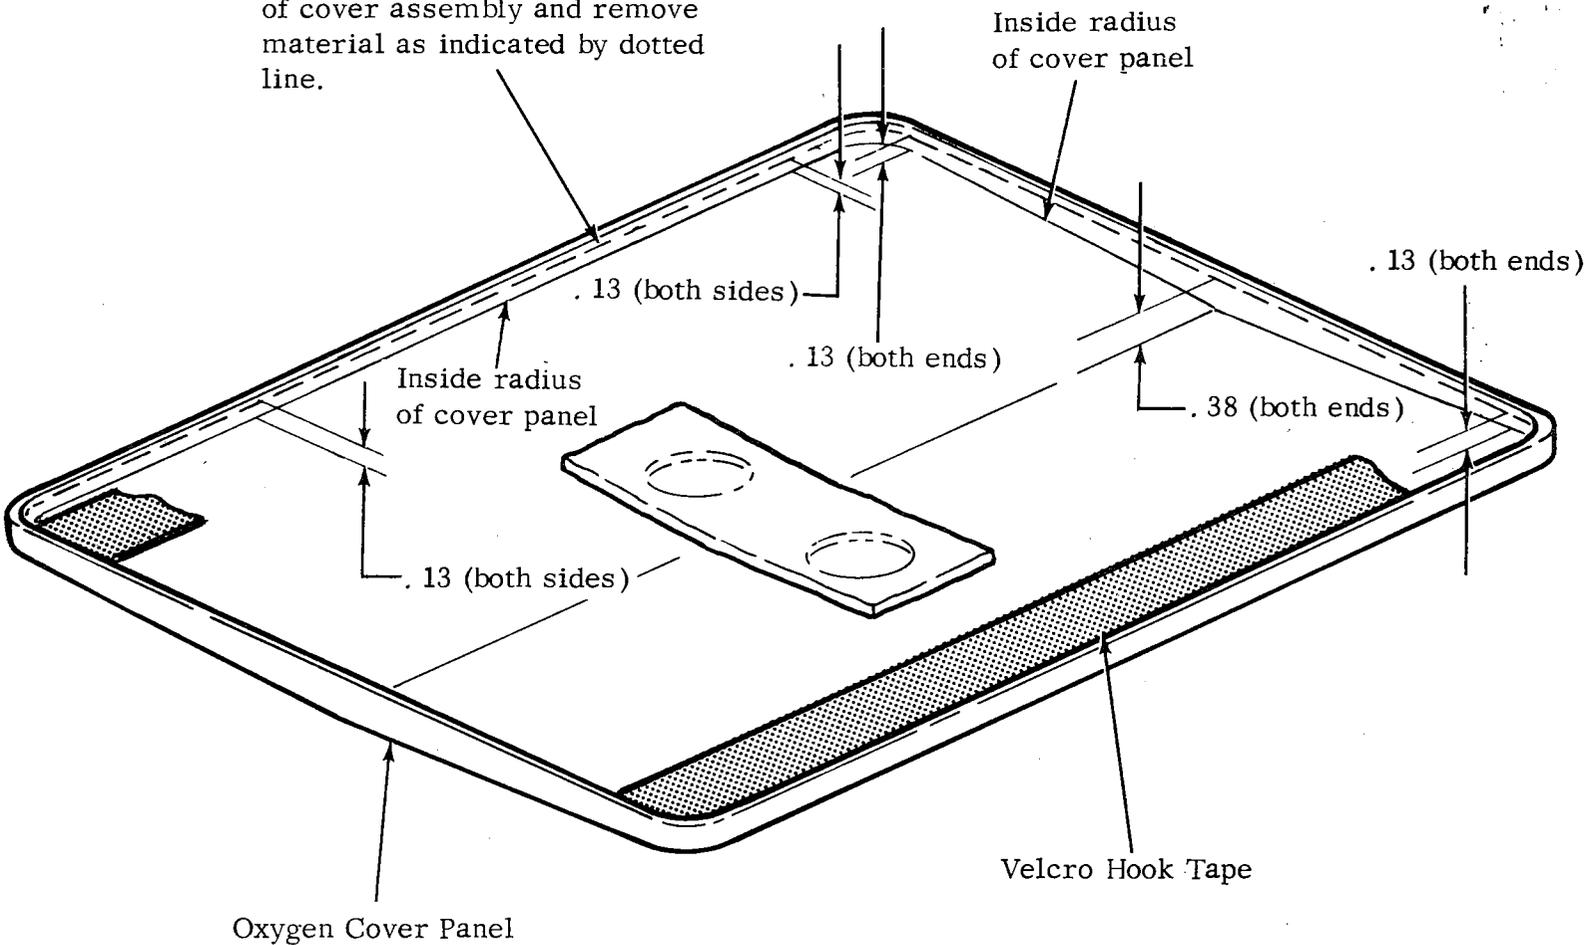
OXYGEN COVER PANEL REWORK

Purpose: Several customer acceptance reports received from Pressurized Navajo and/or Cheyenne owner/operators indicate that the oxygen mask storage cover panels do not fit properly with respect to the cabin center headliner, presenting an undesirable appearance. This may exist as a result of excessive cover panel covering material.

Scribe line along inside flanges of cover assembly and remove material as indicated by dotted line.

1. Remove the three oxygen cover panels from the headliner center panel assembly.
2. Scribe a line, to dimensions shown above, along the inside flanges of the cover assemblies.
3. Remove excess material using the most convenient method.
4. Reinstall cover panels to headliner center panel assembly.
5. Make proper logbook entry of Service Letter compliance.
