SERVICE No. 423 BULLETIN

Piper Aircraft Corporation

Subject: Propeller Electric De-Icer Solenoid Replacement

Models Affected: PA-31P Navajo

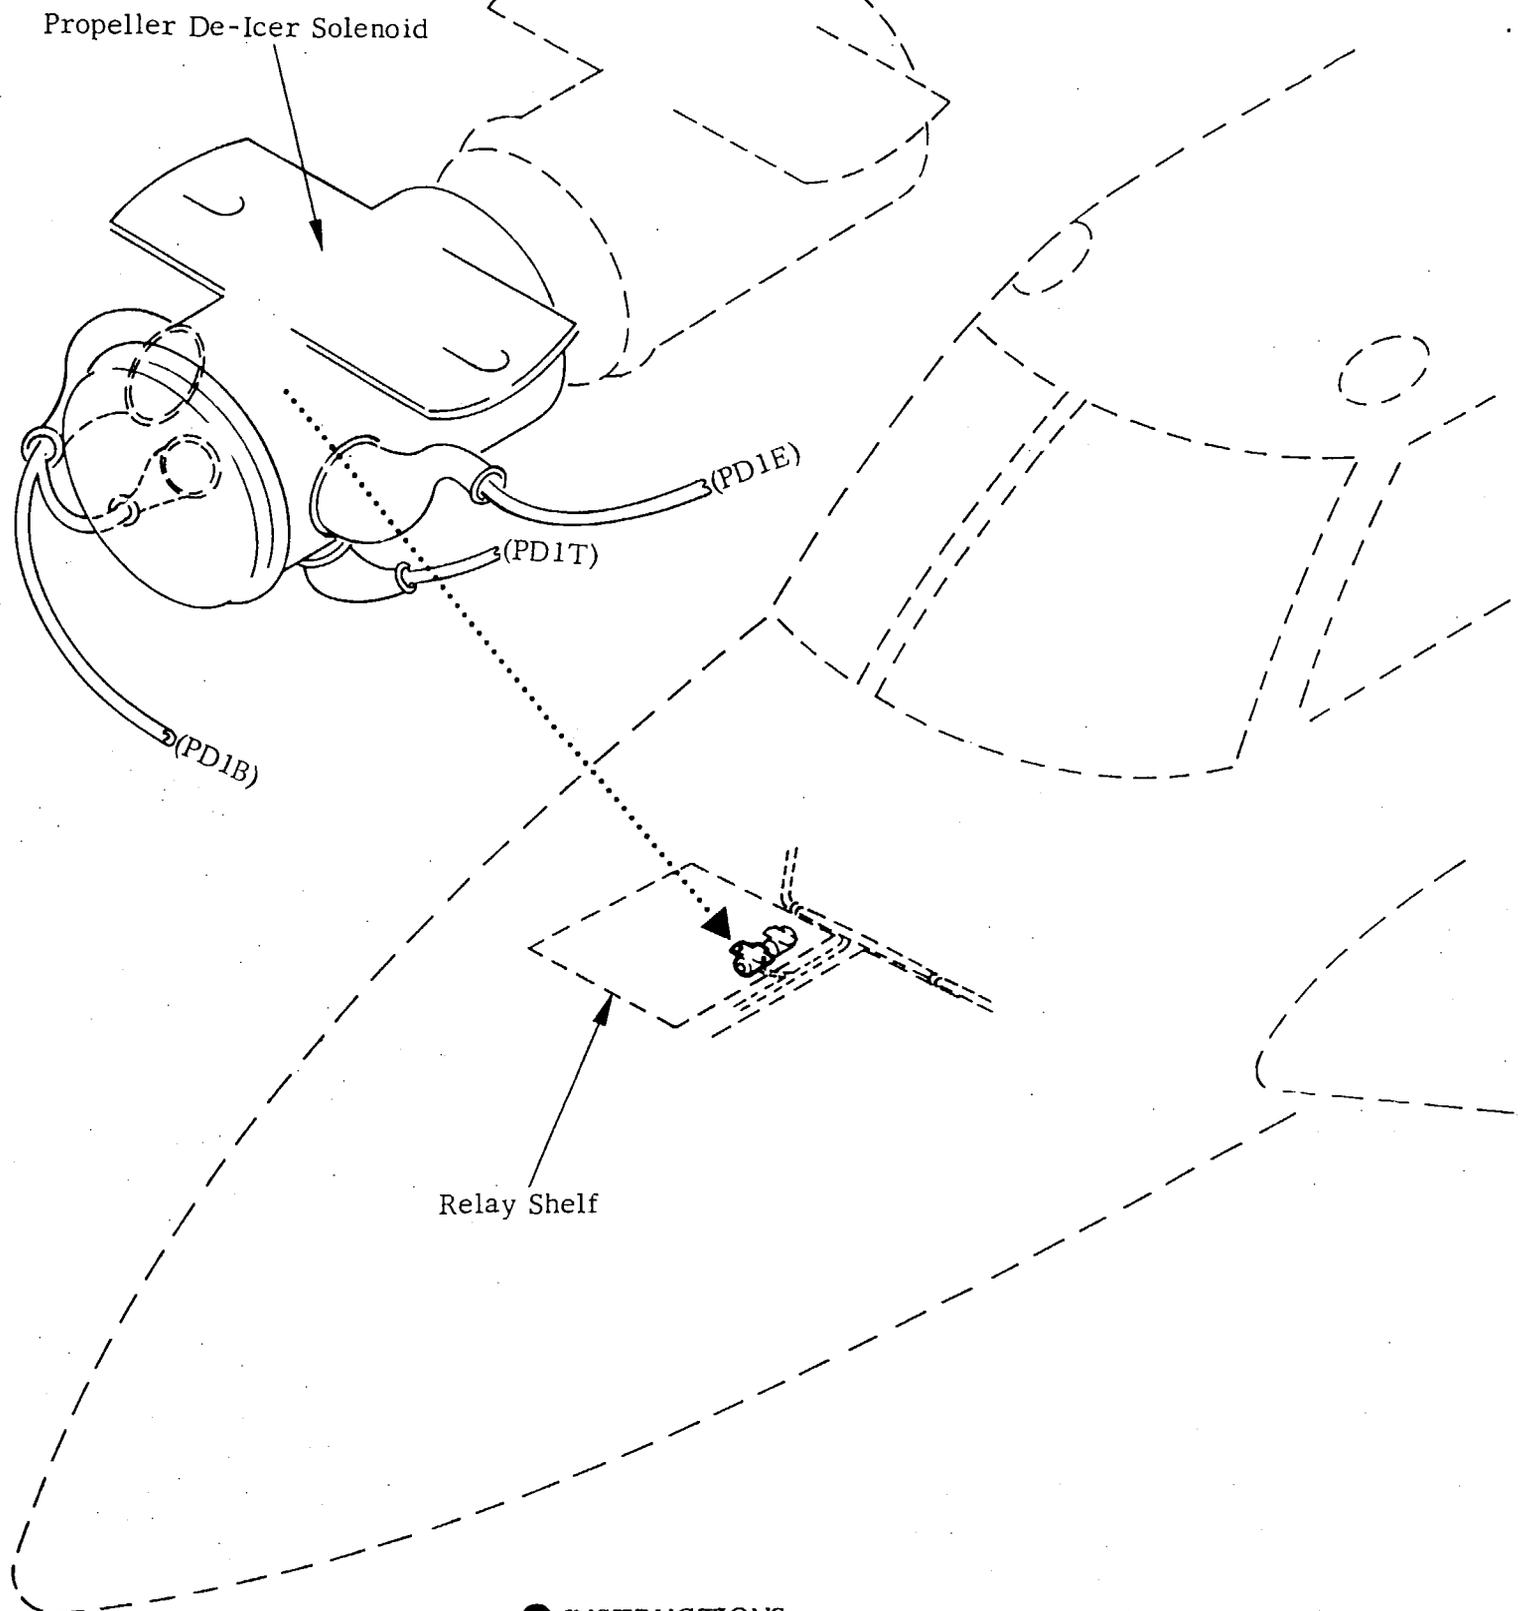
Purpose: To announce a propeller electric de-icer system refinement consisting of a change from the existing "intermittent" type solenoid to a "continuous operation" type solenoid. The new "continuous operation" solenoid is designed to provide increased reliability and extended service life.

● INSTRUCTIONS

1. Remove access panel from right side of forward fuselage to gain access to the relay shelf.
2. Disconnect wires from existing propeller de-icer solenoid and remove solenoid.
3. Install new solenoid P/N 26898-05 and reconnect wires as shown.
4. Reinstall access panel.
