# SERVICE BULLETIN

No. 487

Piper Aircraft Corporation

Control Shaft Collar Attachment Modification

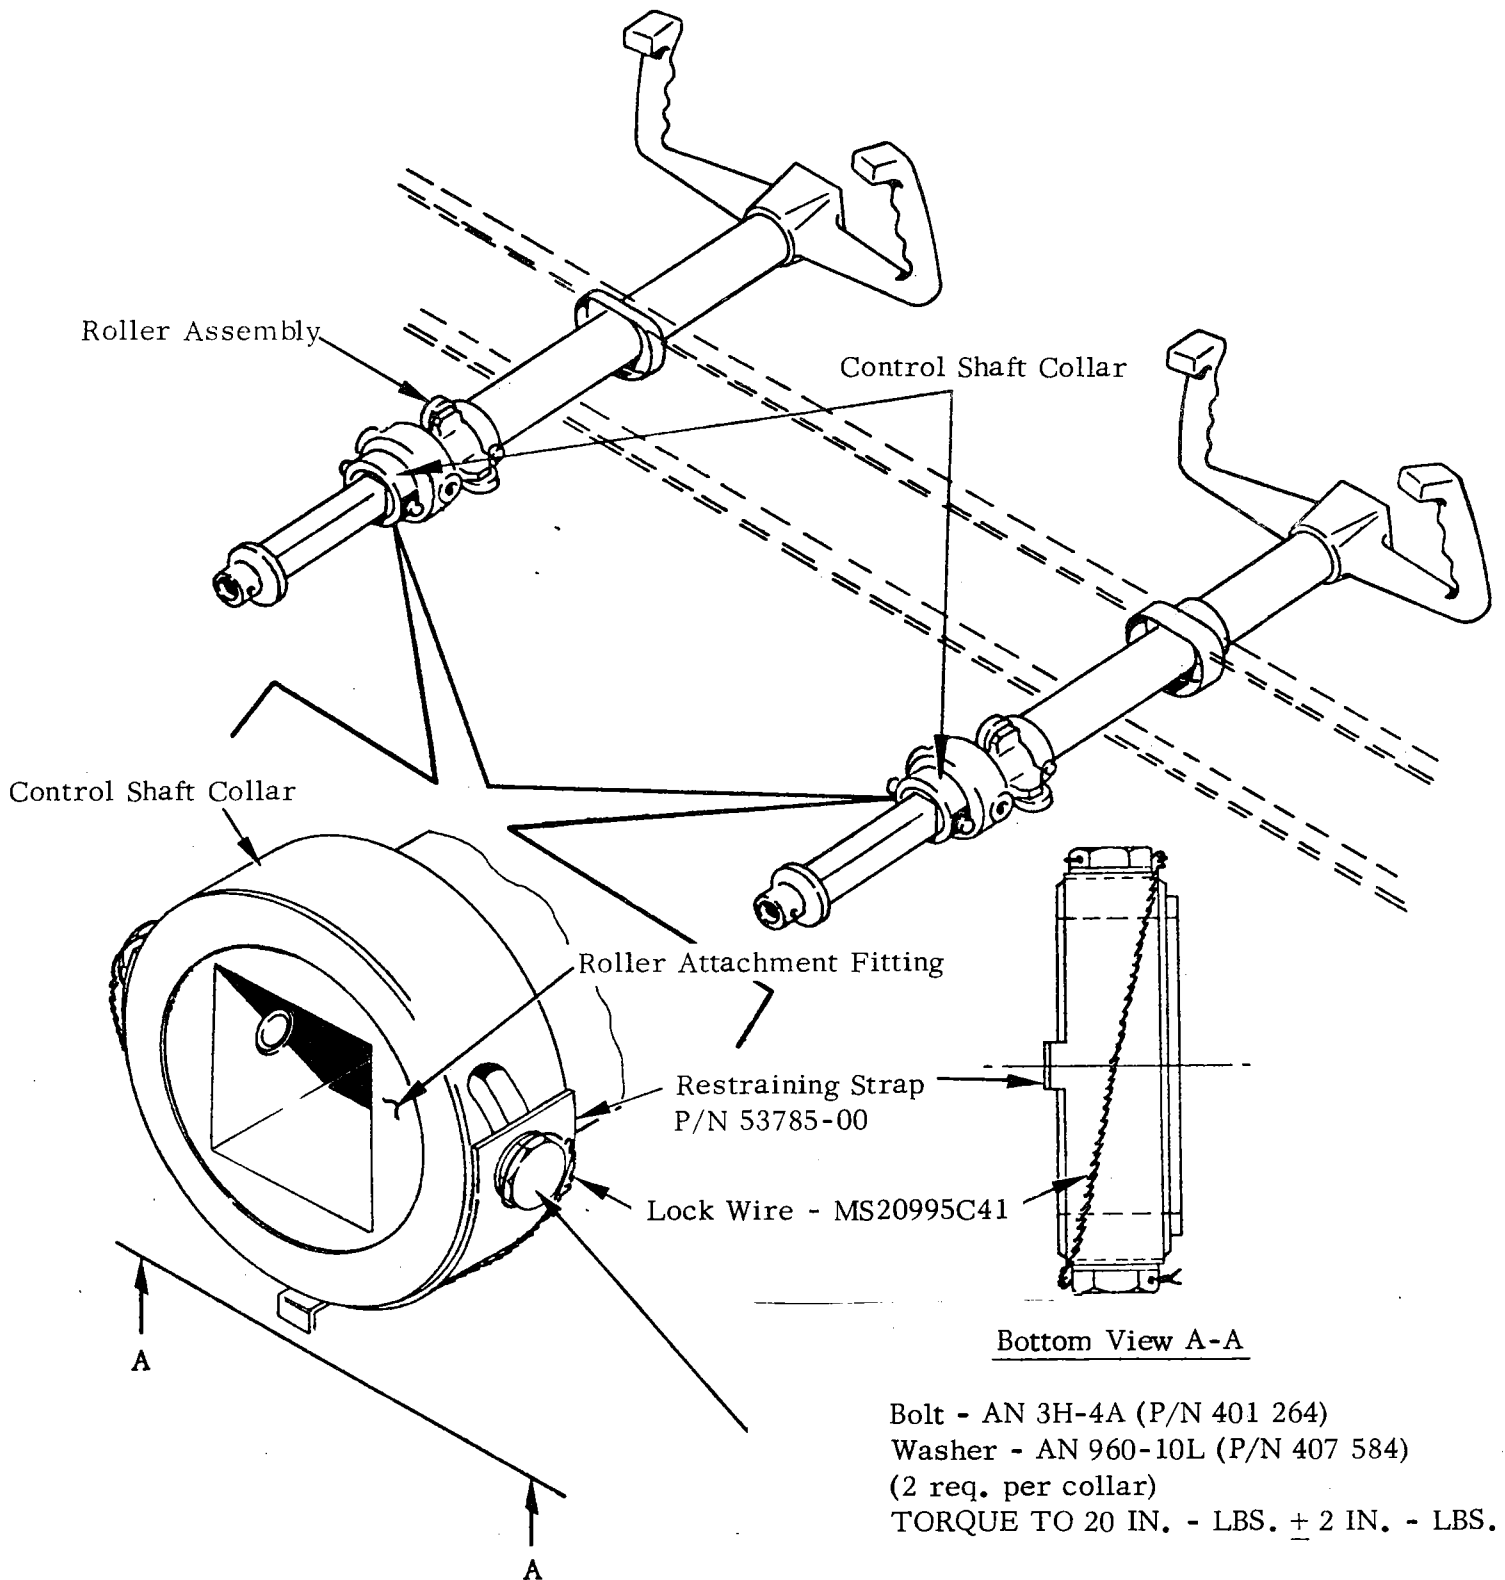
A recent report from the field indicates that the AN 3H3A bolts which attach the control shaft collar to the control shaft tube can be of insufficient length to allow proper bolt thread engagement. Should this condition exist, the bolts can become detached from the assembly, affecting control column function.

1. Refer to attached sketch; move control wheel to gain access to roller assembly. Rotate control wheel as required to gain access to each bolt.
2. Cut lock wire, as shown on sketch detail.

Bolt - AN 3H-4A (P/N 401 264)  
 Washer - AN 960-10L (P/N 407 584)  
 (2 req. per collar)  
 TORQUE TO 20 IN. - LBS.  $\pm$  2 IN. - LBS.

**NOTE:** Inspect to insure that the bolts are not protruding through the Roller Attachment Fitting by placing a .040 feeler gage between the fitting and the square tube. Should the bolt protrude, add one (1) additional AN 960-10L washer under the head and recheck clearance at 20 IN. - LBS.  $\pm$  2 IN. - LBS.
