SERVICE LETTER

No. 701

Piper Aircraft Corporation

Wiring of Overvoltage Relays -- Alternator Paralleling System

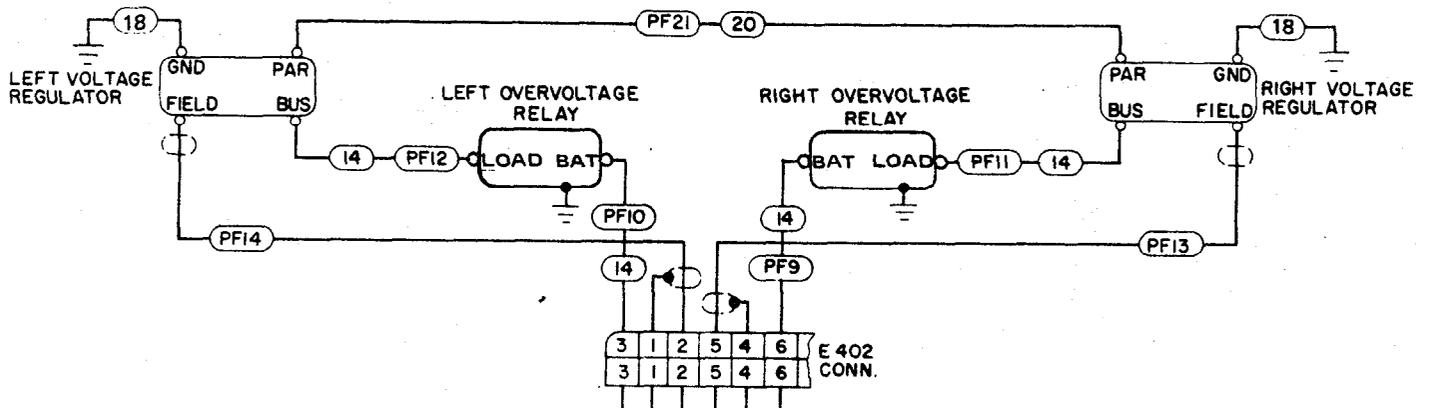
In the existing Electrical System section of the PA-31P Service Manual (Section XI), Figure 11-11a, Page 11-12a, contains an electrical system wiring schematic relative to the alternator paralleling system. It has been brought to our attention that the left and right overvoltage relay terminal connections have not been identified as to which terminal is "battery" and which is "load".

The objective of this service release is to advise owners/operators of the above referenced aircraft that have had overvoltage relays replaced and/or rewired in the field to have the overvoltage relays rechecked to insure the proper terminal connection, in accordance with the attached sketch -- which clearly specifies the overvoltage relay "battery" and "load" terminals.

1. Remove access panel from left side of forward fuselage to gain access to the electrical accessory shelf.
2. Inspect wiring on left and right overvoltage relays to determine if wires on "BAT" and "LOAD" terminals are correctly wired as shown on above schematic.
3. Correct wiring if required and reinstall access panel.
4. Check operation of overvoltage relays in accordance with Overvoltage Relay Test Information, Section XI, Pressurized Navajo Service Manual.
