SERVICE BULLETIN

488

Piper Aircraft Corporation
"DOA EA-1 Approved"

Modification of Landing Gear Selector Cable Forward Attachment Pin.

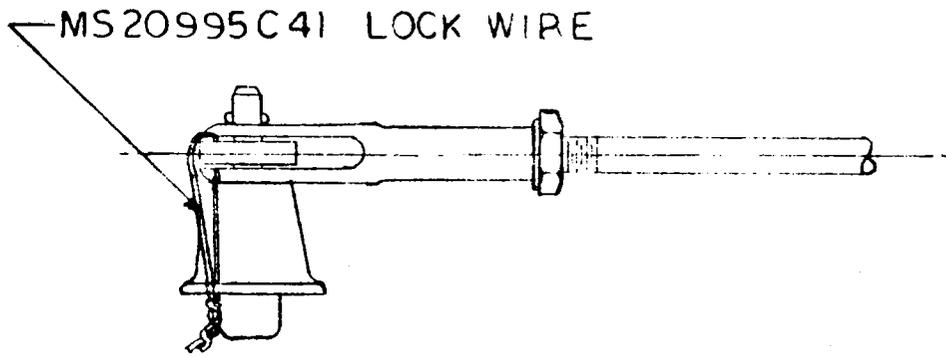
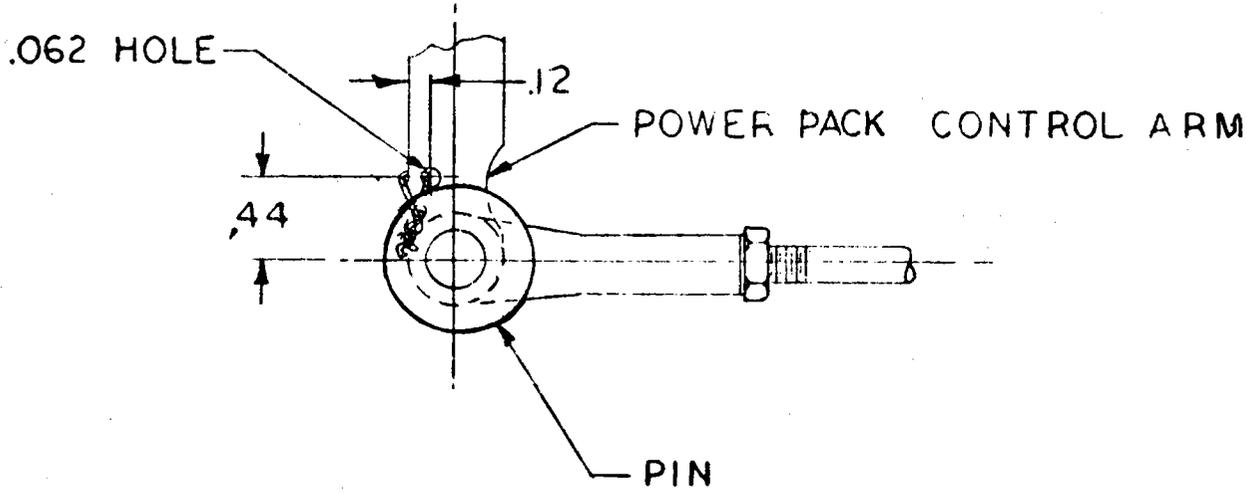
The landing gear selector flexible push-pull control cable assembly is attached to the hydraulic powerpack control arm by a cable attachment pin assembly, Piper part no. 53599-00. A recent incident at the factory indicates that this pin assembly may become disengaged, causing detachment of the landing gear selector cable from the powerpack control arm, with subsequent loss of landing gear (retraction/extension) system control.

5. Safety with approximately three inches of MS20995C41 lock wire (.041 stainless steel) through the hole in the arm and existing hole in pin knob per attached sketch.

Wrap lock wire around arm on side opposite from cable, to prevent interference with cable clevis during normal operation.
