# SERVICE LETTER

No. 688

Unfeathering Accumulator Maintenance and Preventive Maintenance -- reference attached Woodward Service Bulletin No. 33551, dated August, 1973.

PA-31P Navajo

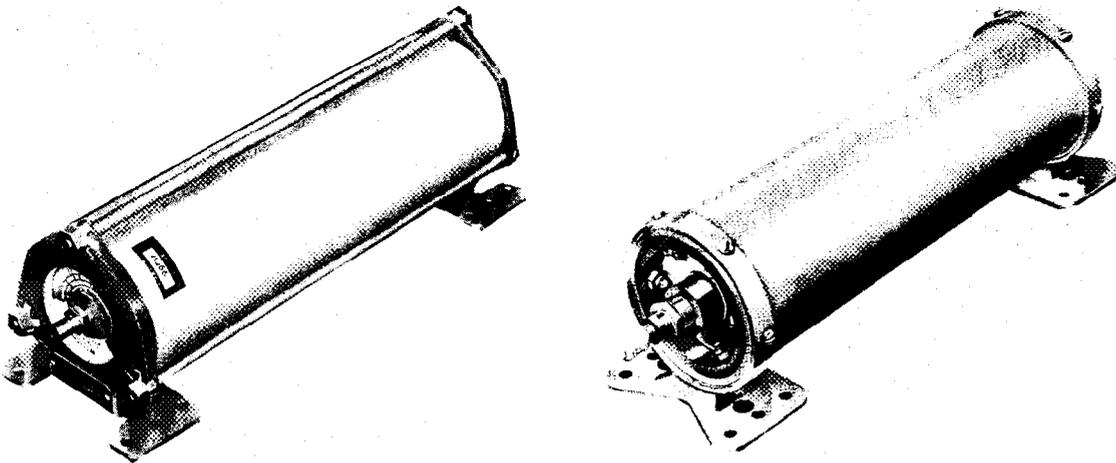
All 8907-001, -002, -003, -004, -005, -006, -007 and former model (on right) accumulator assemblies.

An accumulator that has lost its gas charge and is filled solid with oil may fail from over-pressure if:

In either case, the oil may be trapped in the accumulator with no expansion space. An 84<sup>o</sup> F temperature rise will expand the trapped oil enough to create about 1400 PSI pressure and may fail the accumulator. To prevent rupture of the cylinders the end plates will deform and allow the oil seals to extrude and leak with a loss of engine oil.

1. Check gas charge every 50 - 100 hours. Replenish as required with dry air or nitrogen. Gas charge for P/N 8907-003 is 75 psi, all others are 125 psi. If a unit will not hold 70% of its normal charge from one check to the next, it should be overhauled.

Any accumulator that will not hold a charge should be removed from the airplane and the fitting on the governor sealed with a cap. Warning: Do not remove the hose fitting from the governor. To do so may damage the governor.

2. Overhaul the accumulator routinely. TBO for the accumulator is the same as for the governor and the engine it is used on.
3. Check the unfeathering check valve setting in the governor at governor overhaul. An improperly set unfeathering check valve cannot cause an accumulator failure as long as the accumulator retains an air charge.
