SERVICE *No.884* BULLETIN

Piper Aircraft Corporation
Vero Beach, Florida, U.S.A.

April 8, 1988

Lock Wiring of V-Band Couplings

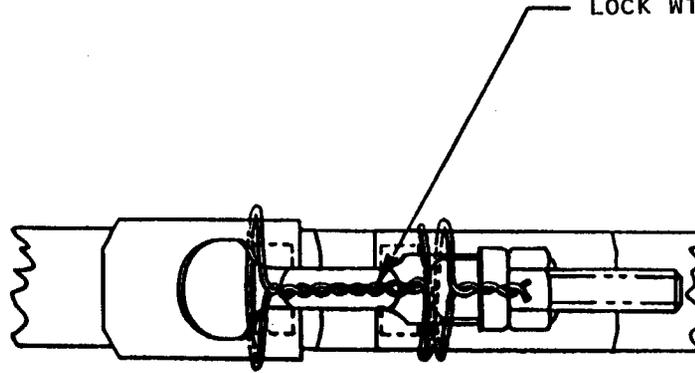
SKETCH "A"

PURPOSE: Reports have been received of broken "T-bolts" in the V-Band Couplings used in the exhaust, bleed air and cabin heat systems on various Piper Airplanes. The failure of a T-bolt can allow the coupling to separate, permitting hot exhaust gases or bleed air to be expelled, creating a fire hazard.

1. Refer to the applicable parts catalog to determine the number and location of V-Band Couplings on the affected aircraft.
2. Inspect all V-Band Couplings for security and integrity of T-bolts and lock wire (if installed). Refer to Sketch "A" attached.
3. If lock wire is damaged or missing, lock wire coupling using MS20995-C41 wire. Refer to Sketch "A".
4. Make an appropriate logbook entry of compliance with this Service Bulletin.

Lock Wire using MS 20995-C41 Wire
