VSP-37  
July 7, 1982

VENDOR SERVICE PUBLICATION

Subject: Bendix Service Bulletins 615, 620, 621

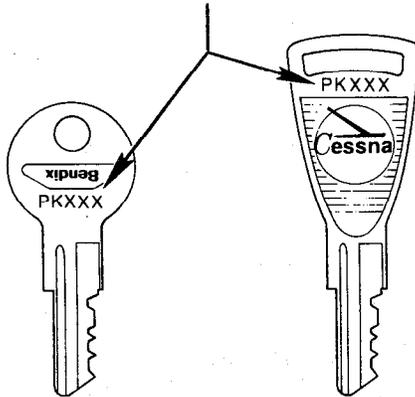
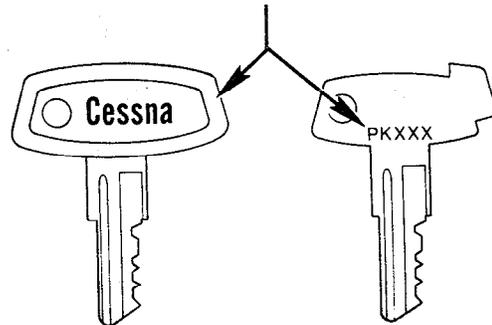
**Figure 1**

**NOTE:** The key PK number is located on the key as indicated in figure 1.

Key PK number stamped in this area.

Have to remove black rubber from top of key to expose the PK number.

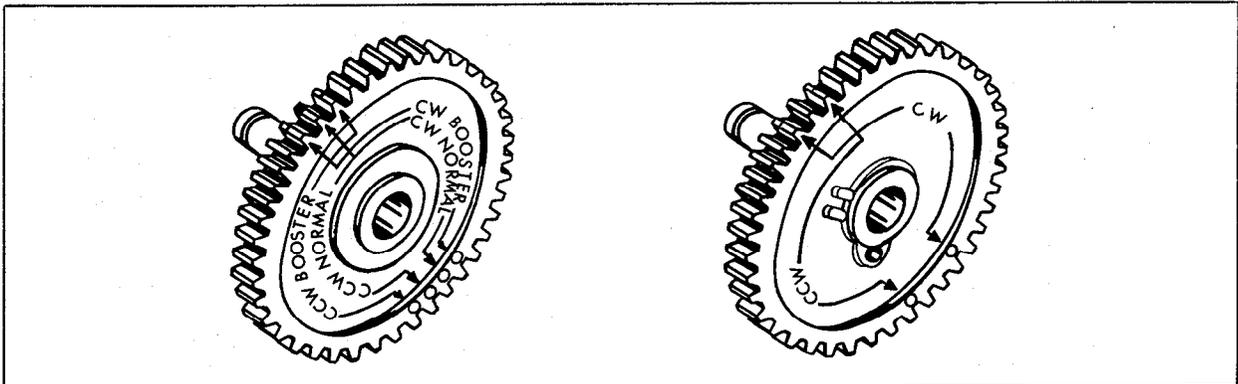
Figure 1. 10-157197 Distributor Gears with Different Timing Marks

2. If old distributor gear, P/N 10-157197, which incorporated two different molded timing identification marks was used (see figure 1), proceed as follows:

- a. Remove paint from booster timing positions with suitable solvent.
- b. Locate normal timing tooth between CW and CCW booster chamfered teeth and paint this tooth and the applicable inner timing mark with red Dykem or red lacquer in accordance with figure 2 or figure 4 for appropriate gear.

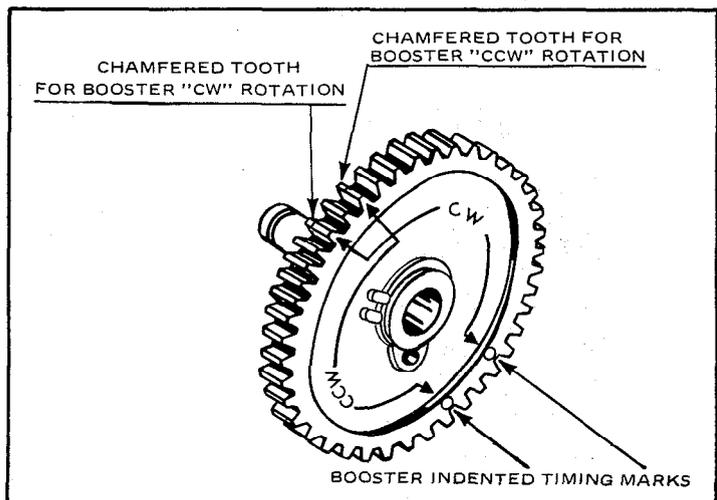
Figure 3. Timing Marks on Present Production Distributor Gear Kit Assembly 10-357586

The molded timing marks incorporated in new present production nylon spare part gears, as supplied in kit, P/N 10-357586, are for the booster timing position. Before installation of a new gear kit, the applicable normal timing mark and center tooth must be marked with red

3. If present production distributor gear as supplied in kit P/N 10-357586 is used (see figure 3) proceed as follows:
  - a. Remove paint from booster timing positions with suitable solvent.
  - b. Locate normal timing tooth between CW and CCW booster chamfered teeth and paint this tooth and the applicable inner timing mark with red Dykem or red lacquer in accordance with figure 4.

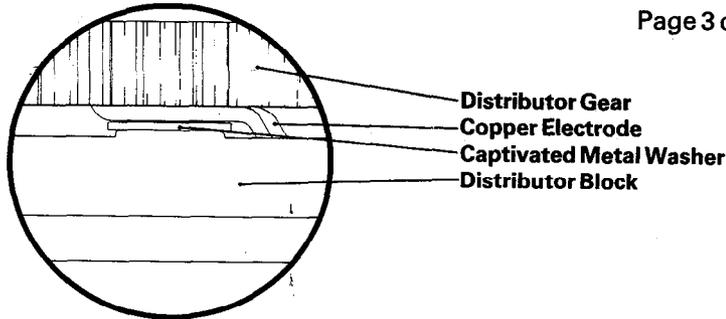
**Original Gear Make Up**  
*(Not incorporating insulating or plain steel skid washer.)*  
**Figure 1**

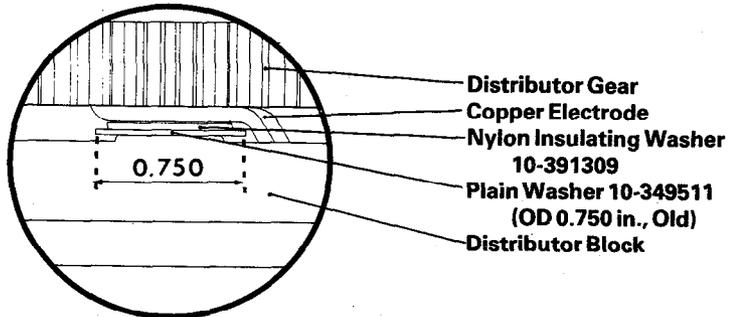
It has been determined that plain steel washer P/N 10-349511 installed on the gear axle between the nylon-insulating washer P/N 10-391309 and the distributor block bronze oil-lite bushing (see figure 2) can cause electrical flash-over in the distributor at altitude. Inspect for compliance as follows:

**Insulated Gear Configuration**  
*(Incorporating 10-357586 Kit parts with incorrect washer.)*  
**Figure 2**

1. Remove the top timing plug.
2. Using a concentrated light beam (a pen light or equivalent) look into the timing hole at the area between the distributor gear and the distributor block parts for existing washer configuration.
3. Current configuration should be as shown in figure 3.
4. Rework magneto whenever configuration is as shown in figure 2.
5. An acceptable configuration is shown in figure 1.

Rework a magneto to the correct configuration as follows:

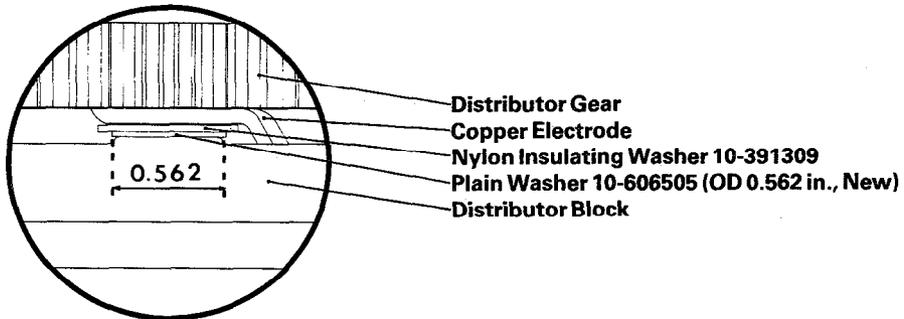
**Current Insulated Configuration**  
*(Incorporating 10-357586 Kit parts with correct washer.)*  
**Figure 3**
