SERVICE LETTER

No-643

Control Shaft Collar Restraining Strap

PA-31 and PA-31-300 Navajo
PA-31P Navajo

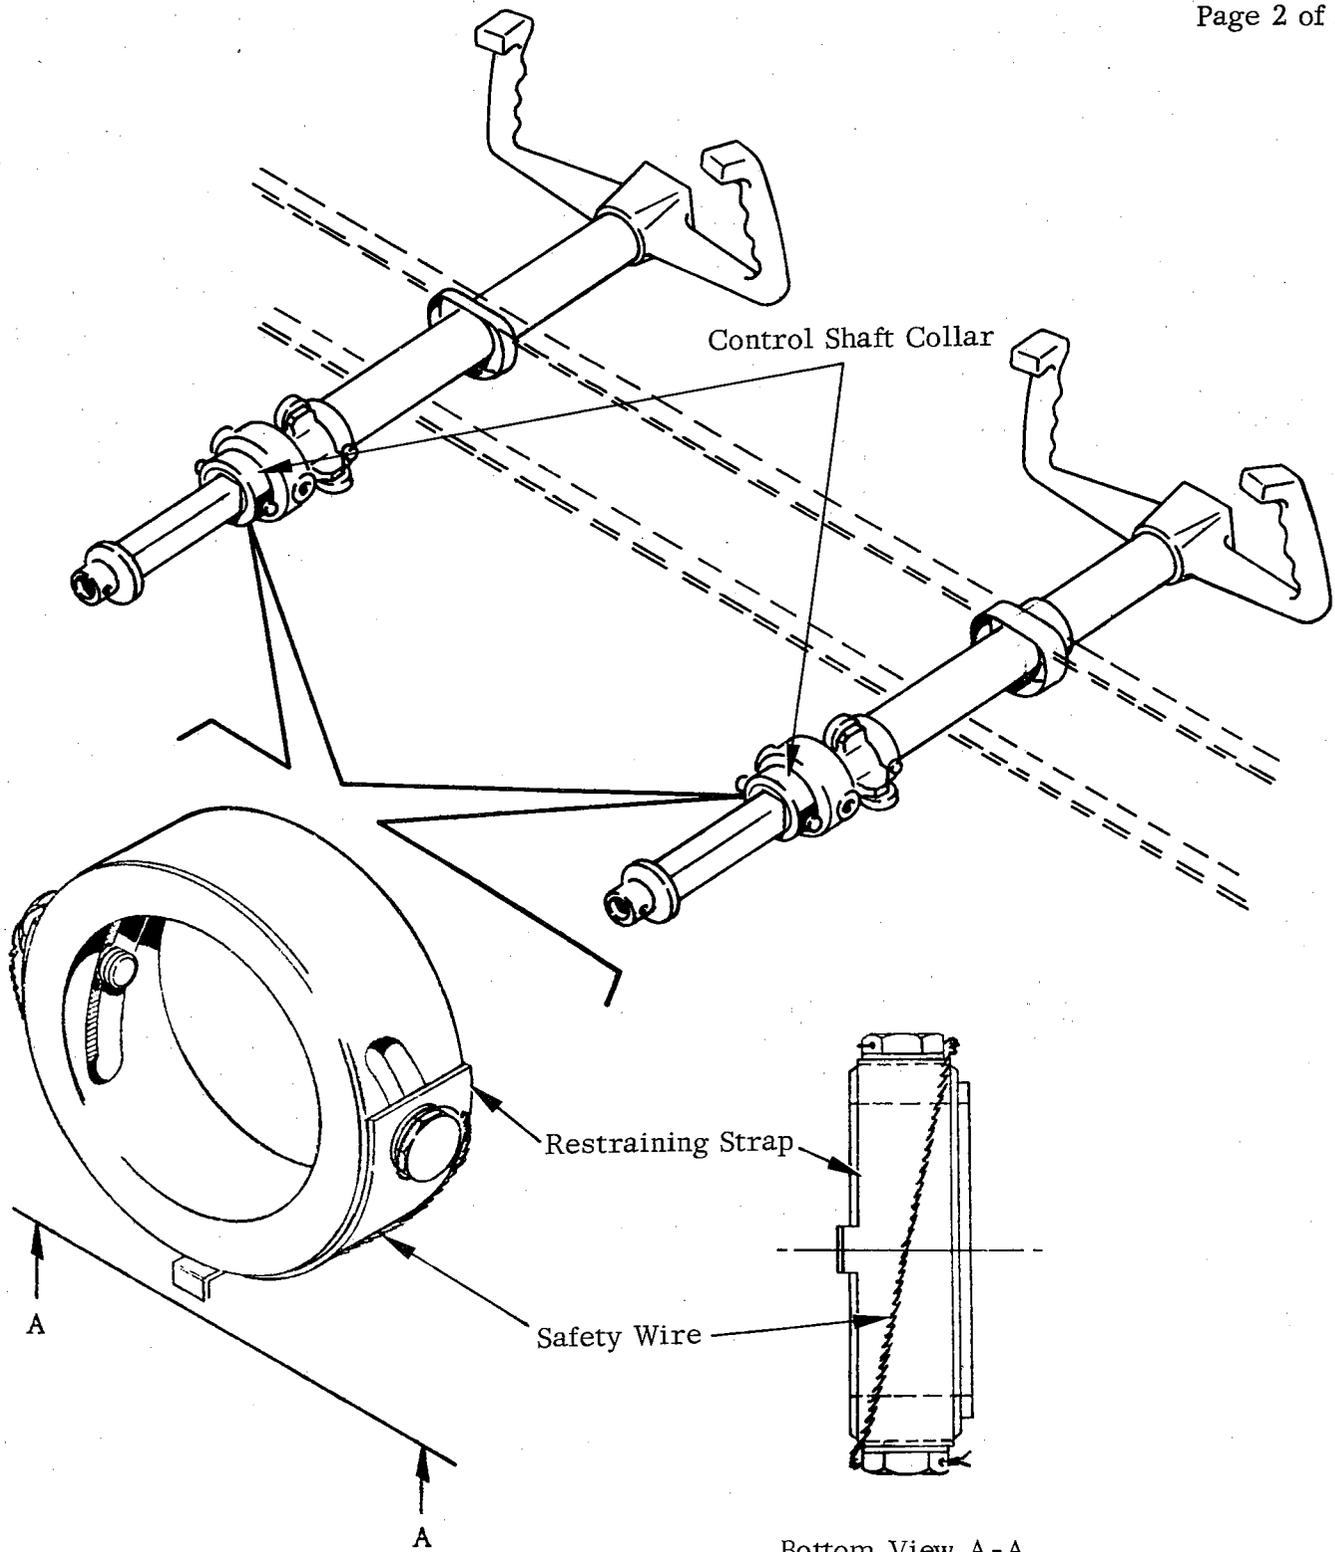
A recent field report has indicated the need for the addition of a safety wire restraining strap and a revised safety wiring method regarding the attachment of the control shaft collar to the control shaft tube assembly.

This service release provides material and instructions for the installation of a safety wire restraining strap and to revise the control shaft collar safety wiring (refer to sketch on reverse side of this Service Letter for a general illustration).
