## VENDOR SERVICE PUBLICATION

SUBJECT: Oil Pump Impeller and Drive Replacement; AVCO Lycoming Service Bulletin No. 385C dated October 3, 1975 (attached).

Service Bulletin No. 385C  
(Supersedes Service Bulletin No. 385B)  
Engineering Aspects are  
FAA (DEER) Approved

SUBJECT: Oil Pump Impeller and Drive Replacement

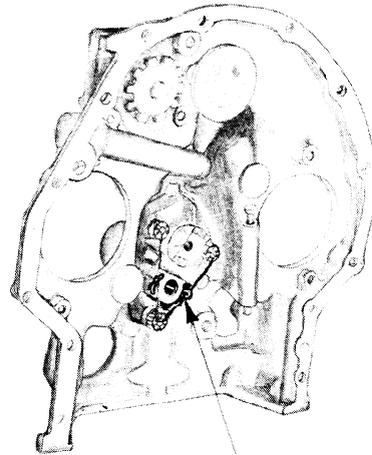
Figure 1. Interior View of Accessory Housing Showing Location of Cotter Pin in Oil Pump Idler Shaft

INSPECTION: Applicable remanufactured engines shipped after December 21, 1972 should be inspected to determine if this modification is required: first of all, if the engine log book indicates the engine has not been modified in accordance with Service Instruction No. 1230 or No. 1272, proceed to remove the accessory drive cover from the mounting pad at the lower right side of the accessory housing to obtain access to the area between the crankcase and the accessory housing. On some engines this accessory drive pad is not machined, in this event it will be necessary to remove either the left magneto or the \*fuel pump to obtain access to the area between the crankcase and the accessory housing. Regardless of which accessory pad is used, determine if the oil pump idler gear is secured with a cotter pin at the location shown in figure 1. This can be accomplished using an inspection mirror, preferably an illuminated one. If the cotter pin is visible, it is unnecessary to perform the modification required by this bulletin.

IF IDLER SHAFT IS SECURED WITH A COTTER PIN AT THIS LOCATION MODIFICATION IS NOT REQUIRED

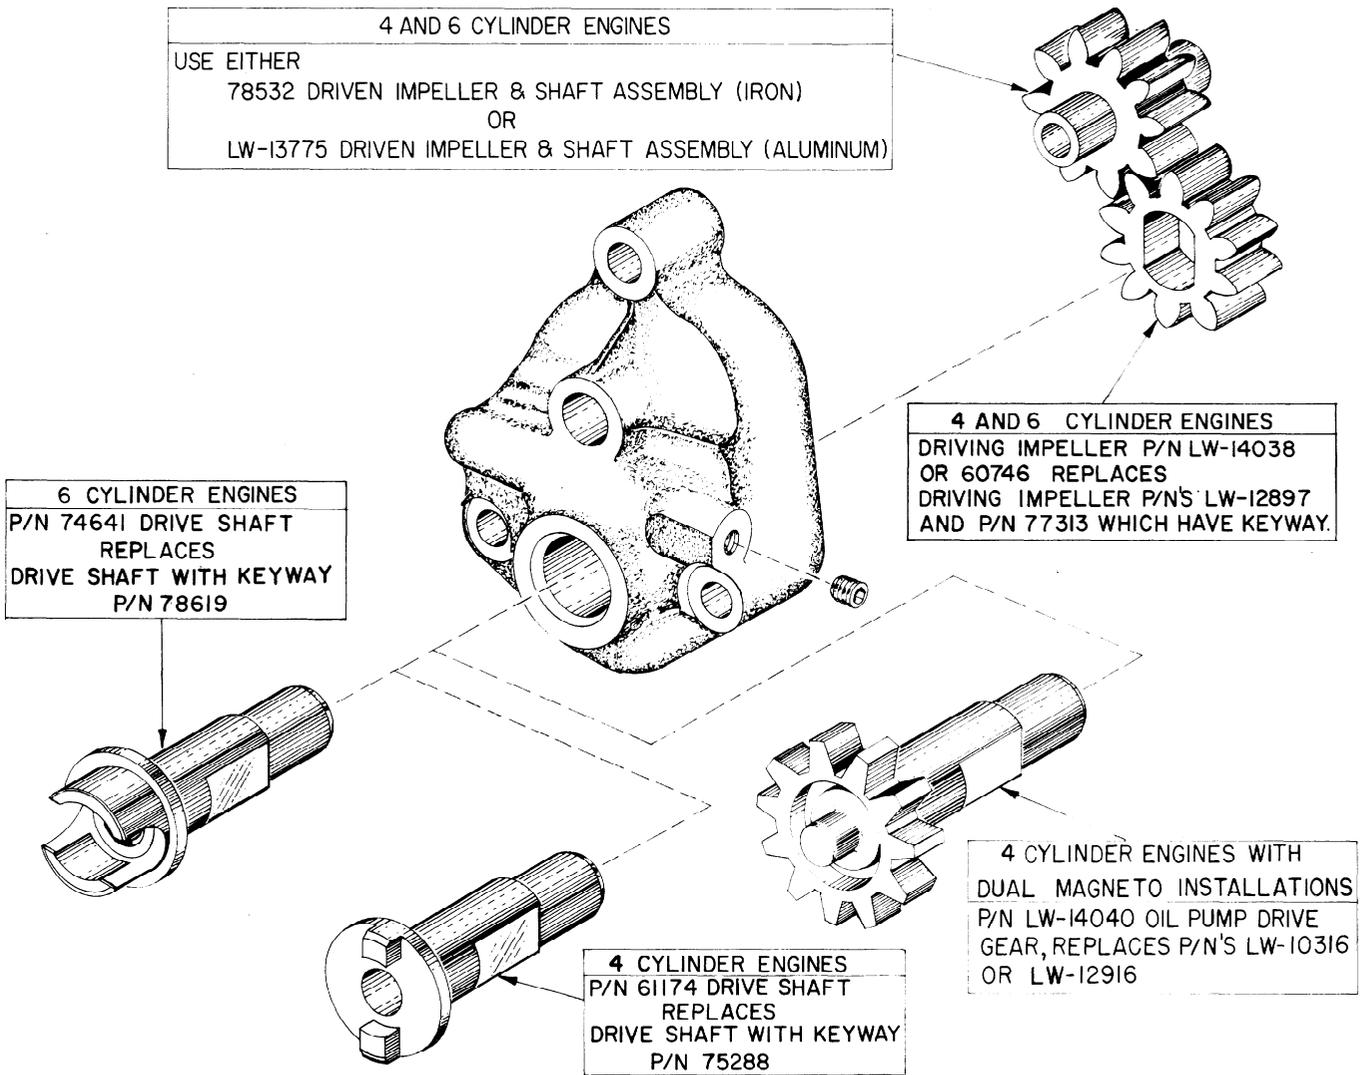
Figure 2. Oil Pump Drive Assembly

This modification consists of replacing the oil pump drive shaft and drive impeller to eliminate the Woodruff key drive which has proven to be the cause of excessive wear in the keyway of the hardened drive impeller. Therefore, it is recommended that all of the applicable engines listed in the chart, as well as any others that may have been modified in accordance with Service Instruction No. 1272, use the following procedure for parts replacement.

3. Reassemble the oil pump using the new drive shaft and drive impeller supplied with the kits shown in the following "Parts Data" section. See figure 2. Be sure all of the parts are lubricated thoroughly during assembly.

After assembly turn the drive shaft several revolutions to determine if it moves freely; if not, open the pump and correct the cause before the unit is reassembled on the engine.
