# SERVICE LETTER

No. 883

Piper Aircraft Corporation

Subject: Wing Flap Rivet Installation

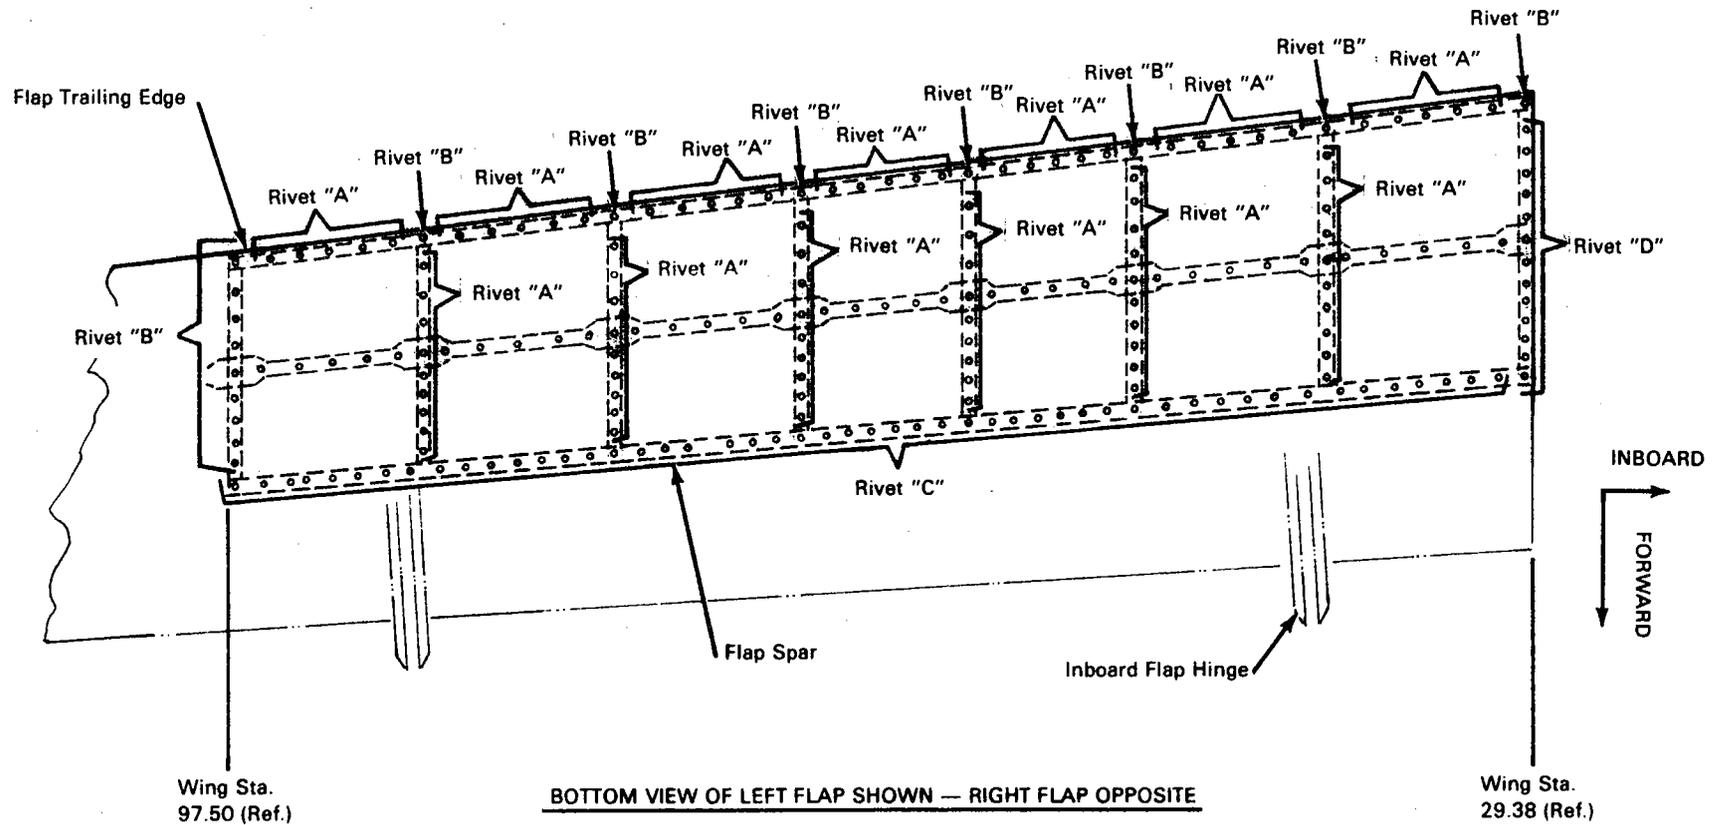
BOTTOM VIEW OF LEFT FLAP SHOWN — RIGHT FLAP OPPOSITE

Reports have been received of loose rivets on the bottom surface of the wing flap assemblies. In several instances recurrent loosening of rivets has occurred in aircraft on which loose rivets were replaced.

1. Gain access to the bottom surfaces of the left and right wing flap assemblies.
2. Replace any rivets showing evidence of looseness. Refer to sketch for proper replacement part.
3. On the bottom surfaces of the wing flap assemblies, from and including Wing Station 29.38 to and including Wing Station 97.50 between the flap trailing edge and the flap spar including the flap spar, add appropriate rivets midspace between existing rivets where the distance between the existing rivets is one (1) inch or greater.
4. Make proper log book entry of compliance with this Service Release.
