# SERVICE No. 534 BULLETIN

Piper Aircraft Corporation

Subject: Turbine Tailpipe Coupling Replacement

PA-31P Pressurized Navajo..... 31P-1 to 31P-7730003 Inclusive

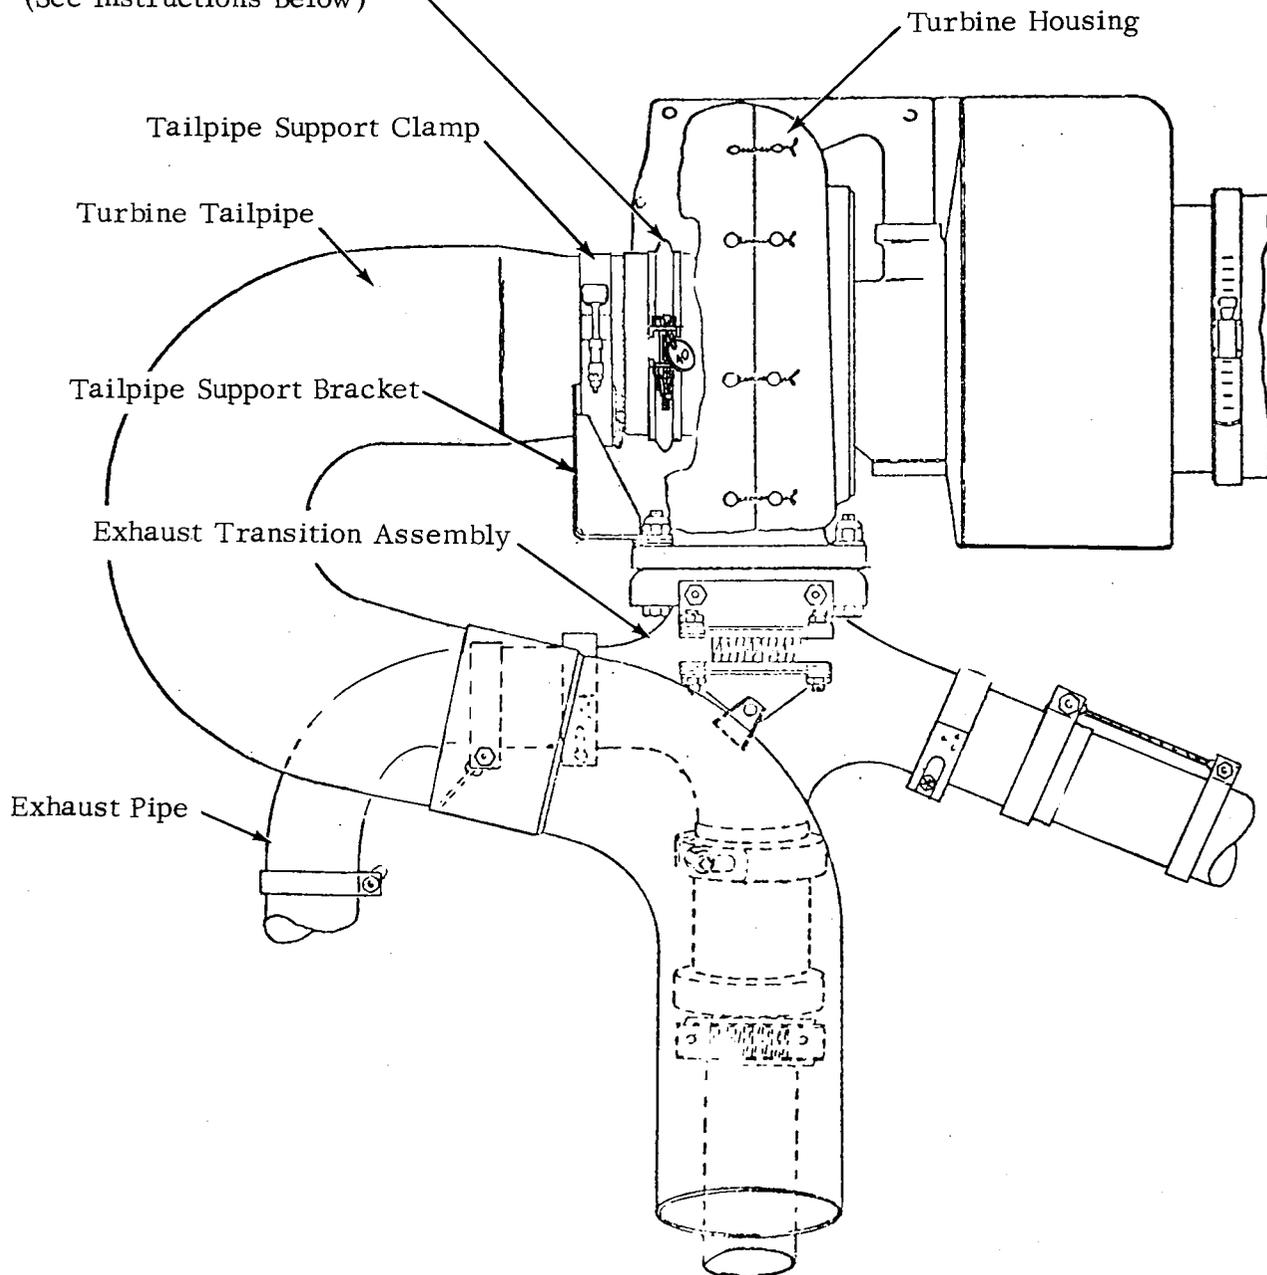
New Turbine Tailpipe Coupling - P/N 556 053  
(See Instructions Below)

Purpose: A recent field report has been received describing failure of the turbine outlet to turbine tailpipe coupling, resulting in separation of the tailpipe from the turbine outlet. This condition could allow hot exhaust gases to escape into the engine compartment, with possible damage to cowls and adjacent powerplant system components.

1. Remove engine cowling from both engines to gain access to the turbine tailpipe couplings.
2. Remove tailpipe support clamp from both engines.
3. Remove existing couplings and install new couplings P/N 556 053 as follows:

- a. Install coupling over end of tailpipe flange, spreading clamp a minimum amount. Do not remove retaining wire from coupling.
  - b. Fit tailpipe flange to turbine flange, making certain flange faces are butted together with no gap.

- c. Position tailpipe for clearance with exhaust pipe. Slide coupling over flanges, position and tighten. Torque to 40 inch-pounds.
4. Position existing tailpipe support clamp around tailpipe and support bracket. Deflect upper end of bracket approx. 1/8 inch away from turbine housing and tighten clamp so as to preload the tailpipe flange against the turbine flange. Torque clamp nut to 25-35 in. lbs.
