SERVICE No. 1002 BULLETIN

Date: June 5, 1997 (M)

SUBJECT: Elevator Down Spring Inspection /Replacement

PA-31P, Pressurized Navajo

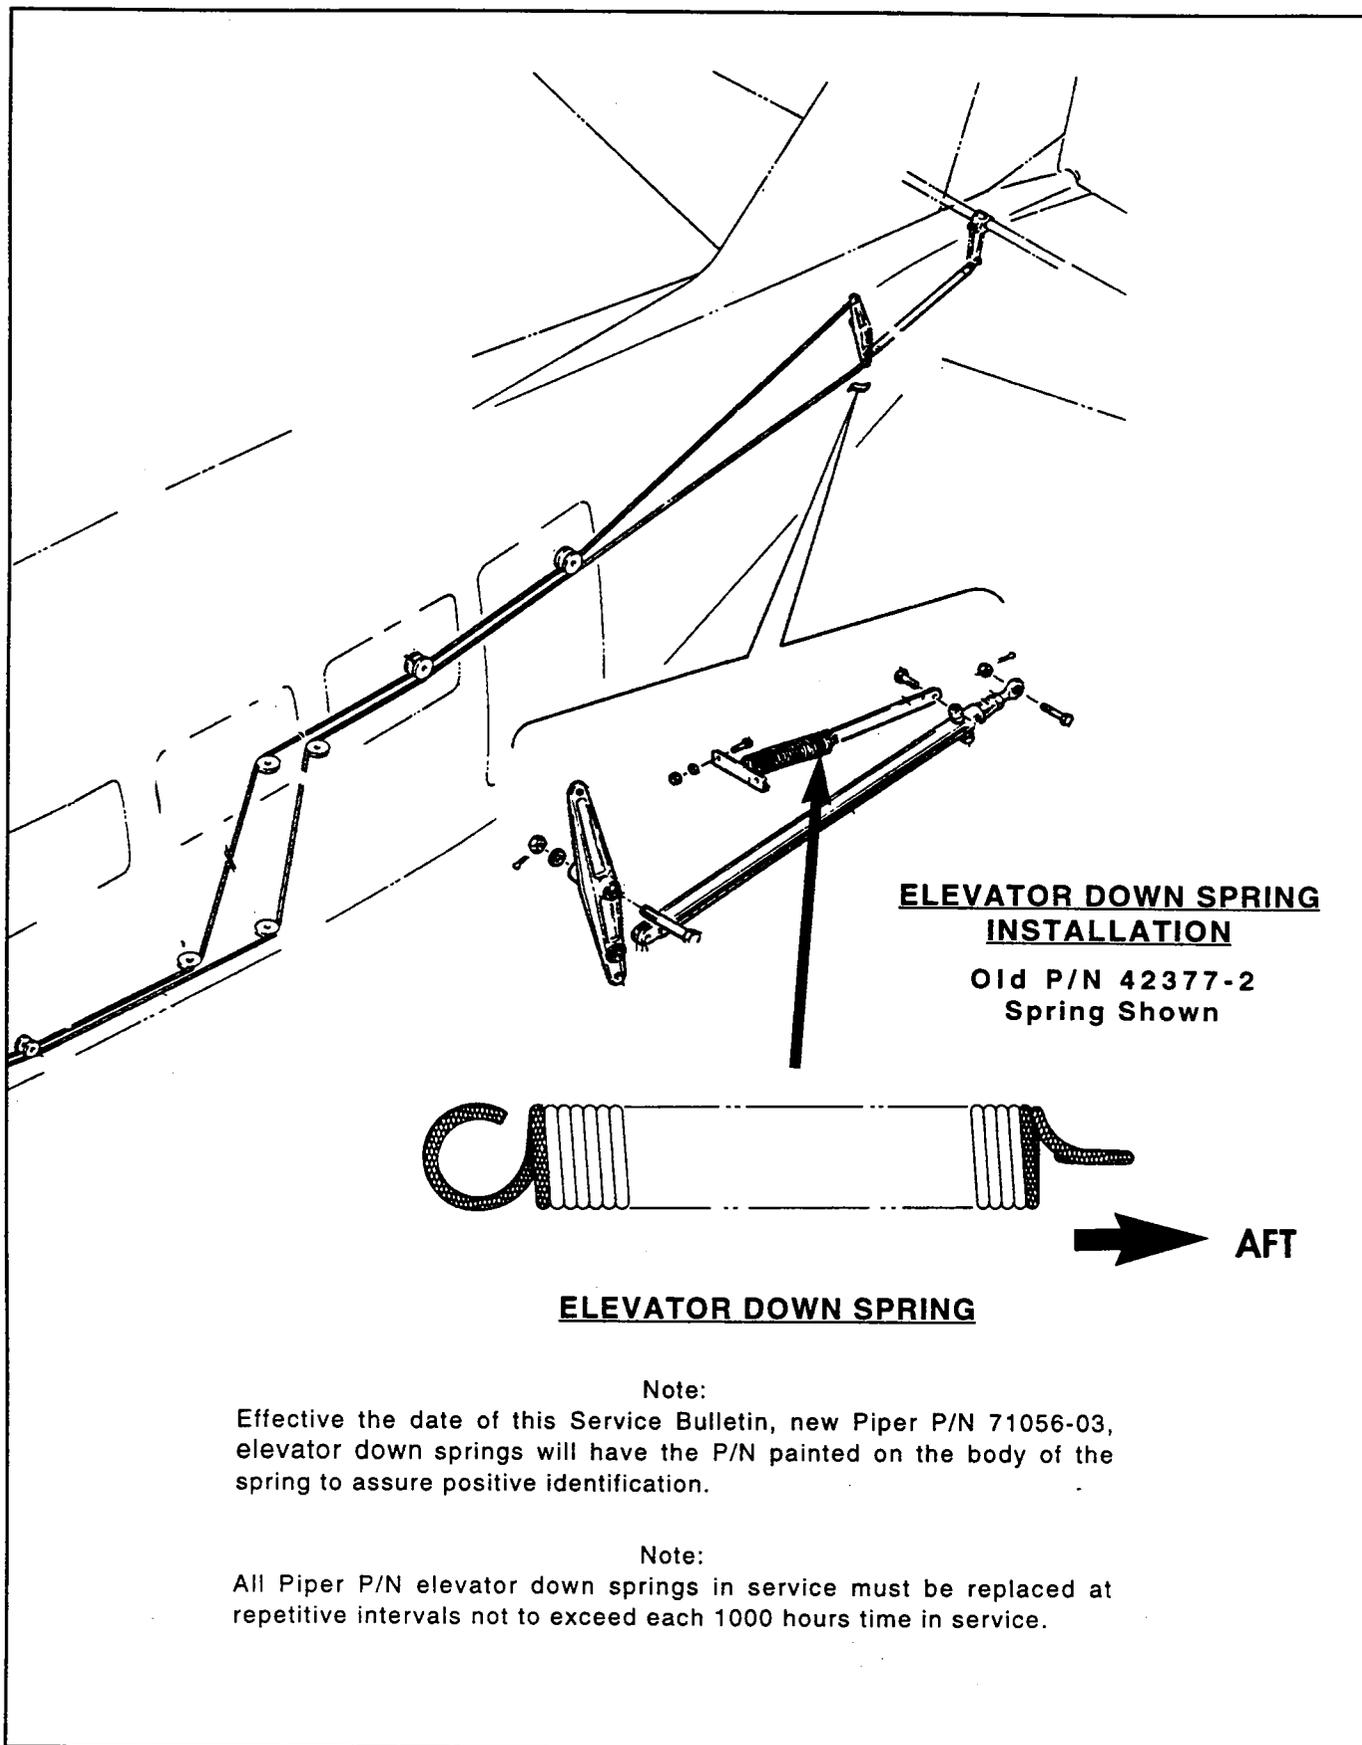
Effective the date of this Service Bulletin, new Piper P/N 71056-03, elevator down springs will have the P/N painted on the body of the spring to assure positive identification.

All Piper P/N elevator down springs in service must be replaced at repetitive intervals not to exceed each 1000 hours time in service.
