SERVICE LETTER

No. 823

Piper Aircraft Corporation

Subject: Heater/Evaporator Return Air Duct Hose Replacement

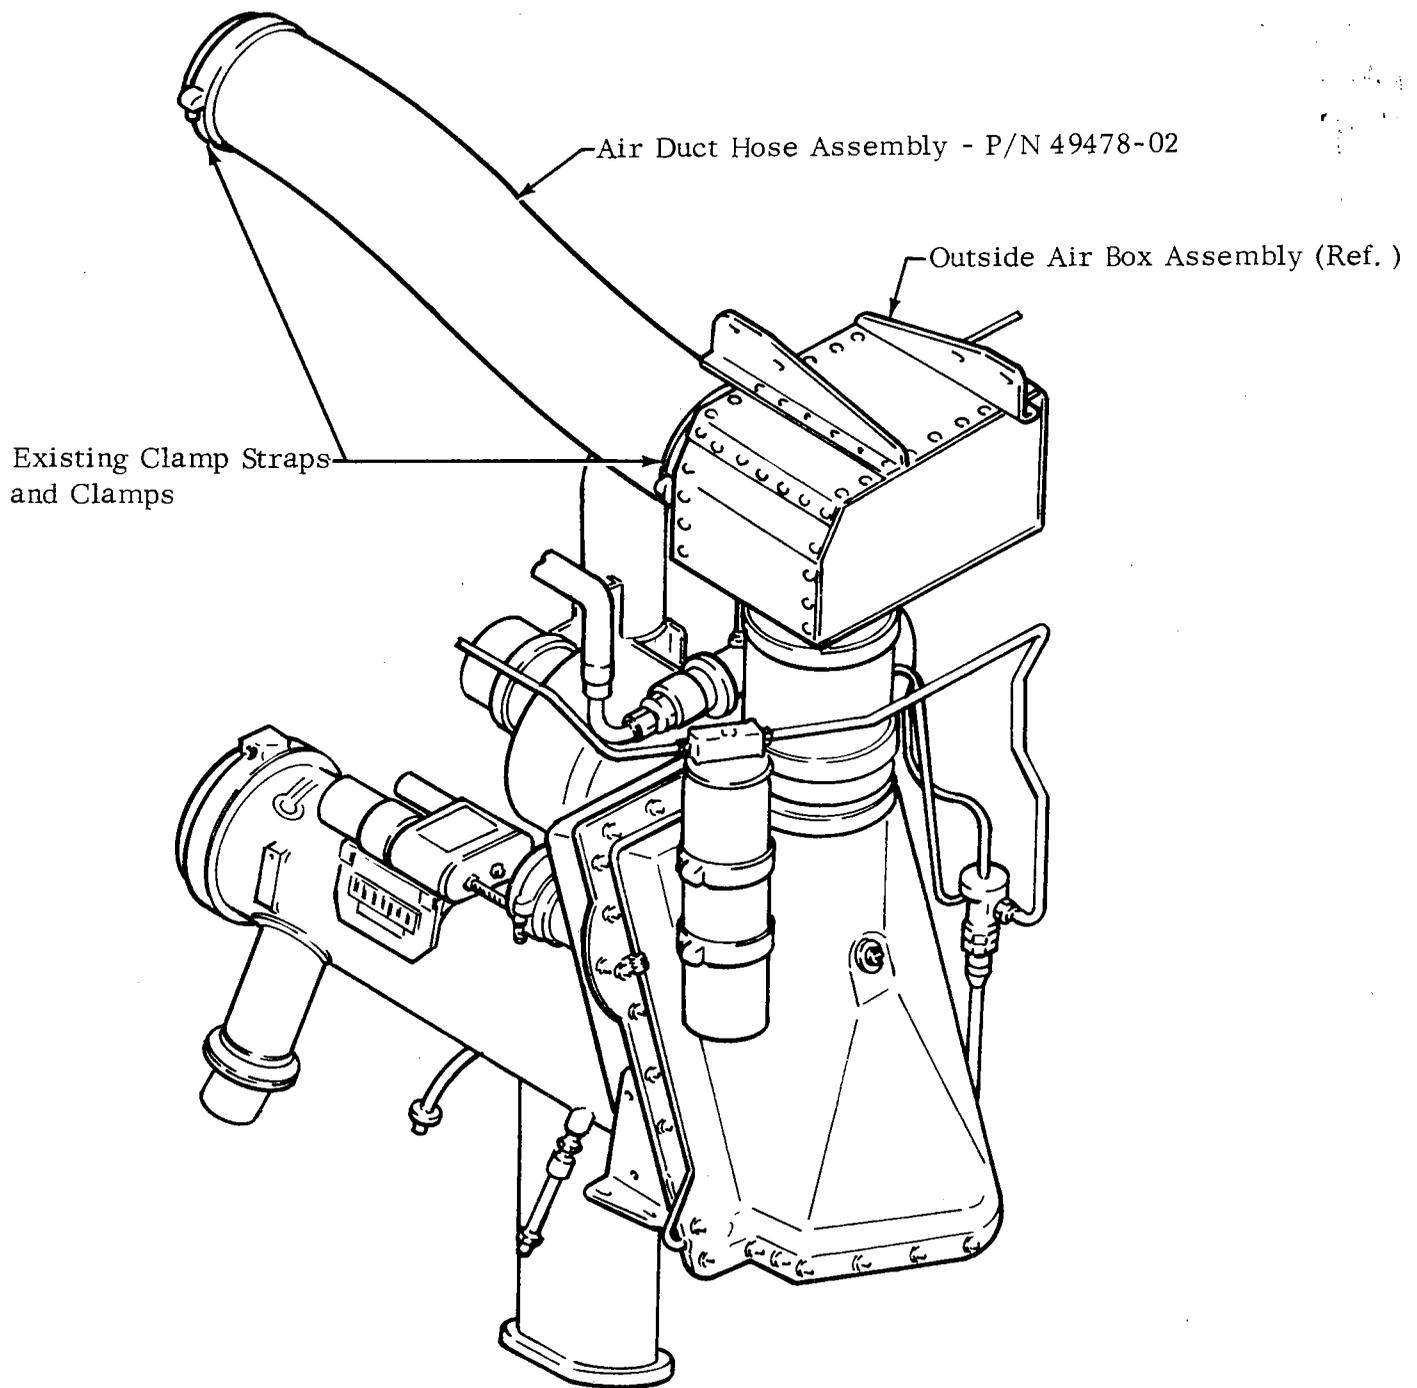
Purpose: The Heater/Evaporator Return Air Duct Hose, Piper part number 55574-02 installed on the aircraft referenced above may separate internally, allowing material to impede the operation of the recirculating blower fan. This in turn can cause loss of the heater/airconditioning circulation system.

1. Remove the access panel from the right side of the fuselage nose section.
2. Replace the existing return air duct hose assembly with new assembly P/N 49478-02. Use the existing clamp straps and clamps to secure new hose assembly.
3. Reinstall access panel to fuselage nose section.
4. Make proper logbook entry of Service Letter compliance.
