SERVICE LETTER

No. 707

Piper Aircraft Corporation

Subject: Modified Flyball Assembly to Improve RPM Control
-- reference attached Hartzell Service Letter No. 75,
dated November 16, 1973.

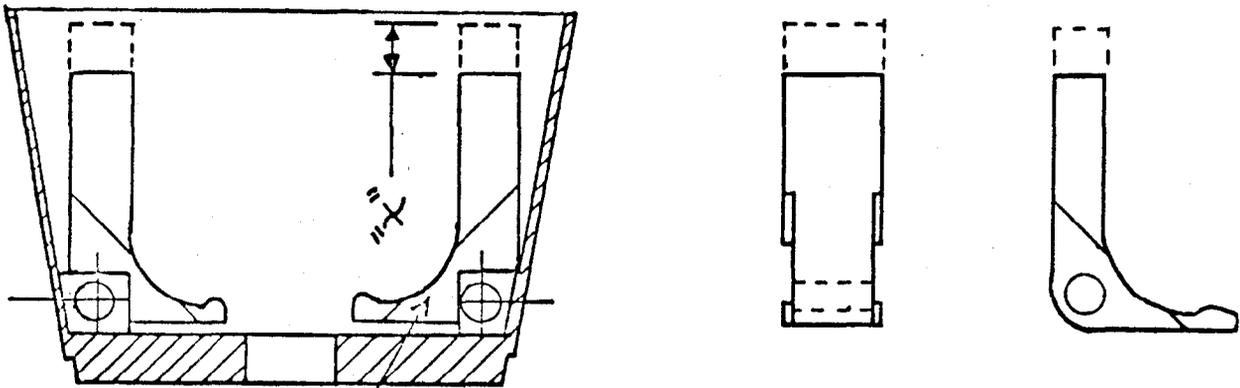
Discussion: To effect an improved RPM control on aircraft with the Hartzell governors, a modified flyweight assembly designed to absorb the torsional motions of the drive gear are being installed in all Hartzell production governors.

A-153(A)-(C) FLYWEIGHT (SEE CHART)
(MATERIAL GROUND FROM
SIDES ON "A" MODIFICATION)

- 1) Determine flyweight assembly needed using parts listed in this letter.
- 2) The flyweight assembly can be changed by:
 - a) removing cover assembly
 - b) removing flyweight assembly locking ring
 - c) removing flyweight assembly
 - d) placing new flyweight assembly in place
 - e) replacing lock ring, making sure it is in place
 - f) replacing cover gasket 50672, and
 - g) installing cover assembly
