VSP-33
December 18, 1981

VENDOR SERVICE PUBLICATION

To: All Piper Distributors and CORPAC's
Subject: Bendix Service Bulletins 611, 616, 617, 619

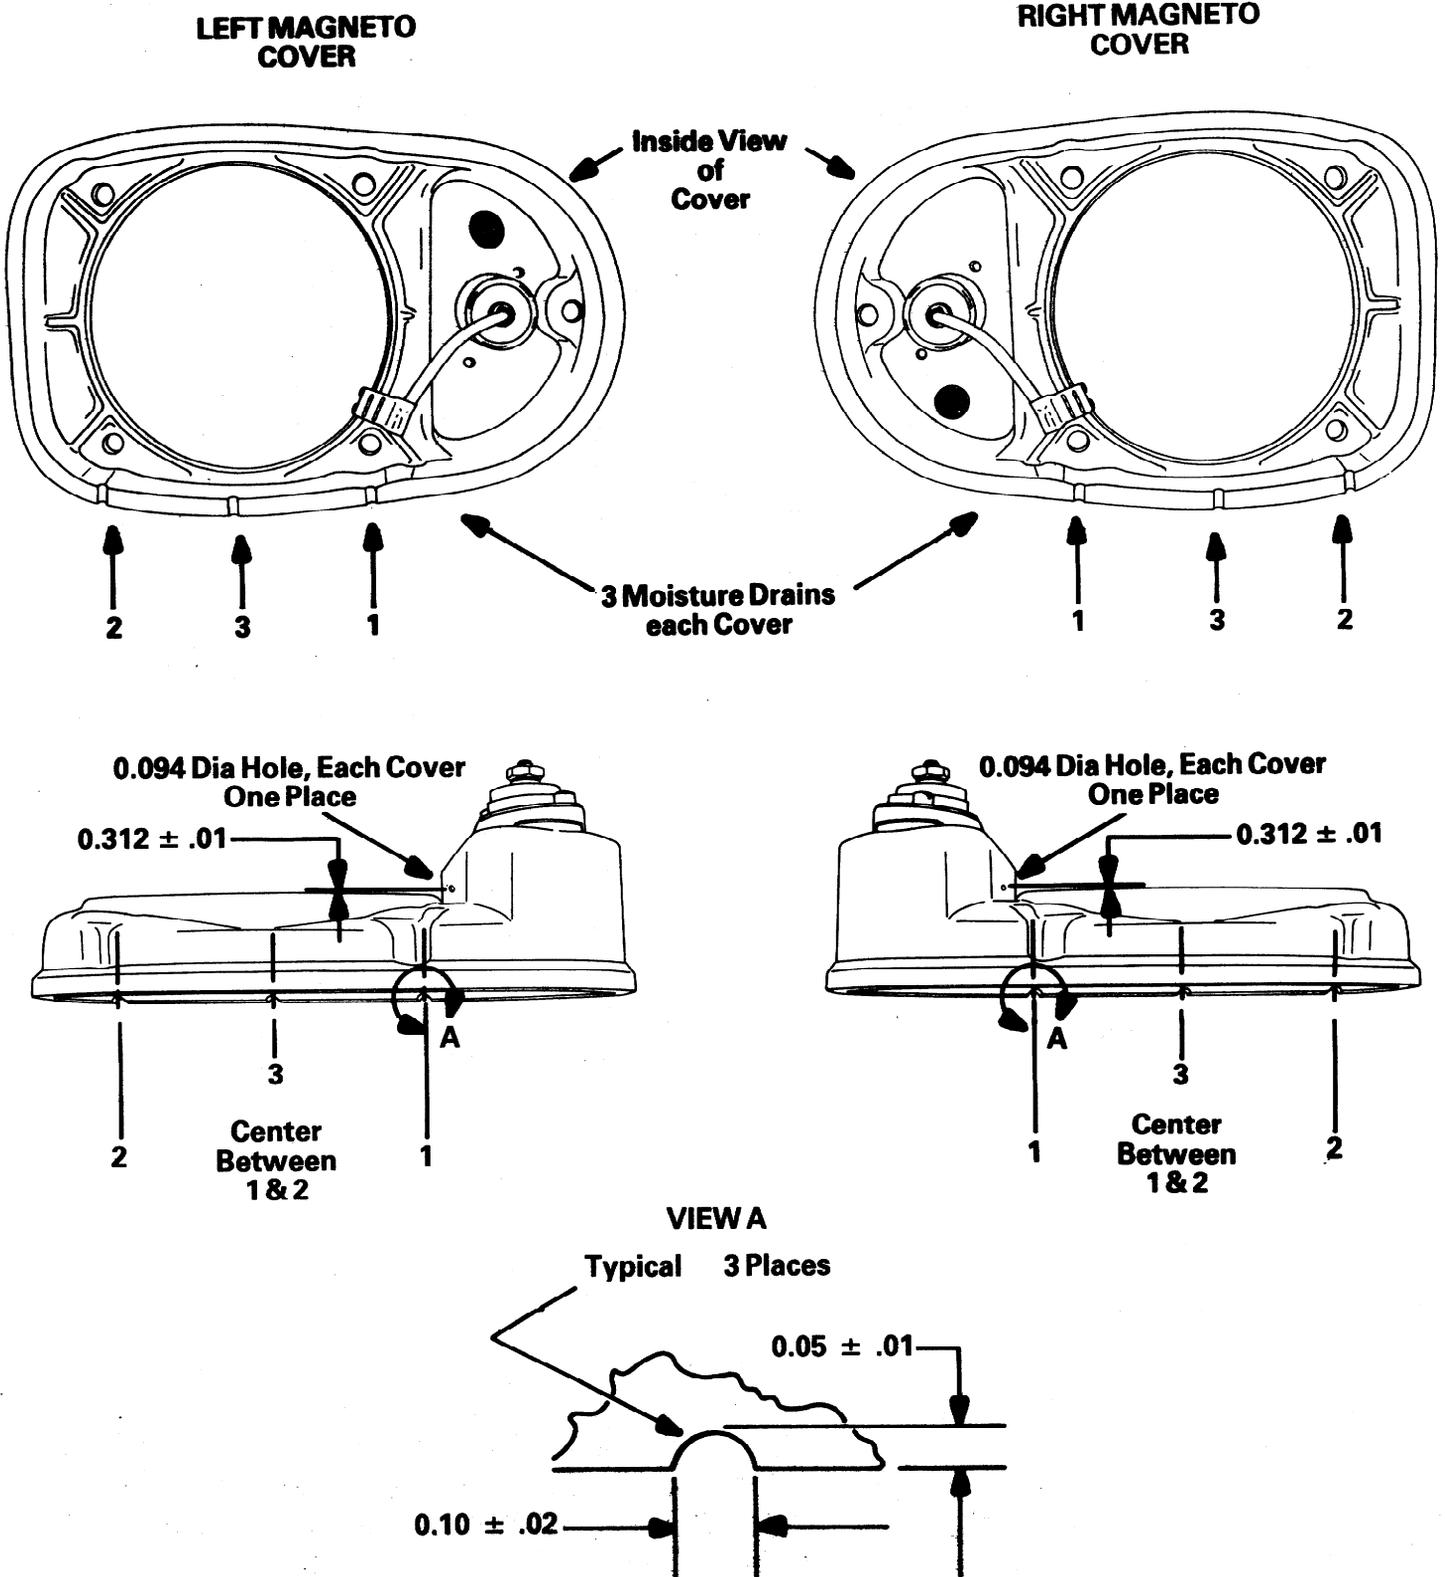
Figure 1. Location of Drain Holes

Field reports indicate that some operators of Teledyne Continental Engines of the 470 and 520 series are experiencing water ingestion in the S-1200

Series Magnetos. This moisture contamination may cause ignition difficulties, resulting in possible engine roughness. The addition of moisture drains and sealing of the screen vent in the magneto cover will provide a means for drainage of accumulated moisture and prevent moisture from entering the magneto through the screen vent.

1. Remove the magneto cover by removing the ignition harness adapter plate from each magneto and then removing the magneto cover securing screw. Pull the magneto cover away from the magneto and carefully pull the capacitor, and retard lead, if used, from the breaker flag terminal(s).
2. Using Figure 1 as a guide, lay out the positions for the moisture drains. Positions 1 and 2 are in line with the stud holes in the cover and position 3 is centered between 1 and 2. Using a small round file, create the three hemispherical recesses as detailed in view A, figure 1.

The moisture drains must be on the lower side of each cover when it is reinstalled on its related magneto assembly on the engine.

3. Lay out the position for drilling a 0.094 in. \pm 0.005 in. hole in the center of the ledge area of the covers and drill one hole in each cover using a 3/32" or No. 42 drill, as shown in Figure 1.

Do not allow the drill to penetrate through the cover and hit the housing of the capacitor which is directly in line with the hole being drilled. Mask drill bit for maximum allowable depth (1/4 in.).

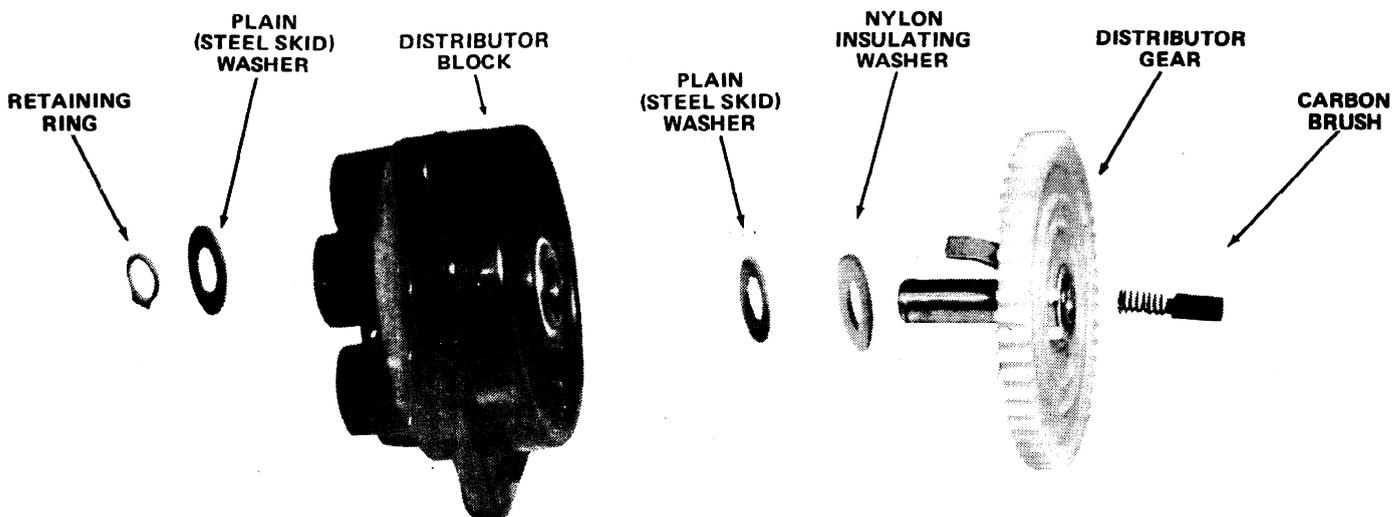
Figure 1. Exploded View

The 10-357584 and 10-357586 Insulated Distributor Gear Kits for S-20 and S-200 Series Magnetos are being provided as a standardization change for Bendix magnetos. With the introduction of these kits, all new Bendix aircraft magnetos delivered from the factory will be provided with insulated distributor gears. The insulated gear kits include all parts (except distributor block) as identified in figure 1.

Assembly sequence of the gear kit to distributor block is shown in the exploded view of figure 1.

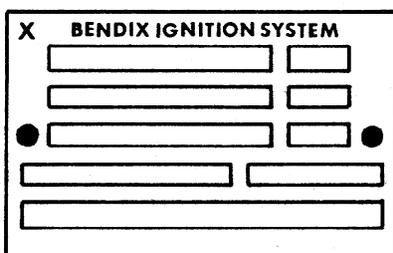
Figure 1. Location of "x" on Identification Plate

All D-2000/2200 series magnetos below serial number 35480 (red label magnetos) and below serial number 8122106 (blue label magnetos) unless identified with an "x" in the upper left corner of the identification plate before the word "Bendix" (see figure 1). The "x" on the identification plate indicates previous compliance.

6. If new serviceable gears, identified with the "z", the "x" and "o", or the "L" are installed in the magneto, identify the magneto by stamping the letter "x" in the upper left corner of the identification plate, before the word "Bendix" (see figure 1).

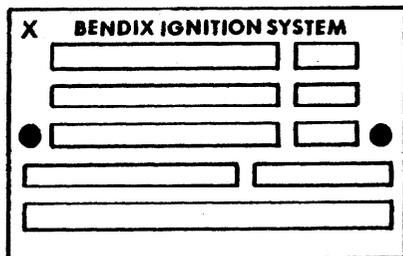
Figure 1. Location of "x" on Identification Plate

All D-3000/3200 Series (blue) Magnetos with Serial Numbers 100 through 1968 not identified by the letter "x" in the upper left corner of the identification plate (see figure 1). The "x" on the identification plate indicates previous compliance.

7. After the magneto has been reassembled with new serviceable gears, identify the magneto by stamping the letter "x" in the upper left corner of the identification plate, before the word "Bendix" (see figure 1).
