SERVICE *No.* 974 BULLETIN

DATE: October 19, 1994

Aileron Hinge Inspection and Replacement

PA-31, 31-300, 31-325 Navajo
PA-31-350 Navajo Chieftain
PA-31-350 T1020
PA-31P-350 Mojave
PA-31T3 T1040

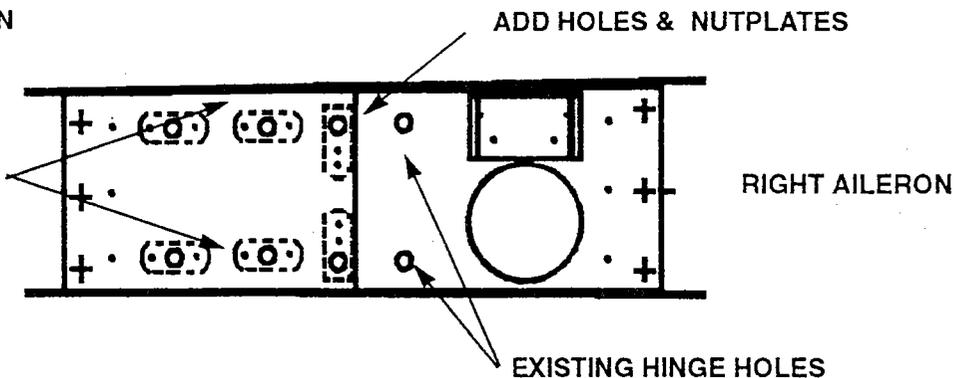
TYPICAL AILERON

Reports have been received of small cracks developing in the aileron spar and reinforcement doubler beneath the inboard aileron hinge attachment point.

INSPECT:
CRACKS WILL
APPEAR ALONG
SPAR FLANGE
AND AT ATTACH
HOLES.

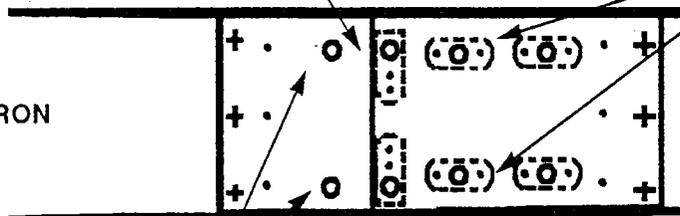
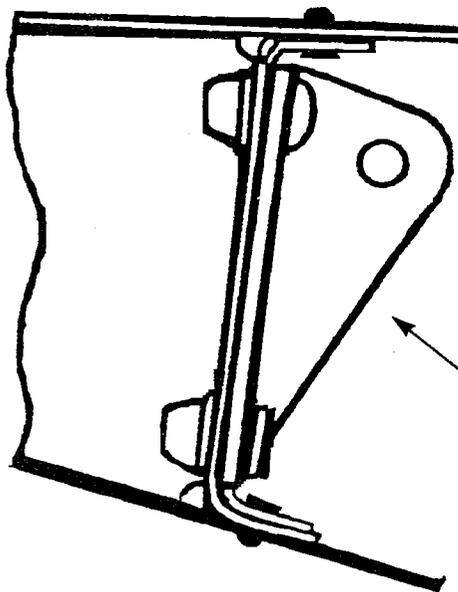
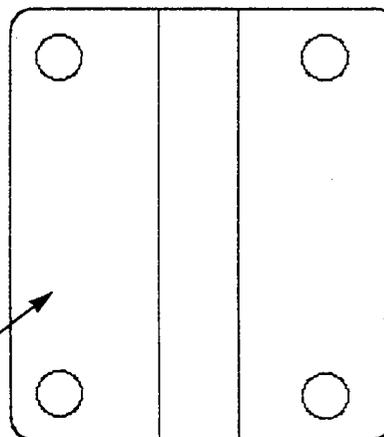
SKETCH A

EXISTING HINGE HOLES

INSPECT:
CRACKS WILL
APPEAR ALONG
SPAR FLANGE
AND AT ATTACH
HOLES.

6. Install the new Hinge Bracket, Piper Part Number 74461-02 (left) and 74461-03 (right), utilizing three (3) each AN3-5A Bolts, Piper Part Number 401-266, three (3) each AN960-10 Washers, Piper Part Number 407-564, and one (1) each MS24694S53 Flush Screw, Piper Part Number 410-035, per Hinge Bracket.

7. If no cracks are present, it will be necessary to drill additional holes and add two (2) additional nutplates to the existing aileron spar assembly. Temporarily install the new hinge bracket to the aileron spar. Using the new hinge bracket as a template, drill two (2) new .191 inch holes in the spar to match.

ADD HOLES & NUTPLATES

INSTALL NEW HINGE
P/N'S 74461-02 (LEFT)
AND 74461-03 (RIGHT)
