SERVICE LETTER

No. 987

Piper Aircraft Corporation

Main Landing Gear Mount Bolt
Inspection

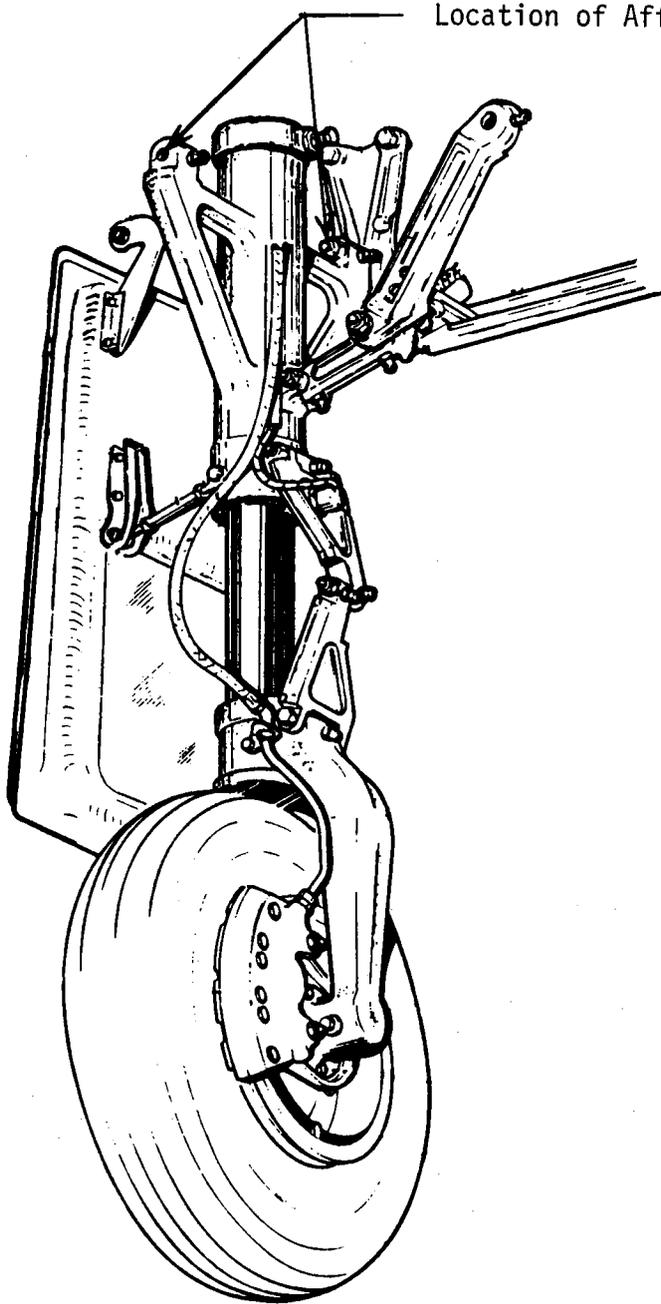
SKETCH "A"

It has been determined that a group of AN-10-36 bolts, Piper Part Number 400-384 were received and distributed, which do not meet the specified minimum diameter. If an installation has been made using these bolts, accelerated wear of the main landing gear pivot point could occur, due to excess clearances at the pivot point.

Location of Affected Bolts

1. Refer to the appropriate aircraft parts catalog and/or maintenance manual for location and quantity requirements for specific model application.
2. Following instructions in the appropriate maintenance manual, remove the affected bolts. See Sketch "A" attached.
3. Measure bolt shank to assure a dimension of .620" to .624", discard any bolt(s) measuring less than .620". See Sketch "A".
4. Reinstall acceptable and/or new bolts as required, perform a landing gear function check per the appropriate maintenance manual.
5. Make an appropriate logbook entry of compliance with this Service Letter.

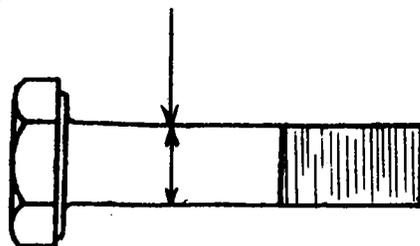
Minimum Diameter .620 inches
