SERVICE LETTER

No. 764A

Piper Aircraft Corporation

Subject: Wing Flap System Maintenance Procedure

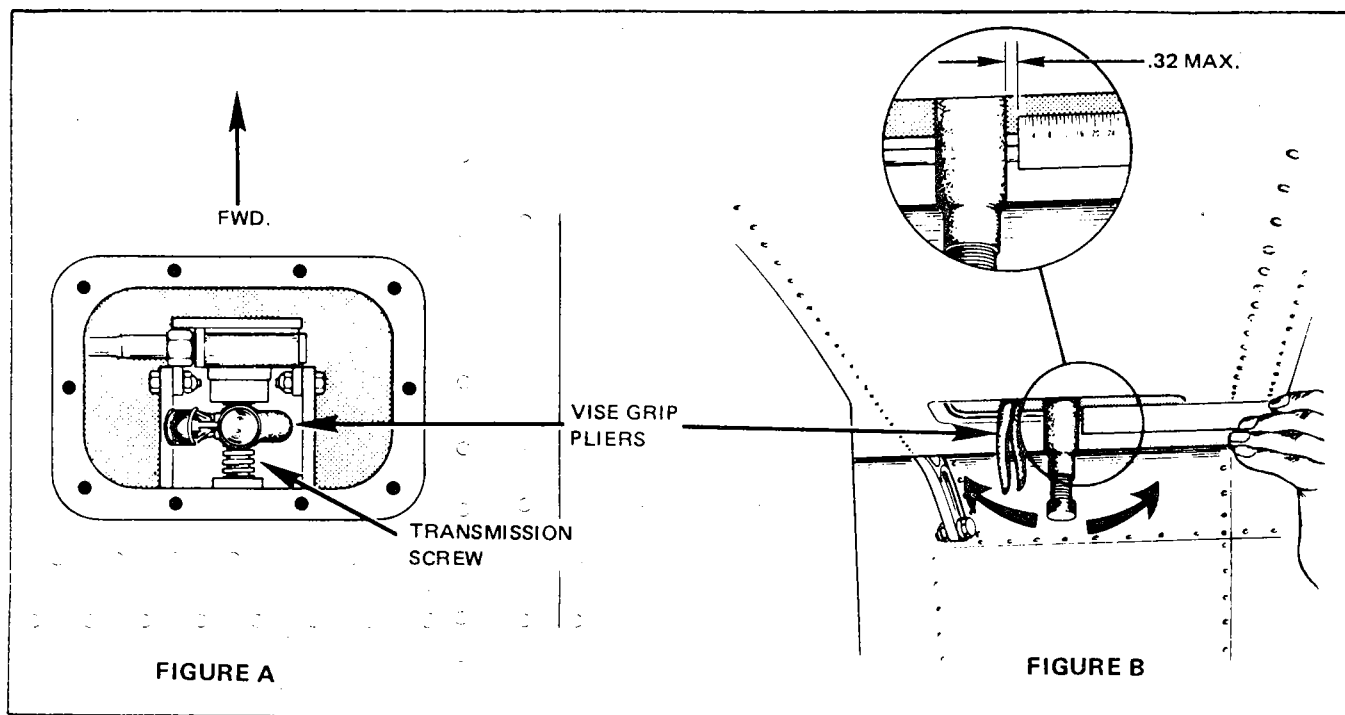
Figure 1. Wing Flap Transmission Inspection

1. INSPECTION OF WING FLAP TRANSMISSION, (Refer to Figure 1.) The flap transmissions are inspected at every 100 hour inspection cycle of the aircraft. This is accomplished without removal of the transmissions, by the following procedures:
 - a. Position the flaps in the extended position (Down).
 - b. Remove the access covers on the lower wing surface to gain access to the flap transmissions.
 - c. With the use of vise grip pliers and exerting light pressure, grasp the exposed portion of the screw close to the transmission as shown. (Refer to Figure 1, views A and B).
 - d. With the pliers secured to the screw, a light pressure will move the pliers and screw as free play in the transmission gear set is taken up in either direction. Do not force the pliers.
 - e. Place a six inch ruler along the skin surface as shown in Figure 1, view B, and measure the overall distance the pliers move.

- f. Should this dimension exceed .32 (5/16) of an inch, replace the transmission assembly or obtain Gear Transmission Overhaul Kit 755 051 for 20:1 ratio transmissions, part numbers 4268-00 and 4268-00-1, or Kit 755 050 for 40:1 ratio transmissions, part numbers 1049-00-1 and 1049-00-3. (See parts catalog for serial numbers affected.) (Refer to appropriate service manual for transmission removal and installation.)
- g. Reinstall the access panels and make appropriate logbook entry.
- h. Repeat inspection at 100 hour intervals.

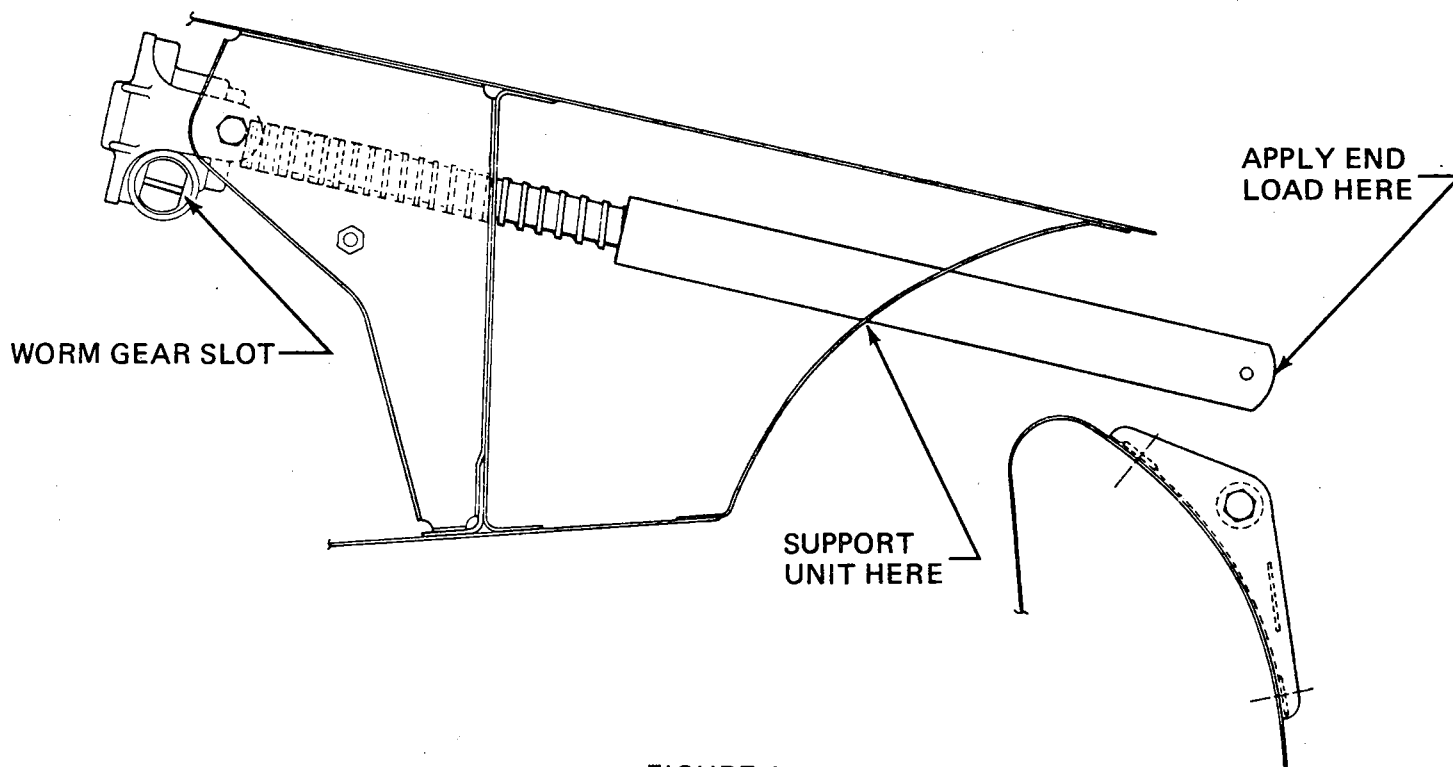
FIGURE A

1. Extend the transmission screw to the end of its travel.
2. Using a flat blade screwdriver inserted into the slot of the worm gear on the transmission (see Figure A), turn the gear 20 turns for the 4268 unit or 40 turns for the 1049 unit and note any tight or high spots as the worm gear is rotated.

The transmission should have an end load applied while turning the worm gear. (See Figure A.)
