# SERVICE LETTER

No. 709

Piper Aircraft Corporation

Subject: Inspection of Pneumatic Pump Mounting Flanges

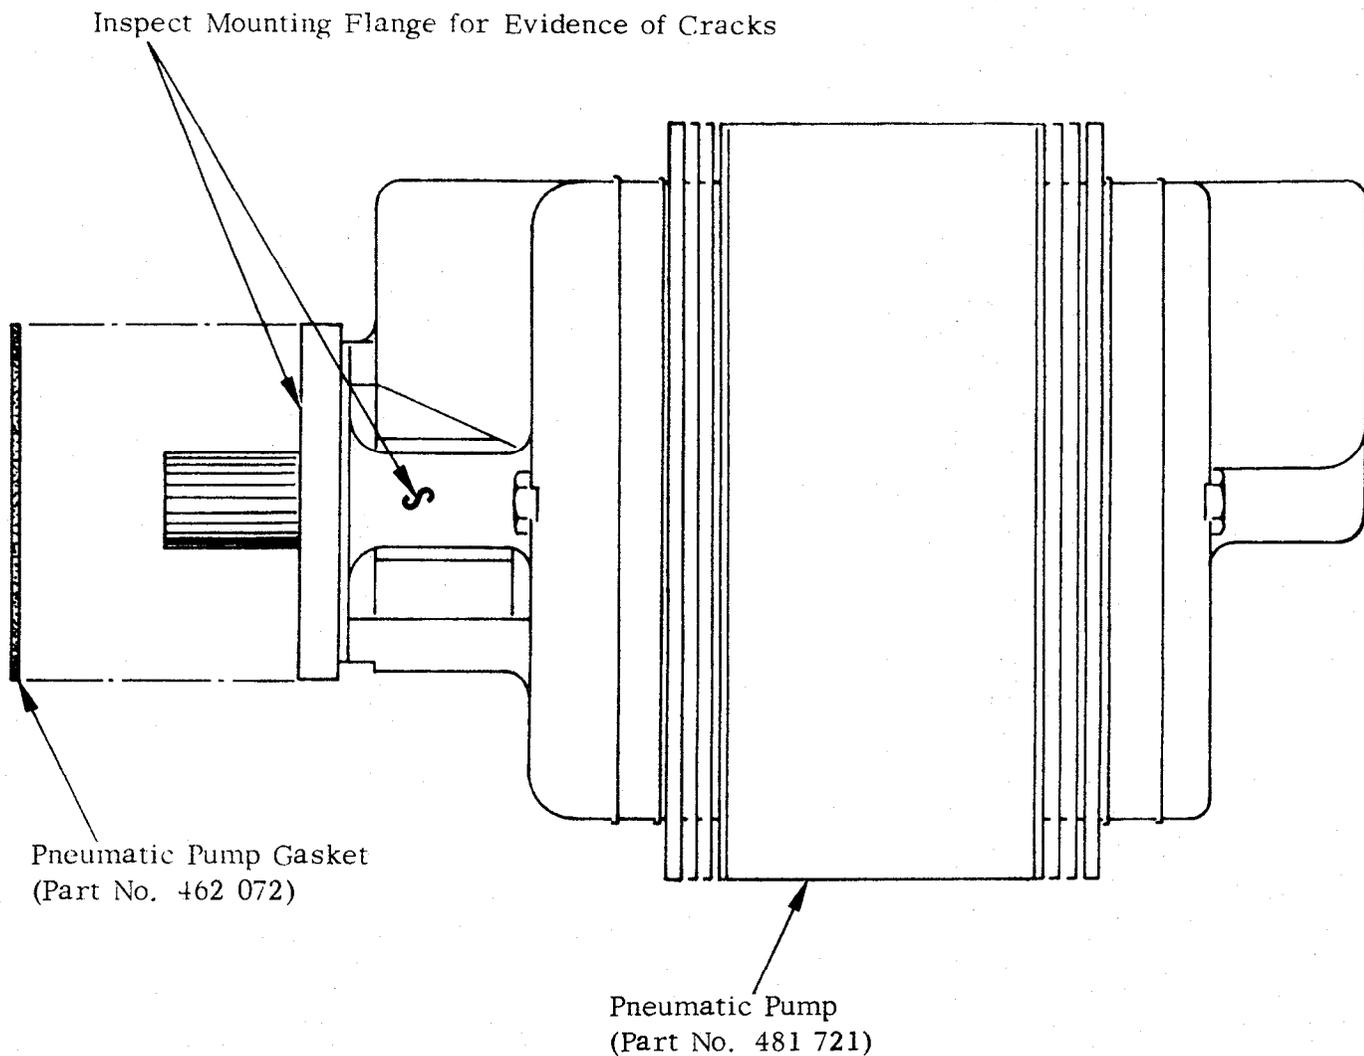
Purpose: There have been a few reported cases of cracks appearing in certain areas of the pneumatic pump mounting flanges (refer to attached sketch for details). Further, the possibility exists that the pneumatic pump mounting nuts may have been improperly torqued following removal of the pump(s) in the field.

1. Remove the engine-driven pneumatic pump from both engines.
2. Carefully inspect mounting flanges, on each pump, for evidence of cracks.
  - a. If cracks are not detected, reinstall existing pump(s).
  - b. If cracks are detected, install new pump(s) Part No. 481 721.
3. Replace gasket following pump removal.
4. Torque mounting nuts 40 to 50 inch lbs. NOTE

1. Gain access to the pneumatic pumps, located on the inboard side of the right engine and the outboard side of the left engine.
2. Refer to attached sketch/instruction sheet for inspection procedure.
3. Replace pneumatic pump(s), as required per instructions (reference attached sketch/instruction sheet, Item No. 2b).
4. Make appropriate log book entry.

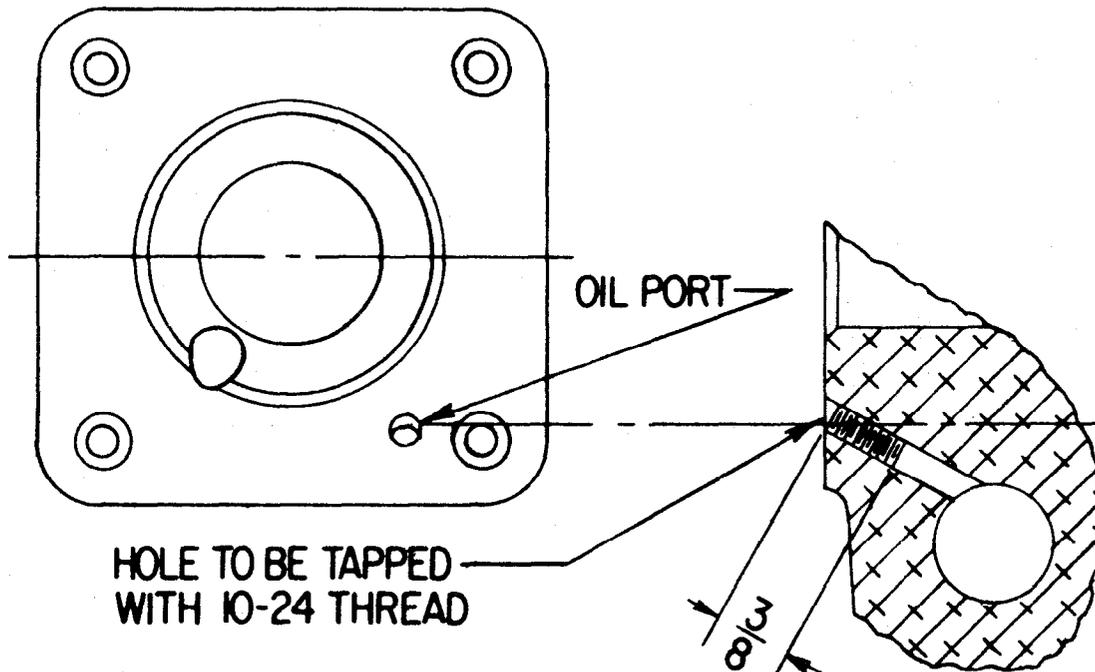
The applicable engines were designed and built with internal oil passages to supply pressure lubrication to the various accessories. However, both hydraulic and vacuum pumps, supplied by the aircraft manufacturer are self-lubricated and the oil supply passages, which terminate on the accessory mounting pads, are not required. Therefore, to avoid oil leaks in the event either accessory pump should become loose or detached, it is recommended that the oil passages be sealed off as described in the following paragraphs.

VACUUM OR HYDRAULIC MOUNTING PAD SHOWING LOCATION OF OIL PORT AND SECTION THRU AREA TO BE TAPPED

See accompanying illustration. Remove accessories and gaskets from both vacuum and hydraulic pump mounting pads. Place cup grease in the oil supply

ports so that cuttings will not enter the main oil galley. Using greased 10-24, H-1 plug tap, proceed to tap a thread approximately 3/8 inch deep in both oil ports. Remove the cup grease from the ports and thoroughly clean the affected areas. Apply Loctite sealant, grade AVV to 10-24 x 1/4 inch recessed socket set screw and install screws to bottom in the tapped holes.
