Piper Aircraft Corporation
Vero Beach, Florida, U.S.A.

SERVICE No. 779B BULLETIN

SUBJECT: Landing Gear Upper Bearing Retaining Pin Replacement and Strut Assembly Inspection.

PART II**SUBJECT:**Landing Gear Upper Bearing and
Strut Assembly Inspection**MODELS AFFECTED:**

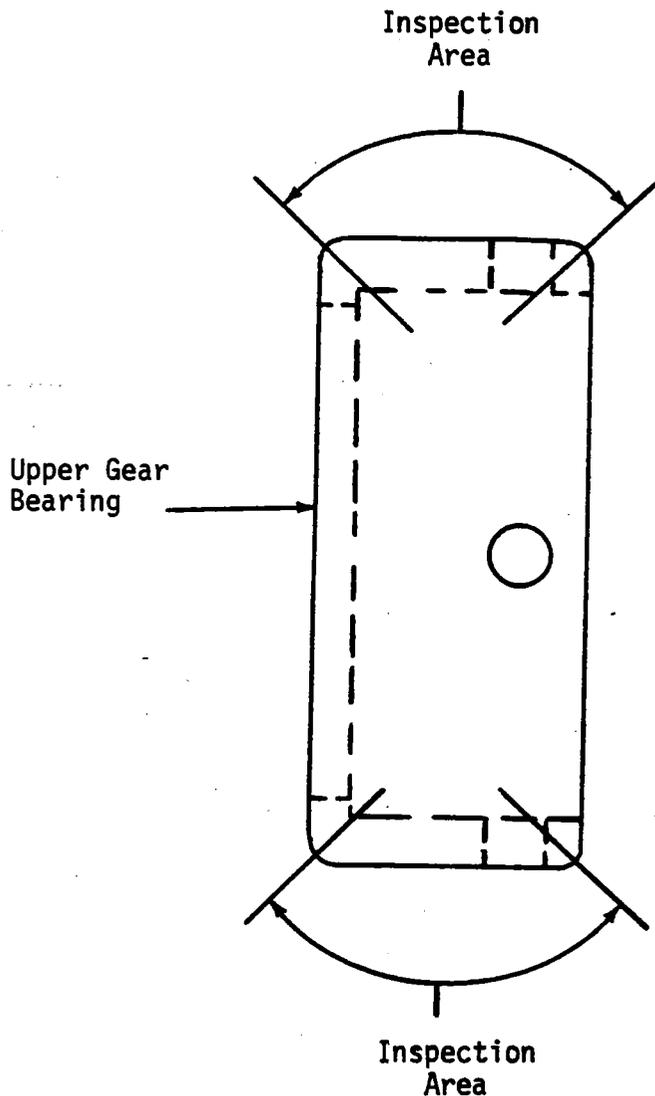
SKETCH "A"

Note: For All PA-31/31T/31P Series Aircraft, Upper Main Gear Bearing, Piper Part Number 40247-00 and/or Upper Nose Gear Bearing, Piper Part Number 31779-00. Inspection Area Must Be Chrome Plated And Have a Smooth Surface (No Ridges Allowed) Between Indicated Points on Entire Outside Surface.

For All PA-42 Cheyenne III Aircraft, Upper Main Gear Bearing, Piper Part Number 57470-02 and/or Upper Nose Gear Bearing, Piper Part Number 31779-02 are Manufactured of Bronze Alloy And Are Not Plated. Inspection Area Should Have a Smooth Surface (No Ridges Allowed) Between Indicated Points on Entire Outside Surface.

Remove the upper bearing and inspect the area shown in Sketch A. If ridges are found in the designated inspection area, replace the bearing. Any replacement bearing should also be inspected per Sketch A prior to installation.
