Piper Aircraft Corporation
Vero Beach, Florida, U.S.A.

SERVICE No. 826A BULLETIN

SUBJECT: Elevator Hinge Inspection/Replacement

(over)
ATA: 5550

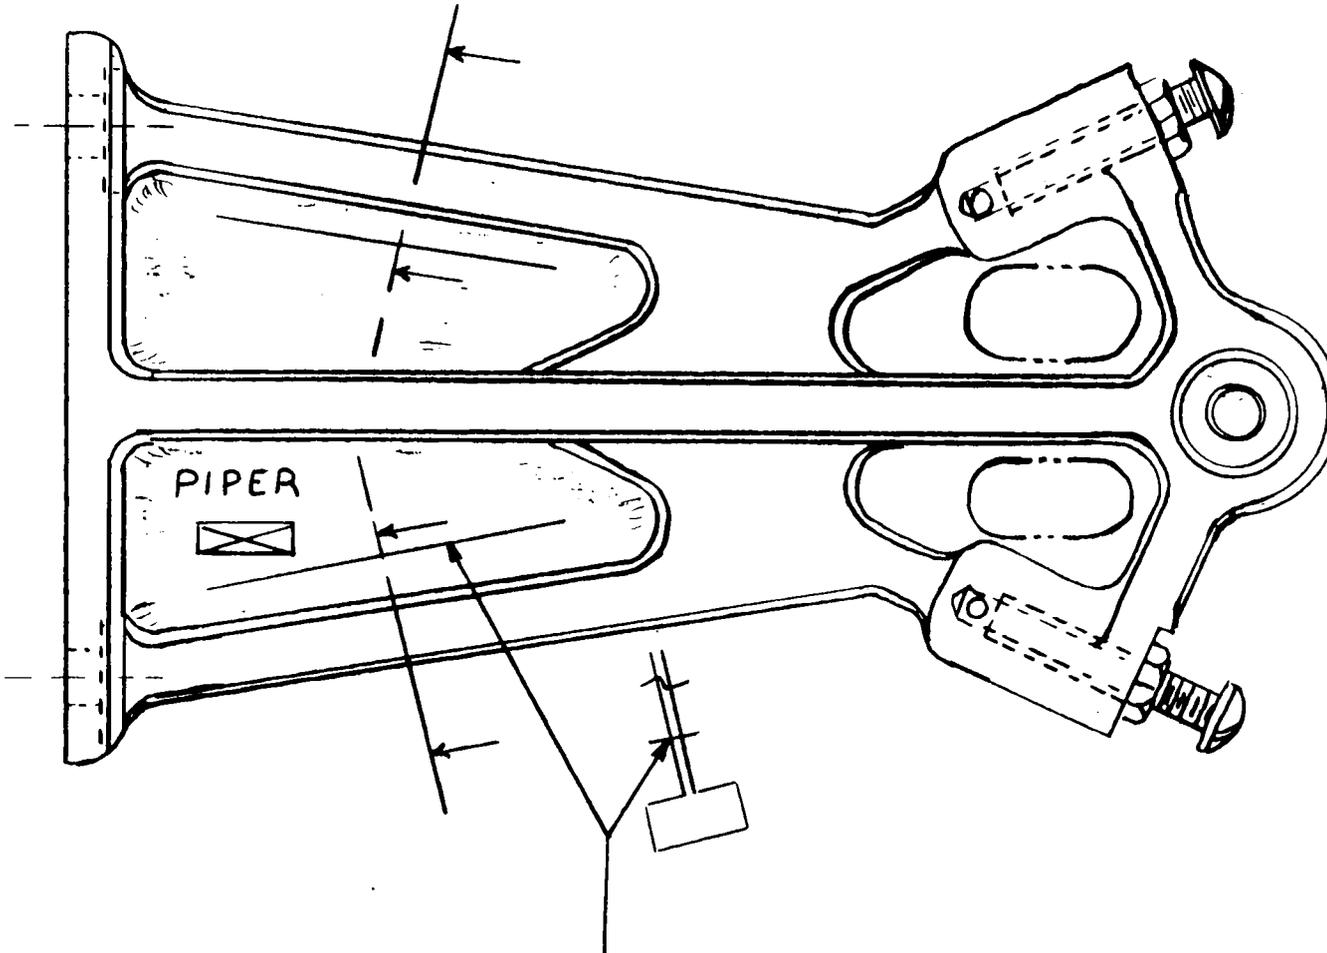
SKETCH 'A'

PURPOSE: There has been an additional report received of a cracked elevator center hinge on a model group not previously addressed. Metallurgical analysis of the original reports has confirmed a forging fault. If this condition exists, and is left uncorrected, impairment of elevator operation or loss of elevator control could result.

APPROXIMATE AREA OF CRACKS IN WEB

1. Gain access to the elevator center hinge by removing the upper and lower tailcone fairing assembly.
2. Remove paint and perform a dye penetrant check of the center elevator hinge in the areas indicated in Sketch "A" attached.

3. If no cracks are found, reinstall the tailcone fairing assembly and make the appropriate logbook entry. No further action is necessary.
4. If cracking is indicated by the dye penetrant check, the elevator center hinge is to be replaced and elevator stops reset in accordance with the appropriate maintenance manual.
5. Reinstall the upper and lower tailcone fairing assembly.
6. Make the appropriate logbook entry of compliance with this Service Bulletin.
