SERVICE No. 344 BULLETIN

Piper Aircraft Corporation

Subject: Revised Emergency Gear Extension Operation Information

Models Affected: PA-31 and PA-31-300 Navajo
PA-31P Navajo

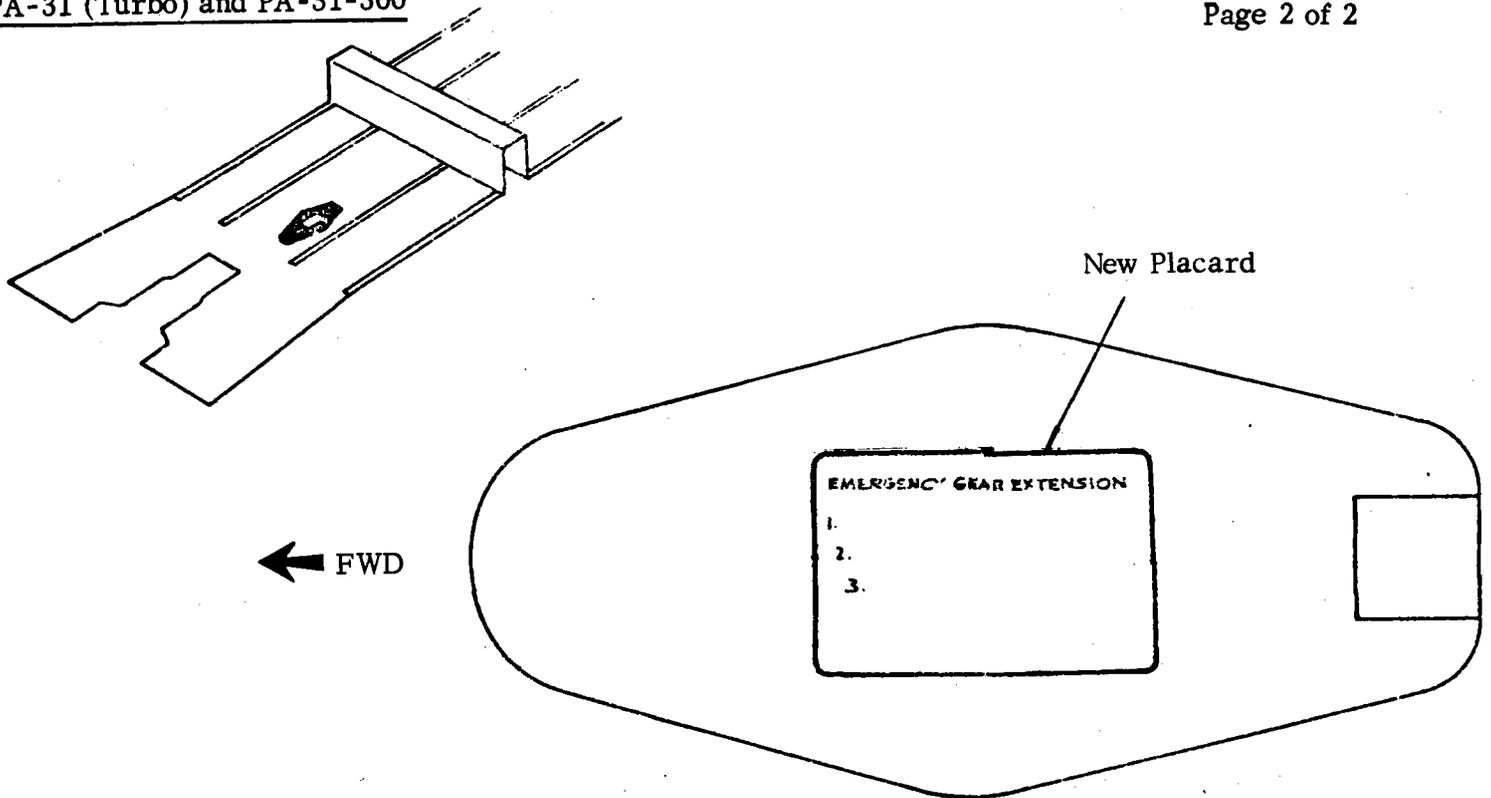
Access Door Assembly (Bottom View)

Purpose: To revise the existing emergency gear extension operation information, which is located on the underside of the emergency gear extension door between the pilot and co-pilot seats and in the appropriate airplane flight manual in the Placards section; Emergency Procedures section. (Sketch on reverse side illustrates the location of the emergency gear extension door on the above referenced aircraft.)

Instructions: Contained in Emergency Gear Extension Placard Replacement Kit, Piper part number 760 570.
