SERVICE BULLETIN

492

Piper Aircraft Corporation

TIGO-541-E1A Exhaust System Modification.

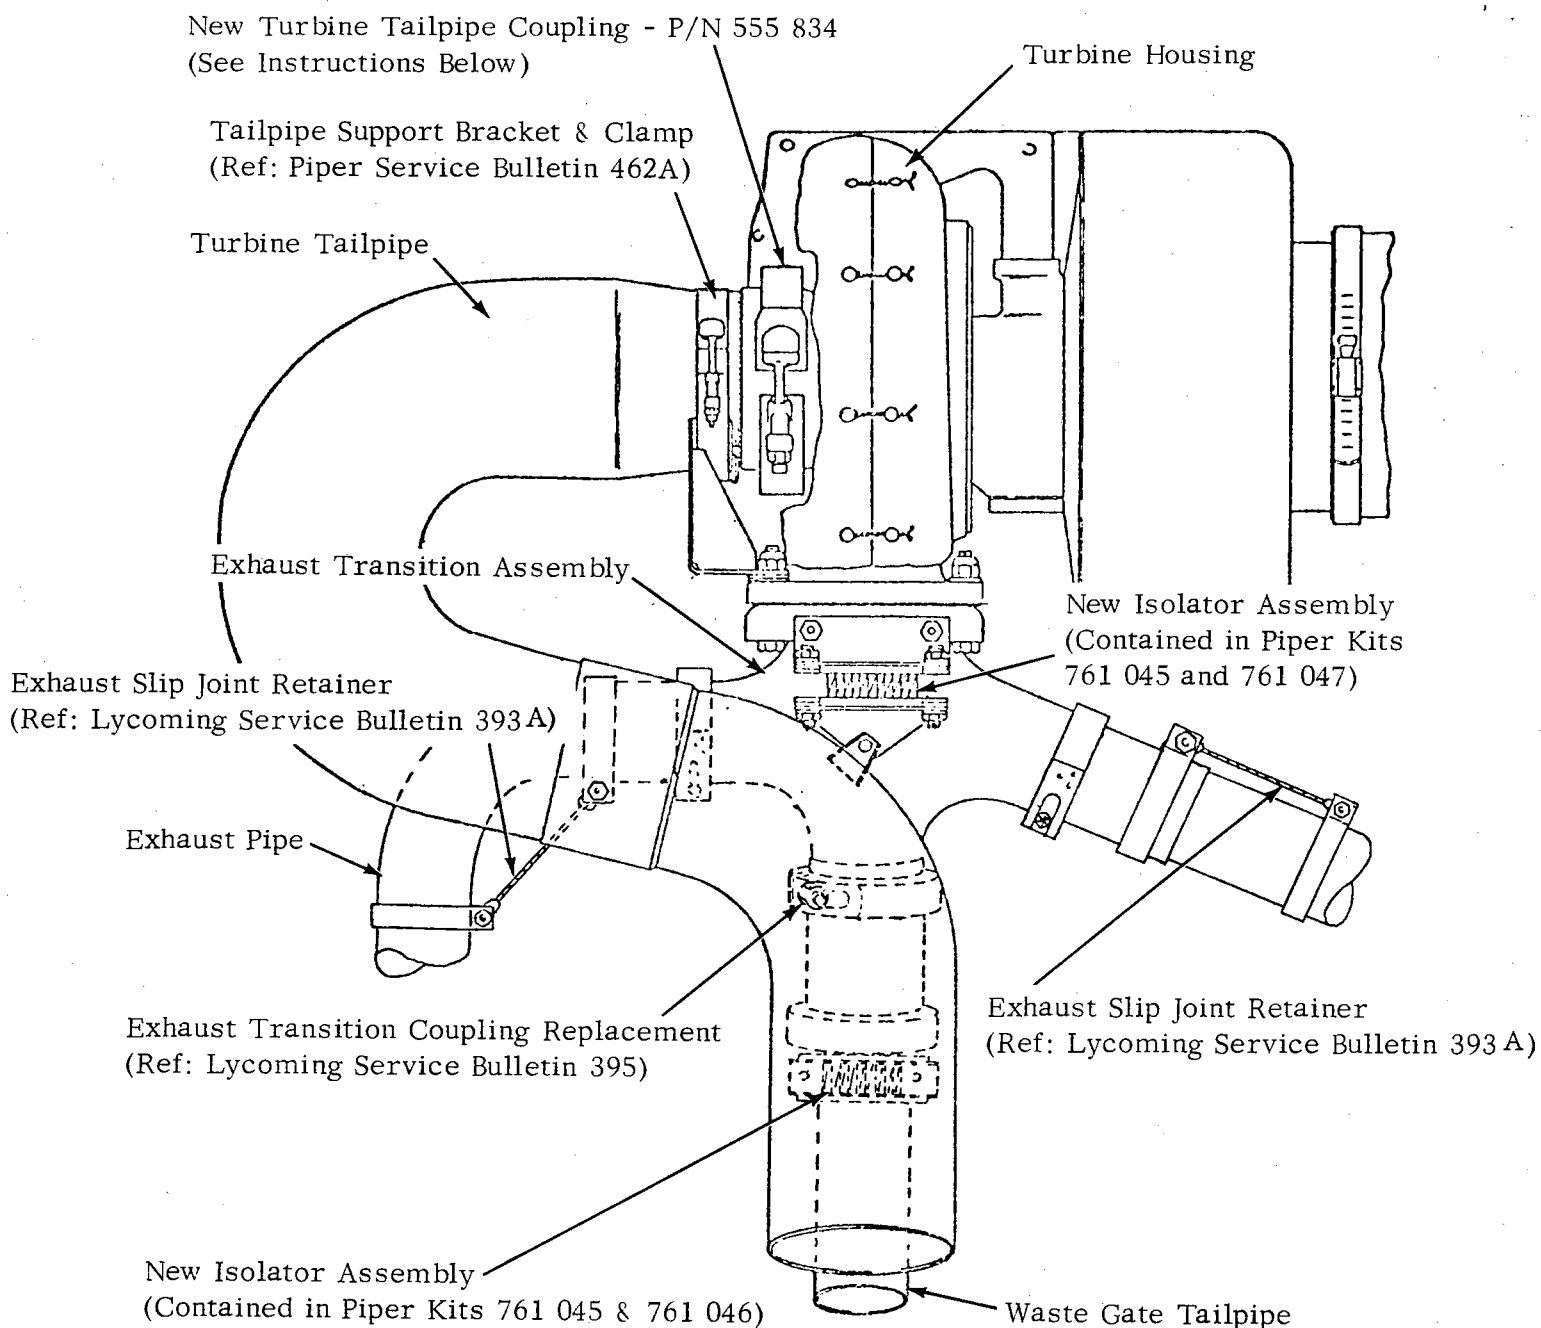
Figure 1.

INSTRUCTIONS - Turbine Tailpipe Coupling Replacement

1. Remove engine cowling from both engines to gain access to the turbine tailpipe couplings.
2. Remove existing couplings and install new couplings P/N 555 834 as follows:
 - a. Install coupling over end of tailpipe flange, spreading clamp a minimum amount.
 - b. Fit tailpipe flange to turbine flange, making certain flange faces are butted together with no gap.
 - c. Position tailpipe for clearance with exhaust pipe. Slide coupling over flanges and tighten. Torque to 45-55 inch pounds.
3. Reinstall engine cowling and make proper logbook entry of coupling replacement.

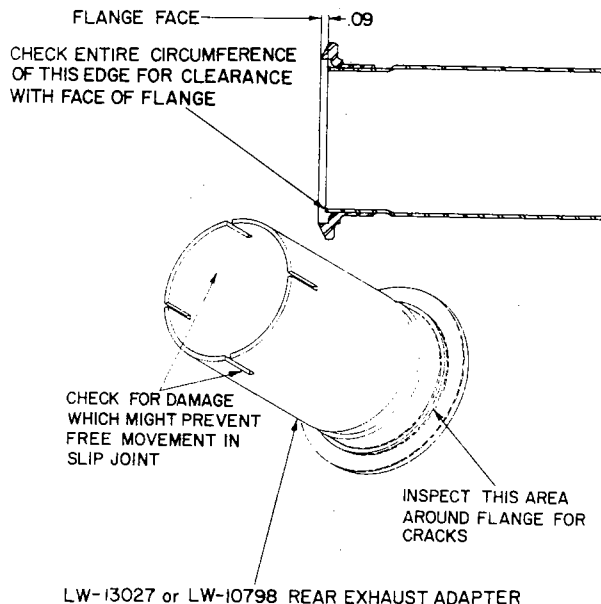
1. Remove spring tensioned rod and clamps or u-bolt clamps as may be the case. These parts are not reused.
2. Inspect exhaust adapter pipes for cracks around flange fillet and slits. (Pipes with or without slits may be reused.) Pay particular attention to condition of slip joint, noting any damage which may prevent free movement of the joint. In addition,

Figure 1. Exhaust Adapter Pipe Showing Areas Requiring Inspection

The exhaust adapter pipes attached to nos. 5 and 6 cylinders, along with the segments attached to the transition assembly, are especially subject to cracks in the area of weldments and attaching flanges. Replace any that indicate such defects.

check the end of the adapter pipe inside the flange mouth; it must be .090 inch below the surface of the flange face. Use a hand grinder if necessary to obtain this clearance. (See figure 1.)

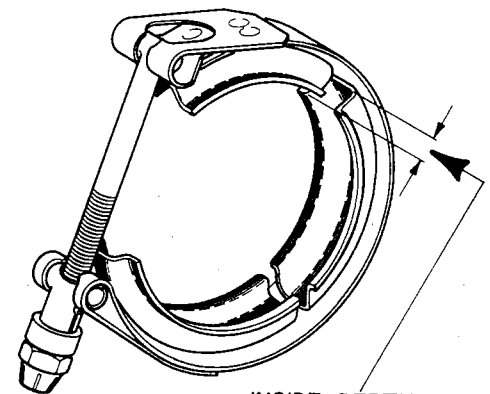
Figure 2. Exhaust Manifold Coupling Inspection Requirement

3. Reassemble exhaust adapter pipes to transition assembly using new 78083 gaskets. Check coupling part number. MVT69183-200 Avco Lycoming P/N LW-12093-5 is the number of the correct coupling to be used. Inspect the 3 v-band sections of each coupling with a depth micrometer as shown in figure 2. Any dimension obtained under .230 inch renders the coupling unfit for further service.

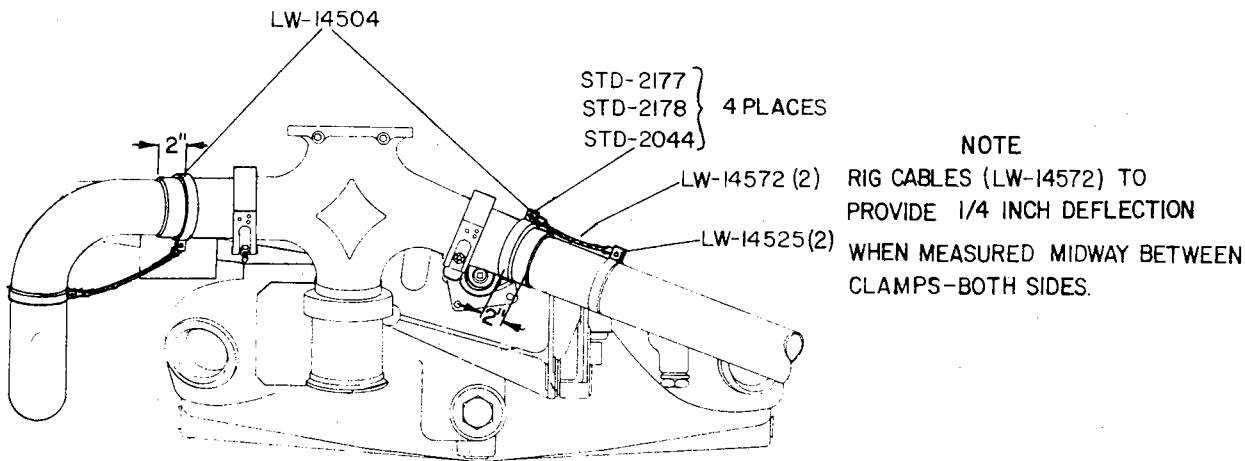
Figure 3. Area of Transition Assembly Showing Cable Assembly

6. Assemble clamps LW-14504 on adapter pipes approximately 2 inches from slip joint and LW-14525 clamps on left and right exhaust pipes. Connect cable assemblies LW-14572 to clamps with attaching parts STD-2177 bolt, STD-2178 washer and STD-2044 nuts. Attach these cables, leaving enough slack to provide 1/4 inch deflection of the cables after assembly. (See figure 3.) Tighten nuts to 60 ± 10 inch/lbs.

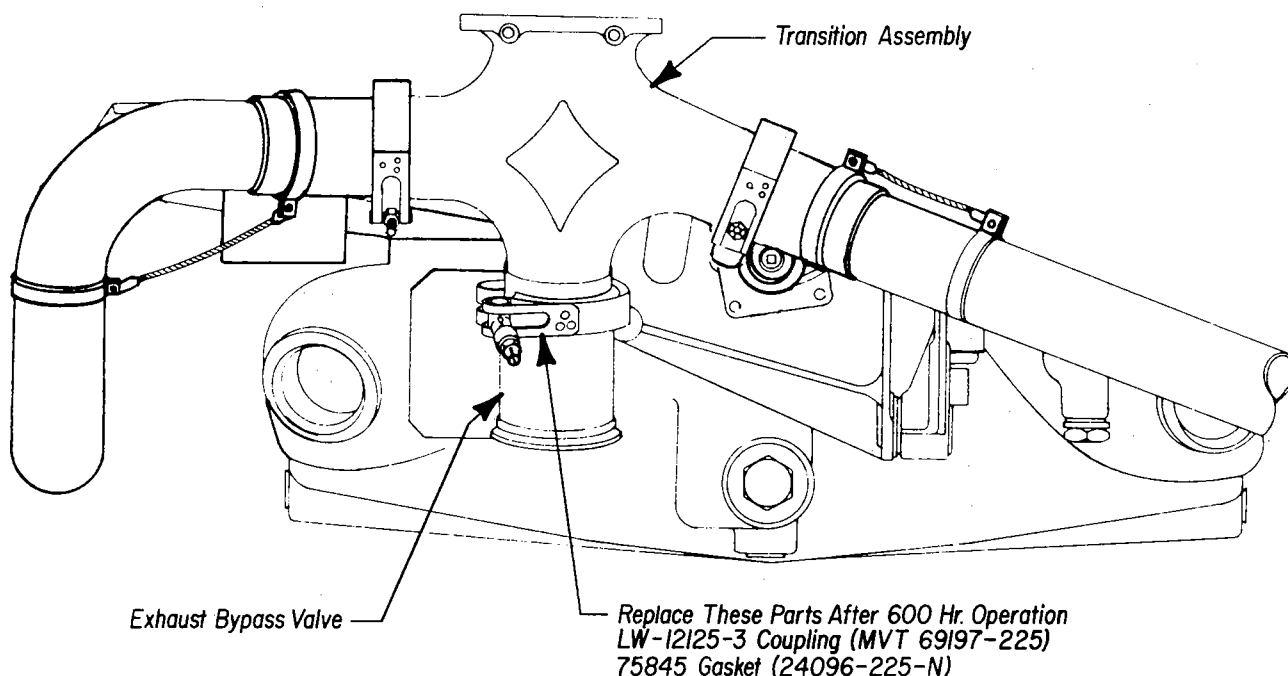
It has been determined that over a long period of time continuous use of the Marmon clamp LW-12125-3 (MVT69197-225) possibly can result in failure from erosion and deterioration, causing severe loss of engine power because of separation from the controlling waste gate. Replacement of the clamp and gasket is accomplished as follows:

Figure 1. Diagram of Rear Portion of Engine Showing Location of Coupling to Attach Transition Assembly and Exhaust Bypass Valve

1. Loosen the nut that attaches the Marmon clamp located between the transition assembly and the exhaust bypass valve. See figure 1. Remove the clamp and gasket.

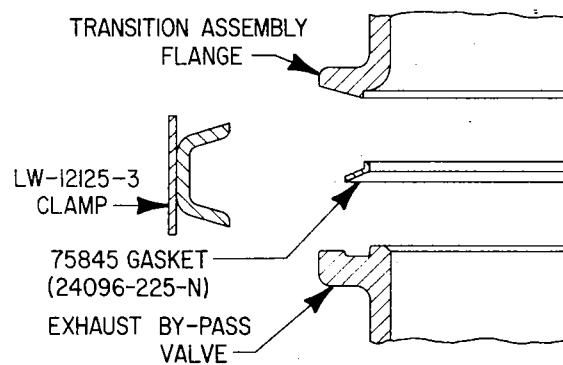
Figure 2. Diagram of Section Thru Transition and Exhaust Bypass Valve Showing Details of Clamp and Gasket Assembly

4. Place the gasket P/N 75845 in its proper position between the two mating flanges. Be sure it is seated firmly. Also be sure it is not upside down; that is, the straight, vertical side must face upward. See figure 2.
