Piper Aircraft Corporation
2926 Piper Drive
Vero Beach, Florida, U.S.A. 32960

SERVICE No. 967 BULLETIN

Aileron Hinge Inspection and Replacement

PA-31P Pressurized Navajo
PA-31T Cheyenne II

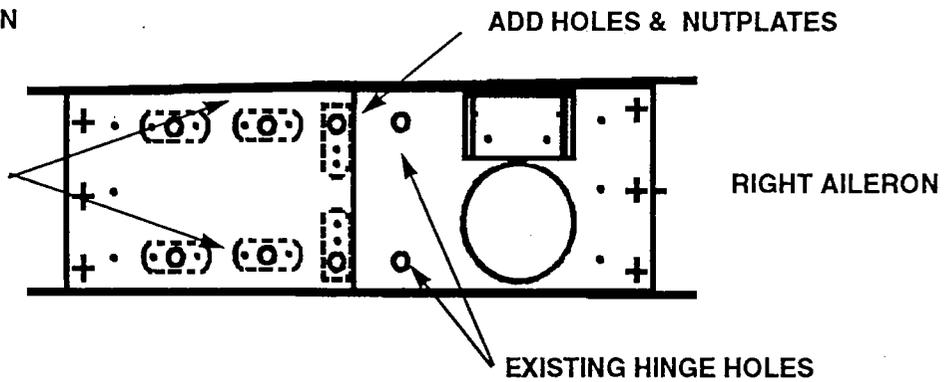
TYPICAL AILERON

Reports have been received indicating that small cracks are developing in the aileron spar and reinforcement doubler beneath the inboard aileron hinge attachment point.

INSPECT:
CRACKS WILL
APPEAR ALONG
SPAR FLANGE
AND AT ATTACH
HOLES.

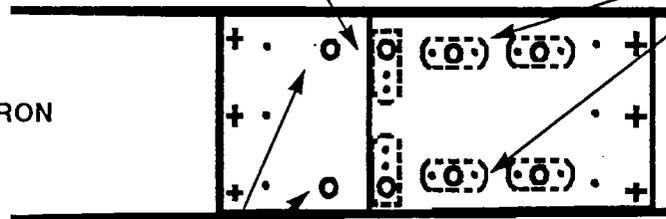
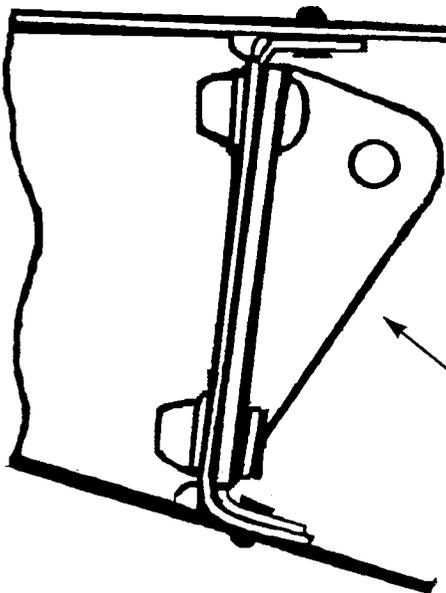
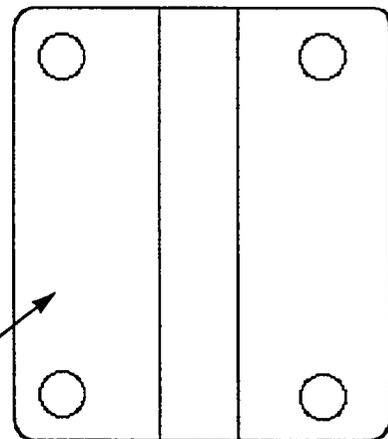
SKETCH A

EXISTING HINGE HOLES

INSPECT:
CRACKS WILL
APPEAR ALONG
SPAR FLANGE
AND AT ATTACH
HOLES.

ADD HOLES & NUTPLATES

INSTALL NEW HINGE
P/N'S 74461-02 (LEFT)
AND 74461-03 (RIGHT)
