# SERVICE BULLETIN

No. 546

Piper Aircraft Corporation

Inspection of Whelen Wing Tip Strobe Lights;  
Reference F.A.A. Airworthiness Directive  
75-05-04

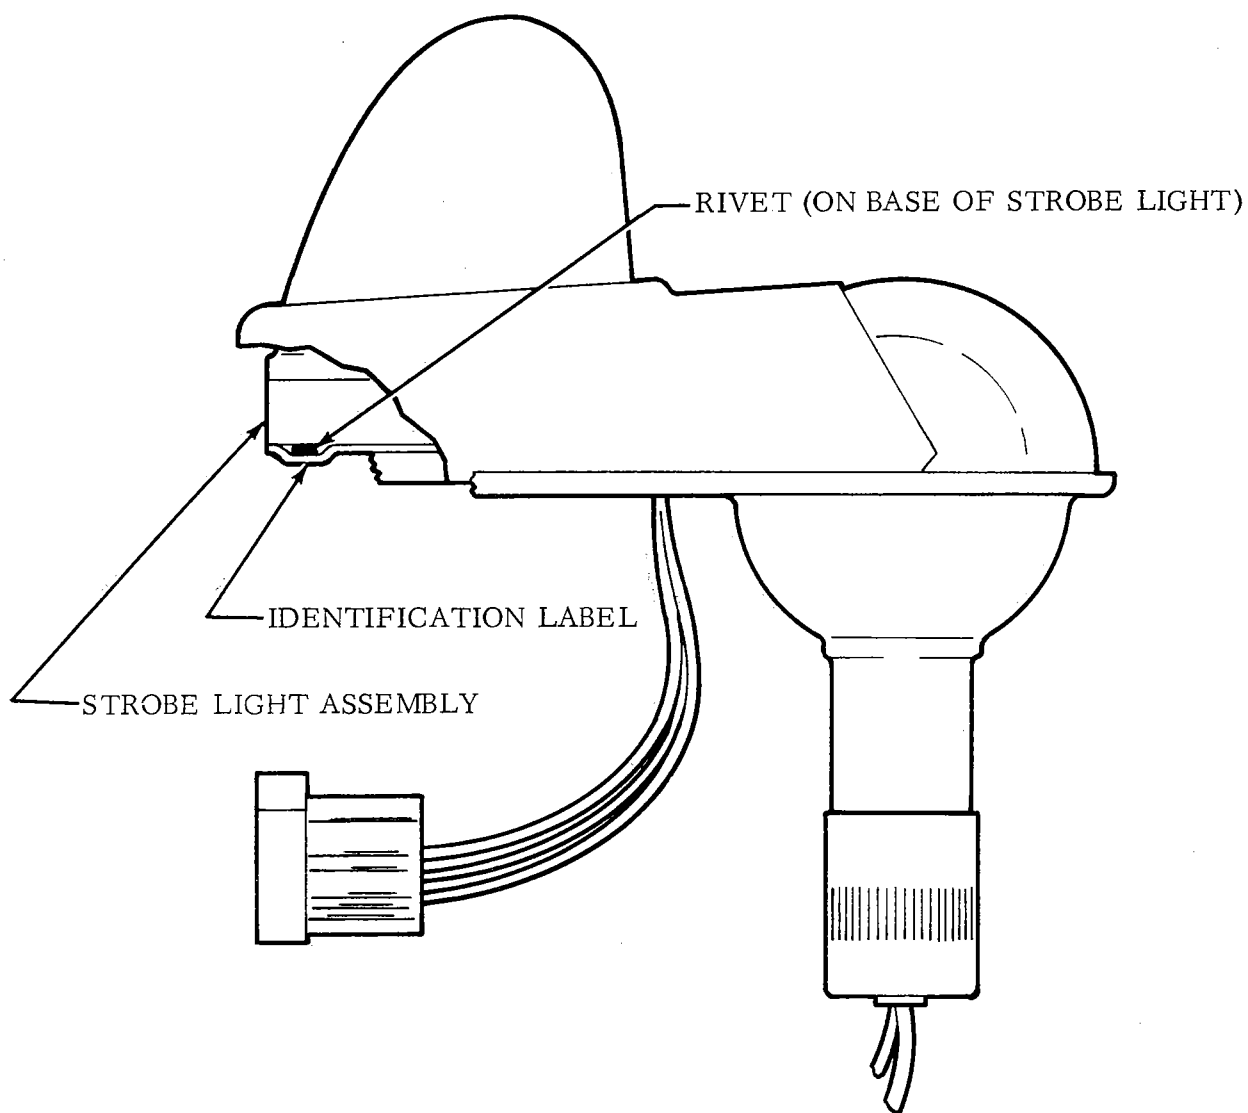
WHELEN NAVIGATION AND STROBE LIGHT ASSEMBLY

Purpose: The subject Airworthiness Directive was issued against the Whelen Engineering Company A-427 Strobe Light Assemblies "to preclude possible ignition of flammable fluids or vapors by arcing at the strobe light flash tube" (quoted from A.D. 75-05-04). The affected strobe light units may be installed as original equipment on the aircraft specified above, and it has been brought to our attention that a number of these strobe light units may not be in accordance with the subject Airworthiness Directive.

1. Expose wing tip strobe light assembly to view (refer to attached sketch for a typical strobe light assembly illustrated view).
2. If the following modification has already been accomplished, no further action is required; make appropriate entry in aircraft log book re compliance with this Service Release.

3. If the following modification has not been accomplished, proceed as follows:
  - a. Install on the base of the Whelen A-427 Flash Tube Assembly a pressure sensitive vinyl label conforming to Whelen drawing no. A-30052, Revision 1 dated October 15, 1974 or later F.A.A. approved revision.

1. Scotch Brand Type 33+ Vinyl Plastic electrical tape or equivalent tape - approved by an F.A.A. Maintenance/Avionics Inspector may be used in lieu of the vinyl label (if any plastic tape is used, it must be formed to cover the rivet at the rear of the flash tube without covering the identifying part number).

3. b. If the flash tube incorporates a label, the new label or tape may be installed directly over the old label.
- c. Install label or tape only when the label or tape and the flash tube are at a temperature above 50 degrees F.
4. Make appropriate service release compliance entry in aircraft log book.
