SERVICE No. 430 BULLETIN

Piper Aircraft Corporation

Inspection of Exhaust System Couplings

PA-31P Navajo

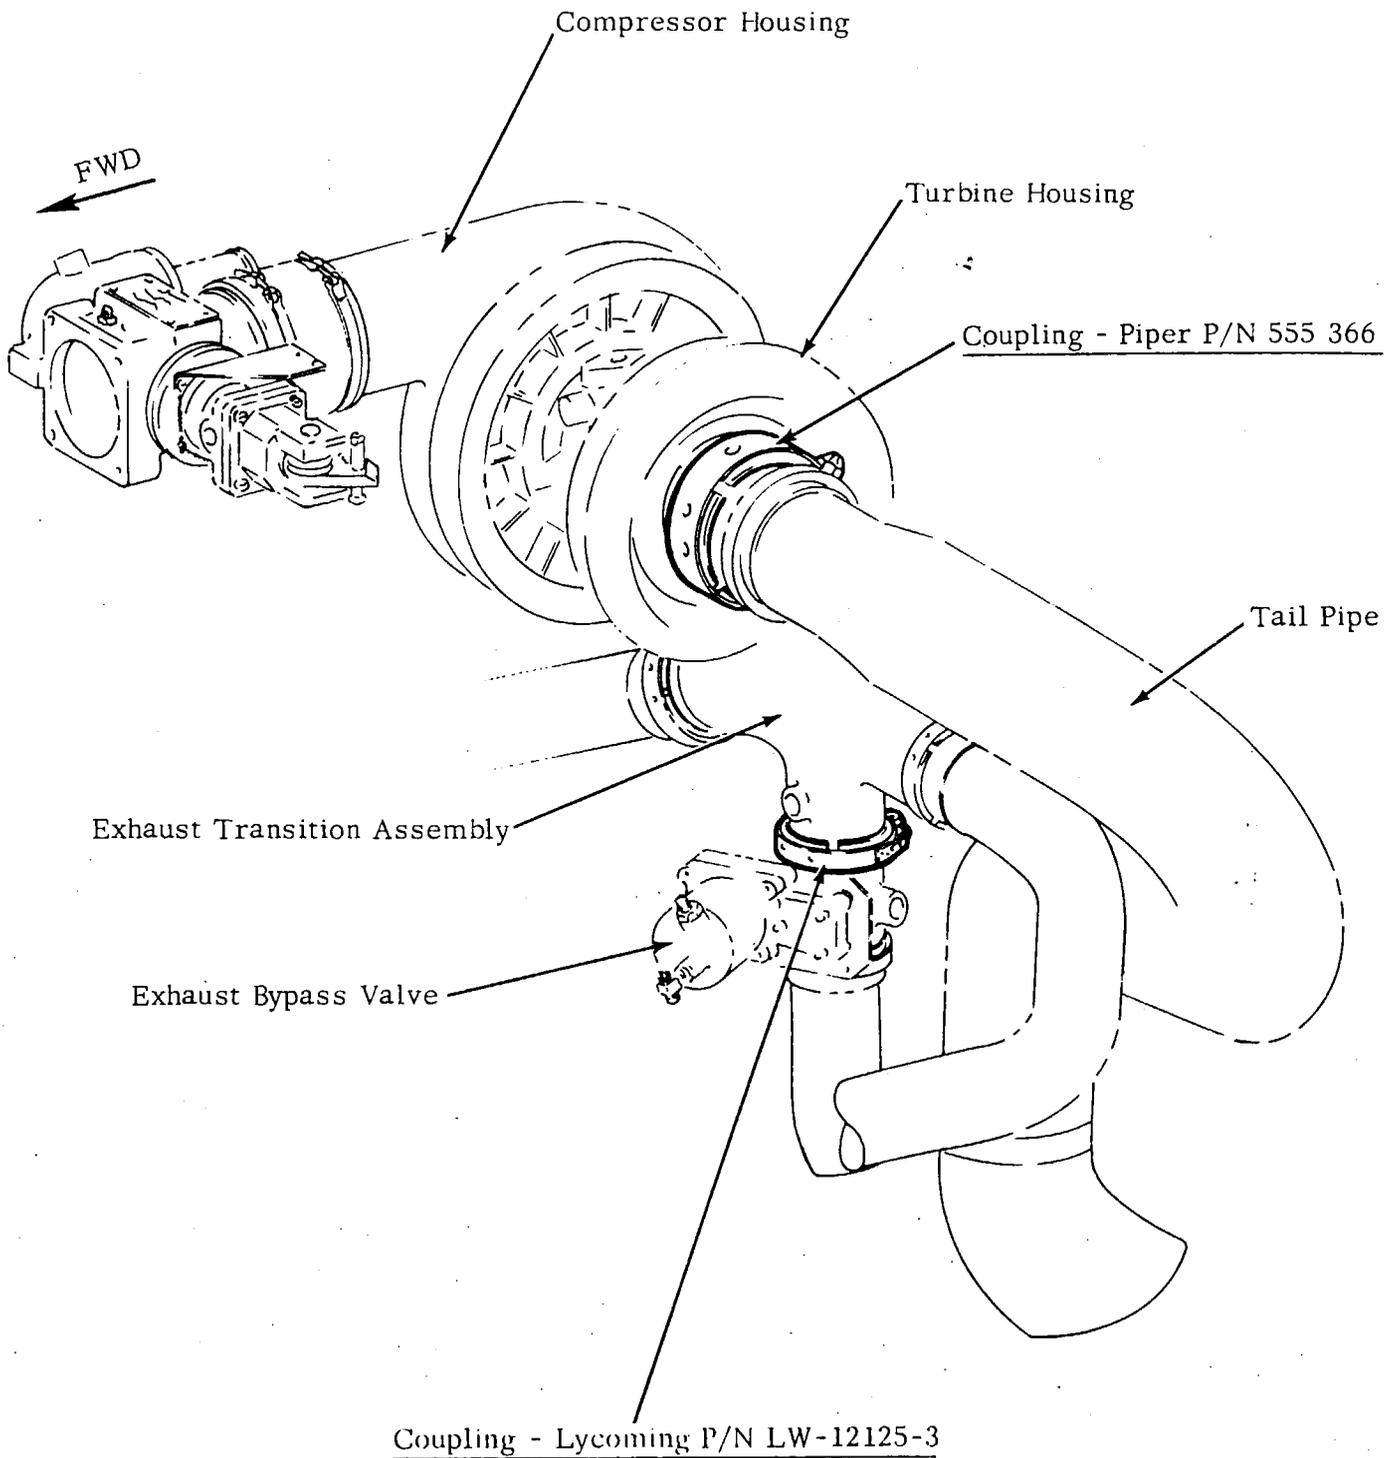
A report has recently been received from a Piper Field Service Center describing failure of Exhaust System Couplings (Piper) Part No. 555 366 and (Lycoming) Part No. LW-12125-3. It is believed that these failures may be due to improper torque values being applied during installation and/or improper handling procedures during inspection of the exhaust system and turbine wheel. At present, Piper Aircraft is conducting an evaluation of the couplings; however, until this investigation is completed, it is recommended that the above couplings be visually inspected in accordance with Compliance Time, above and replaced if the inspection reveals evidence of cracks and/or distortion (Ref. the attached sketch for an illustration of the affected area). Also, until further notice, it is recommended that whenever coupling (Piper) Part No. 555 366 is removed for inspection or maintenance purposes, that it be replaced with a new like part.

1. Gain access to the area described on the attached sketch.
 2. Using a flashlight and mirror, inspect the subject couplings for evidence of cracks and distortion.
 3. If either of the subject couplings is found unserviceable per #2 above, replace. NOTE: Be sure to tighten clamp to proper torque value -- Reference Piper Pressurized Navajo Service Manual, Section VIII, Table VIII-II.
 4. If no evidence of cracks and/or distortion is apparent, no further action is required at this time; return aircraft to service.
 5. Make appropriate log book entry.
-
