SERVICE BULLETIN

No. 526A

Piper Aircraft Corporation

Subject: Pilot/Copilot Microphone and Phone Jack Relay Modification

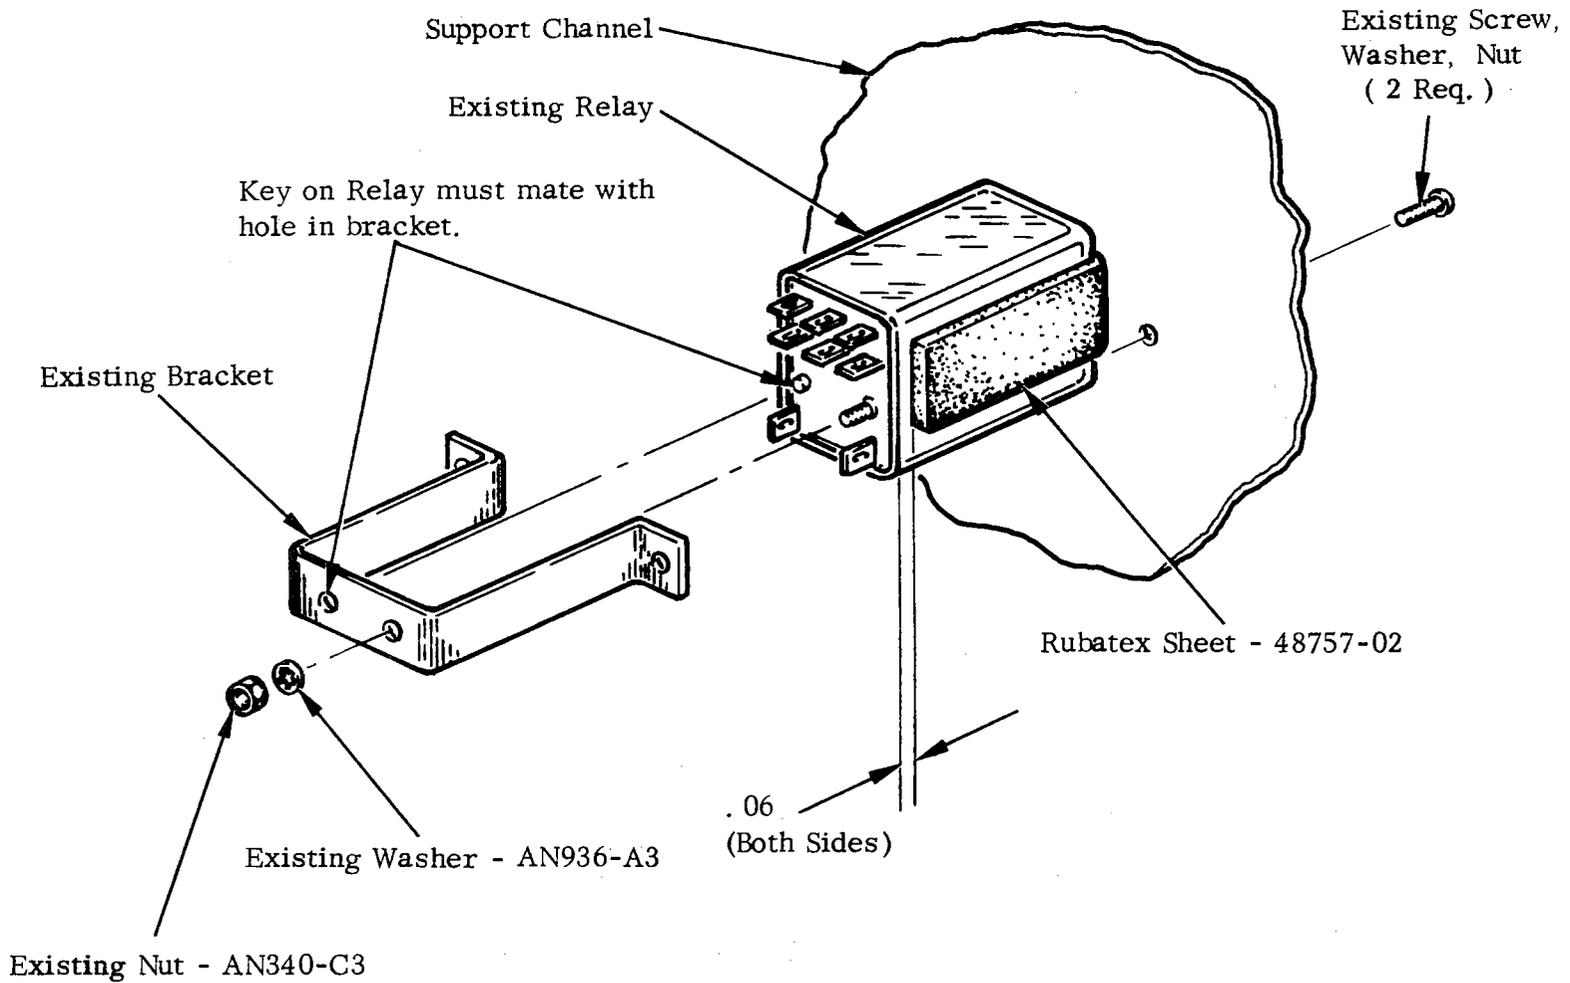
PILOT/COPILOT MIKE AND PHONE JACK RELAY DETAIL

Purpose: Intermittent operation of the copilot's microphone was determined to have occurred as a result of the pilot/copilot's microphone and phone jack relay loosening (through vibration) from its mounting bracket. This can, in turn, cause the 28 volt pin on the relay coil to contact the mounting bracket, causing an electrical short.

1. Ensure master switch is off.
2. Locate pilot/copilot mike and phone jack relay, as shown in detail above. The relay will be located near the copilots mike and phone jack.
3. Remove relay and attaching bracket as one unit. Retain hardware for reinstallation.
4. Disconnect relay from bracket. Retain washer and nut for reinstallation.
5. Wrap rubatex sheet 48757-02 around relay and trim to dimension shown above. Attach existing relay, with rubatex sheet, to existing bracket as shown using existing nut and washer.
6. Reinstall switch and bracket assembly to aircraft using existing hardware.
7. Make proper logbook entry of Service Bulletin 526A Compliance .
