SERVICE LETTER

No. 666

Piper Aircraft Corporation

Propeller Governor Speed-Adjusting Shaft, Lever and Lever Clamp Screw Replacement -- reference attached Woodward Service Bulletin No. 33549, dated May 1973.

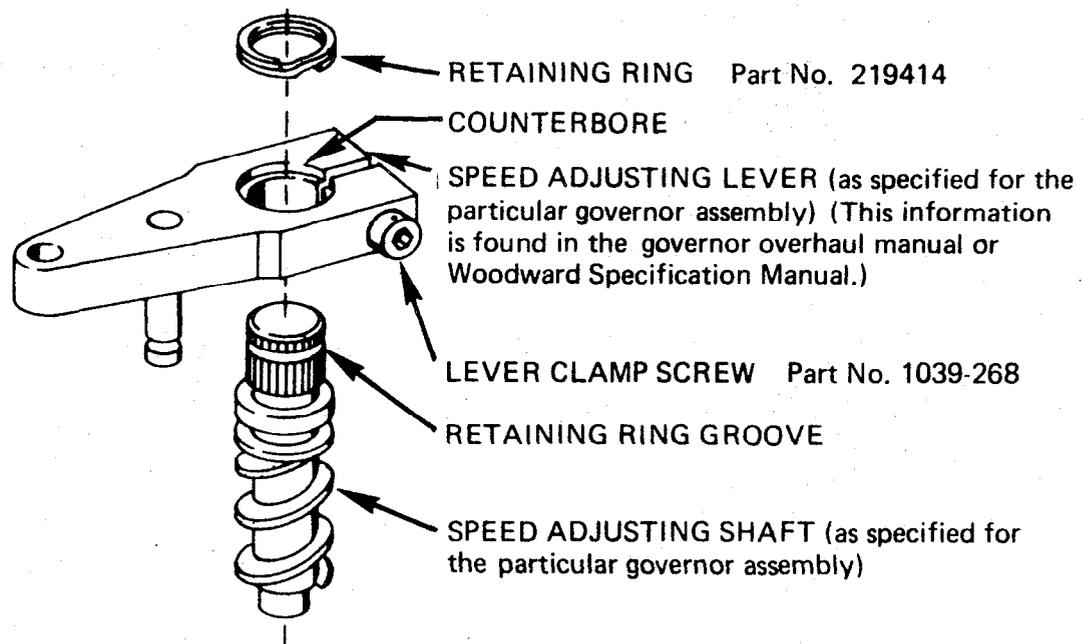
There have been instances of control levers sliding axially on the speed-adjusting shaft when not properly clamped. If complete disengagement occurs, this will cause the propeller to feather. Changes to prevent disengagement are now incorporated in all current new or factory-serviced lever-type propeller governors.

4. At next regular governor overhaul, if not already incorporated, install the following new parts to provide positive lever retention.

1. Speed adjusting shaft with retaining ring groove.
2. Speed adjusting lever with counterbore.
3. Retaining ring.
4. Lever clamp screw (installed torque of 33-38 lb. ins. is required).
