SERVICE LETTER

No. 783

Piper Aircraft Corporation

Subject: Inspection of Air Conditioning System
Capillary Sensor

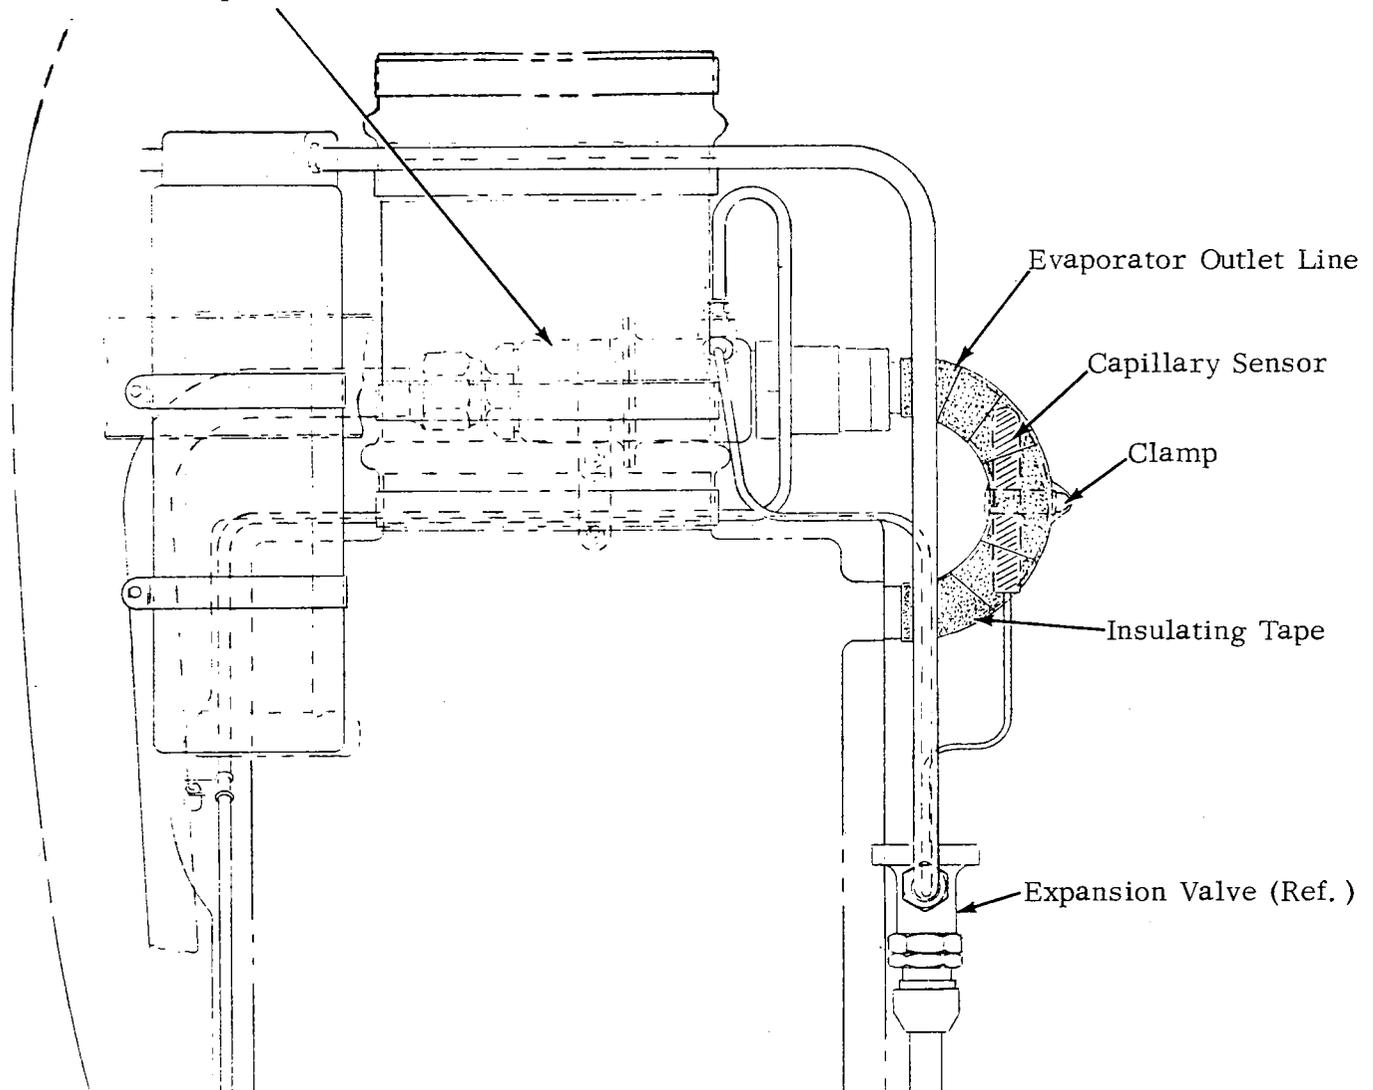
VIEW LOOKING AFT AT EVAPORATOR UNIT

1. Remove access panels from both sides of fuselage nose section to gain access to the evaporator unit.
2. Inspect capillary sensor to determine if it is properly positioned and clamped against the evaporator outlet line as shown above.

- a. If clamp is present and capillary sensor does not protrude above the curvature of the evaporator outlet line, no further action is required.
 - b. If clamp is not present and/or if capillary sensor protrudes above the curvature of the evaporator outlet line, proceed as follows.

1. Carefully remove insulating tape from evaporator outlet line and capillary sensor. Clean tape residue from line and sensor using MEK or acetone.
 2. Secure sensor to line, as shown above, using clamp P/N 454 921 (SAE Type 10 or Breeze #QS100-M10).

3. Apply insulating tape P/N 189 777 (P. T. I. Prestite Insulating Tape 1/8" x 2") over outlet line, capillary sensor and clamp.
3. Reinstall access panels and make proper logbook entry of Service Letter 783 compliance.
