SERVICE LETTER

No. 718

Subject: Bendix Magneto Bulletin No. 566 -- reference attached Avco Lycoming Service Bulletin No. 373, dated March 22, 1974.

SUBJECT: S-1200 Distributor Block and Gear Change

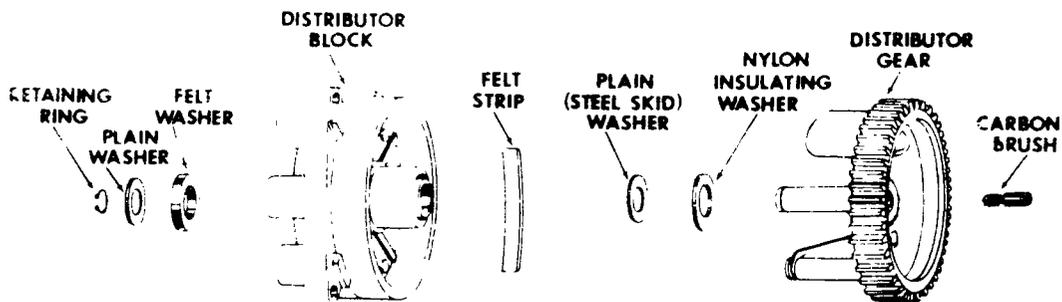
Figure 1.

Detailed Instructions:
It has been found that the addition of a nylon insulating washer and steel skid washer between the distributor gear electrode and the block bushing, as shown in figure 1, reduces the possibility of deterioration of the lubricant and possible seizure of the parts.

Assemble large distributor gear, nylon and steel washers to new or reworked block as follows using figure 1 as a guide.

Once modified, the distributor block can be used only with a gear having the nylon and steel washer installed over the shaft as shown in figure 1.

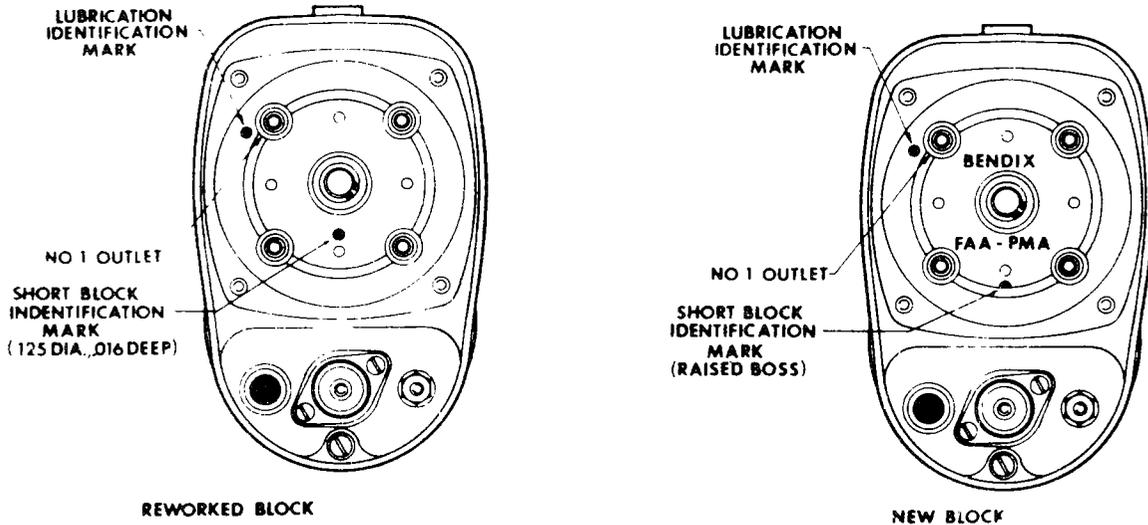
Figure 2

The addition of the washers make it necessary to shorten the gear end of the bushing and block. New production blocks incorporating the change are identified by a raised

boss between the high tension towers at the six o'clock position and molded in letters as shown in figure 2. Reworked blocks are identified by a drill point indentation in the same location. New and reworked blocks both have different part numbers from the current (old) block. See Table 1.

a. If distributor block is not marked with a raised boss or drill point indentation to the left and adjacent to the No. 1 high tension tower (see figure 2), remove old lubricant from bushing as follows.

(3) Identify distributor block by drilling flat bottomed indentation .125 inch diameter and .016 inch deep located as shown in figure 2.
