SERVICE No. 1008 BULLETIN

Date: September 30, 1997 (M)

Elevator Butt Rib Refinement

PA-31, 31-300, 31-325 Navajo
PA-31-350 Navajo Chieftain
PA-31-350 T1020
PA-31P-350 Mojave

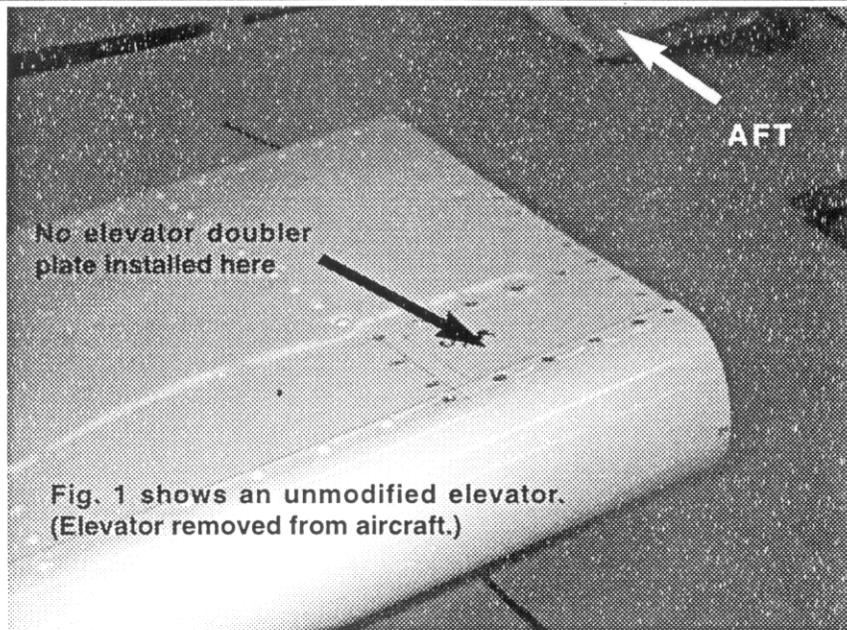
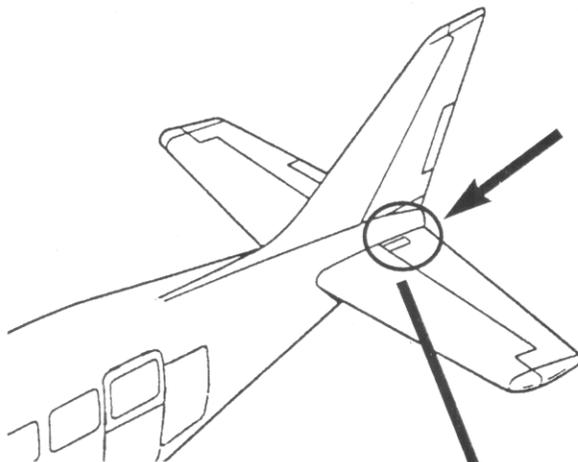
Approximate location of doubler plate on left and right elevators. Installation of doubler plate indicates the installation of the Elevator Butt Rib Refinement Kit p/n 766-642.
