# SERVICE LETTER

No. 866

Piper Aircraft Corporation

Subject: Windshield Wiper Arm Retaining  
Wire Installation

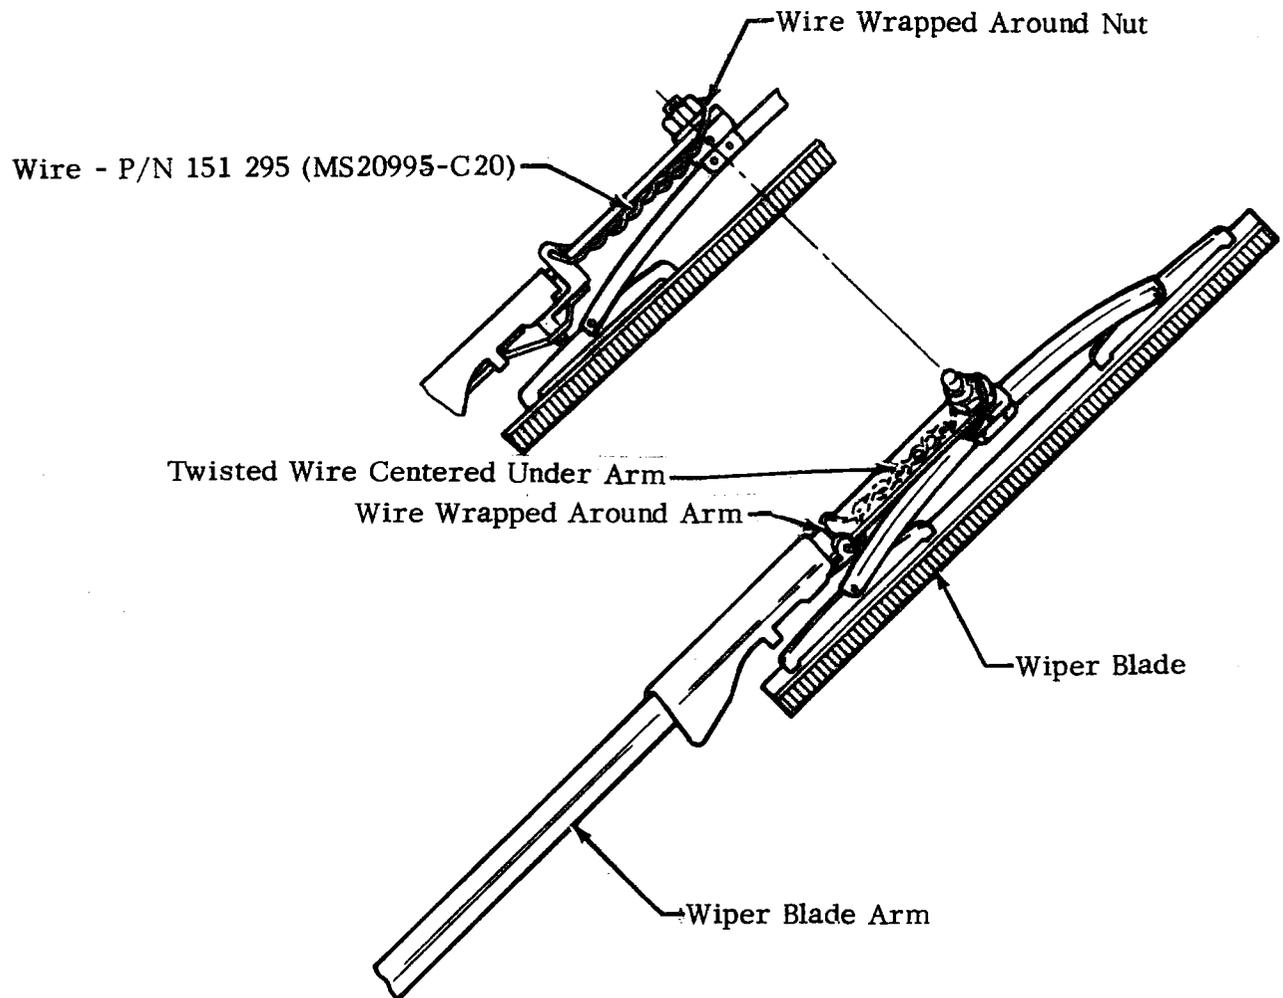
Typical Windshield Wiper Blade

Several reports have been received of windshield wiper arms separating during wiper operation. Such separation could result in the scratching of the windshield by the wiper arm.

Refer to sketch. Install MS20995-C20 wire as shown to safety the two sections of the wiper arm. Make appropriate logbook entry of compliance with this service release.
