SERVICE BULLETIN

No. 494B

Piper Aircraft Corporation

Subject: Inspection of Flap Control System

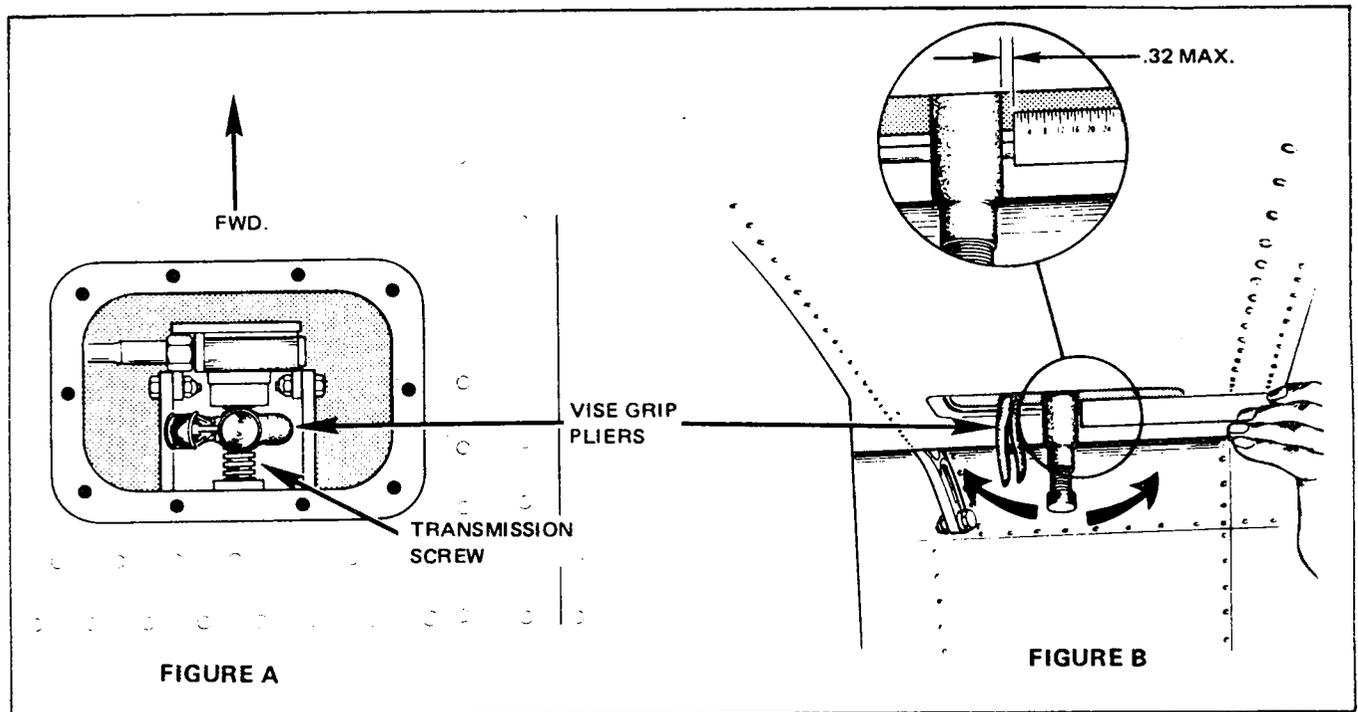
Figure 1. Wing Flap Transmission Inspection

Purpose: Piper Service Bulletin No. 494 and FAA AD 76-10-06 were issued in response to reported flap system conditions that have occurred on the above referenced aircraft. Primarily, flap system malfunctions resulted from flap transmission failures due to excessive transmission internal component (pinion and worm gear) wear - identified as excessive "play" or "lost motion" in the transmission screws. Other flap system components (reference Instructions No. 2, below) may have been a factor.

- c. With the use of vise grip pliers and exerting light pressure, grasp the exposed portion of the screw close to the transmission as shown. (Refer to Figure 1, Views A and B).

- e. Place a six inch ruler along the skin surface as shown in Figure 1, below, View B, and measure the overall distance the pliers move.
 - f. Should this dimension exceed .32 (5/16) of an inch, replace the transmission assembly or obtain Gear Transmission Overhaul Kit 755 051 for 20:1 ratio transmissions, part numbers 4268-00 and 4268-00-1, or Kit 755 050 for 40:1 ratio transmissions, part numbers 1049-00-1 and 1049-00-3. (See Parts Catalog for serial numbers affected; refer to appropriate Service Manual for transmission removal and installation.)

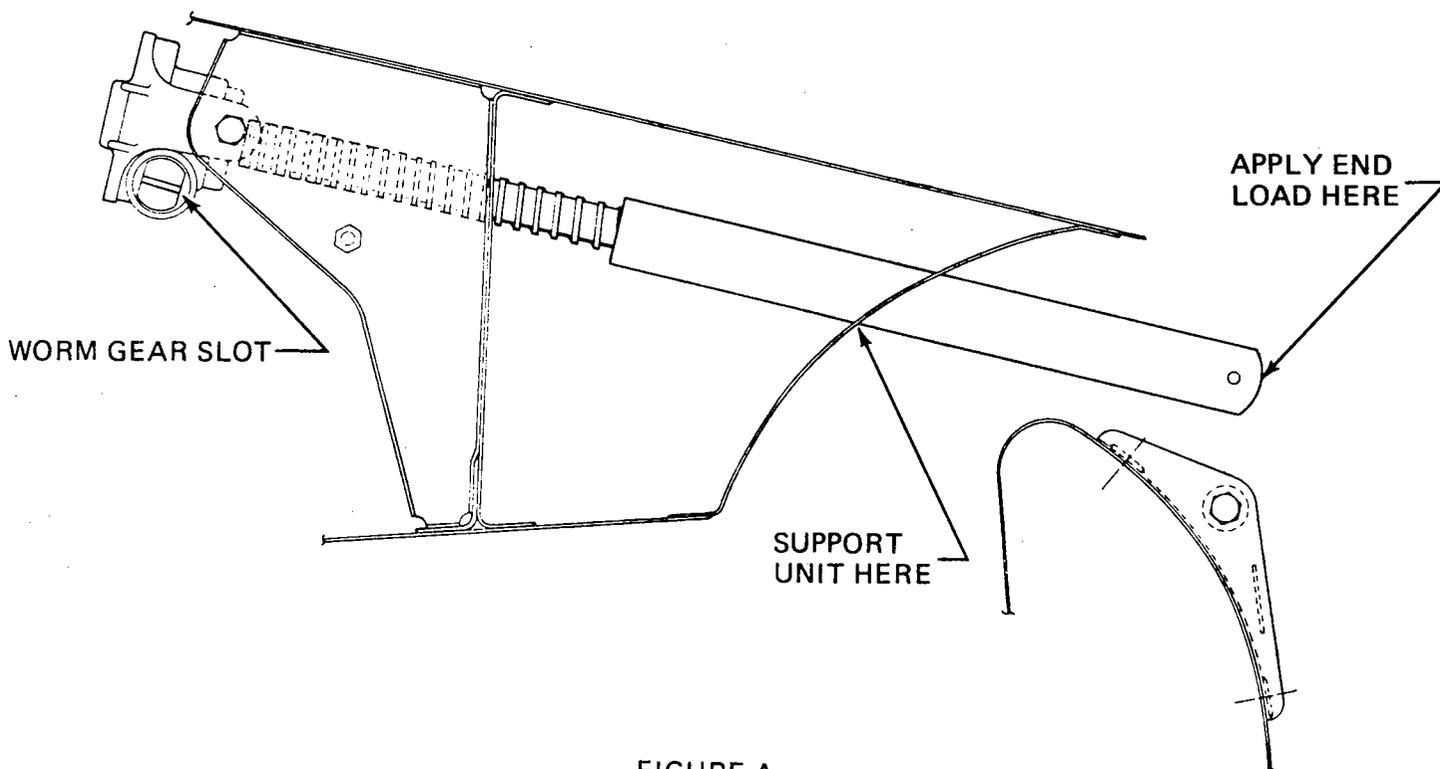
FIGURE A

1. Extend the transmission screw to the end of its travel.
2. Using a flat blade screwdriver inserted into the slot of the worm gear on the transmission (see Figure A), turn the gear 20 turns for the 4268 unit or 40 turns for the 1049 unit and note any tight or high spots as the worm gear is rotated.

The transmission should have an end load applied while turning the worm gear. (See Figure A.)

5. If the rod or screwdriver can be rotated by finger pressure only, no further action is required and the transmission is ready for use in the aircraft. If the rod or screwdriver cannot be rotated by finger pressure only, the transmission will require a run-in prior to being used in the aircraft.
