Piper Aircraft Corporation
Vero Beach, Florida, U.S.A.

SERVICE No. 845A BULLETIN

Date October 9, 1987 M

SUBJECT: Main Landing Gear, Forward Side Brace Inspection/Replacement

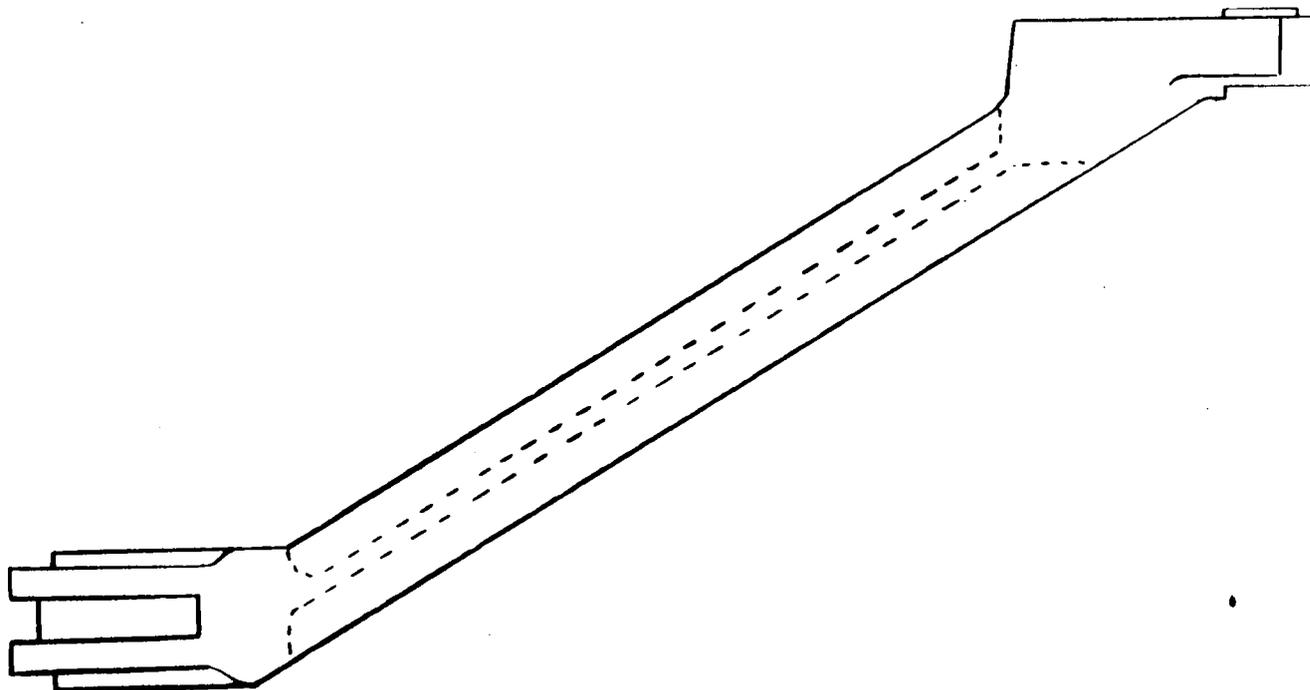
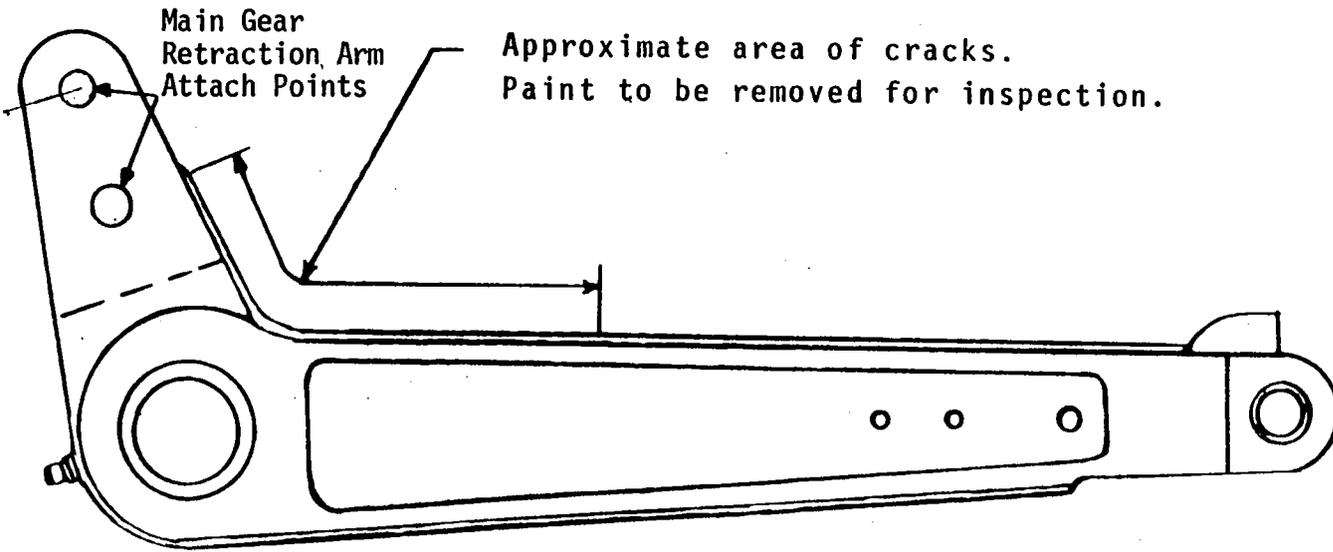
SKETCH "A"

PURPOSE: Field reports have been received of main landing gear forward side braces cracking during the landing gear cycle. A failed side brace would prevent landing gear retraction and could cause landing gear collapse under high side load conditions. It has also been determined that any operation of the landing gear above maximum landing gear operating speed (V_{LO}) greatly increases stress and could cause side brace failure.

1. Remove paint in area indicated on Sketch "A" on both Main Landing Gear Forward Side Braces, Piper Part Number 40279-16 left and 40279-17 right for PA-31T2; Piper Part Number 40279-08 left and 40279-09 right for PA-31, PA-31P, PA-31T, and PA-31T1 Models.

NOTE: Installation of new improved main landing gear forward sidebraces will require the use of longer bolts at the main gear retraction arm to sidebrace attach points, see Material Required. Refer to Sketch 'A'.

2. Inspect area for cracks using dye penetrant or zyglo procedures.
3. If cracking is indicated, replace the affected part prior to further flight, per the appropriate aircraft maintenance manual.
4. Make the appropriate logbook entry of compliance with PART I of this Service Bulletin.

1. Refer to the appropriate maintenance manual for specific instructions.
2. Remove main landing gear forward side brace on left and right main landing gear.
3. Install new main landing gear forward side braces. (See Material Required for specific part number).
