SERVICE BULLETIN No. 591

Piper Aircraft Corporation

March 22, 1978

Subject: Inspection of Goodyear BTC-39 Fuel Cells

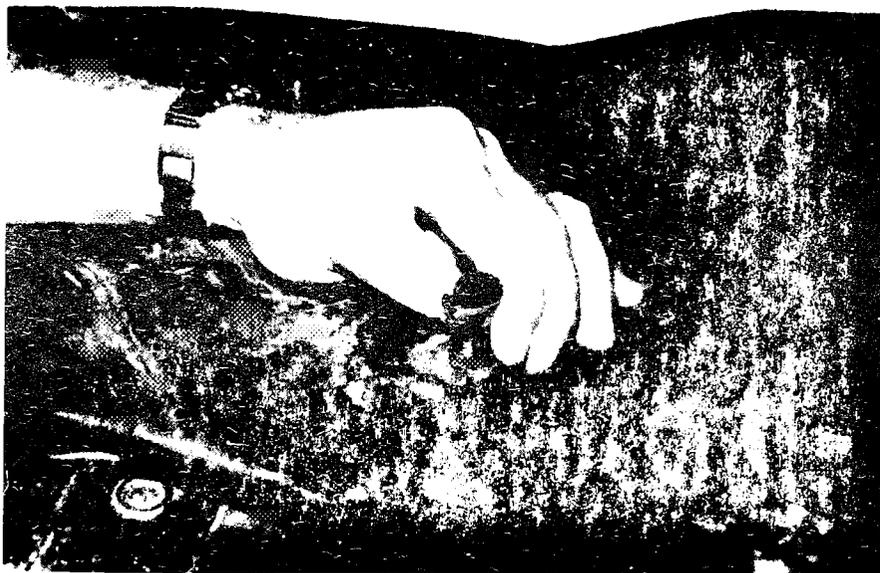
FIGURE 1

The fingernail test consists of using the fingernail to attempt to scrape the rubber off the nipple fitting (see Figure 1). If the rubber has not degraded, the fingernail will glide across the rubber without damage to the rubber. If an unsatisfactory condition exists, the fingernail will dig into the rubber. The rubber will have a consistency of either art gum or chewing gum.

4. Any fuel tank found seeping or with soft nipples should be replaced.
5. Replacement fuel tanks should be installed in accordance with aircraft manufacturers instructions.
