# SERVICE LETTER

No. 694

Piper Aircraft Corporation

SUBJECT: Exhaust Manifold Clamp Inspection

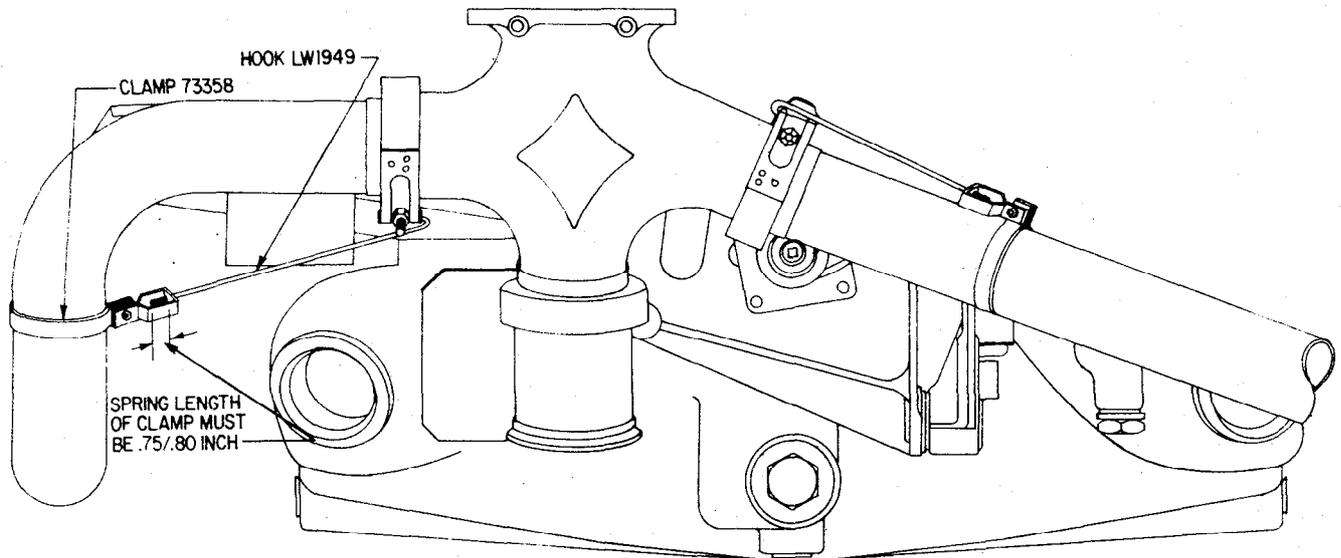
Rear View Showing Tensioning Devices

As a means of preventing the exhaust manifold from separating at the slip joint, thus losing the exhaust pressure to the turbocharger, a tensioning device is provided on the exhaust manifold which consists of a clamp, hook and spring as shown in the illustration.

Examine the clamp for any movement; if it can be moved in any direction, it is not tight enough. To tighten, draw the nut on the bolt as far as possible. If the clamp can still be moved, remove the nut and bolt leaving the clip and hook loose. Fasten both tangs of the clip on the outside of the tangs of the clamp as shown in the

illustration. If the clamp still can be moved, replace the component parts with those shown in the list below.

The compressed length of spring is .75-.80 inch.
