Piper Aircraft Corporation
Vero Beach, Florida, U.S.A.

SERVICE No. 860
BULLETIN

Date April 14, 1987

SUBJECT: Main Landing Gear Downlock Cable
Anti-Rotation Stop Replacement

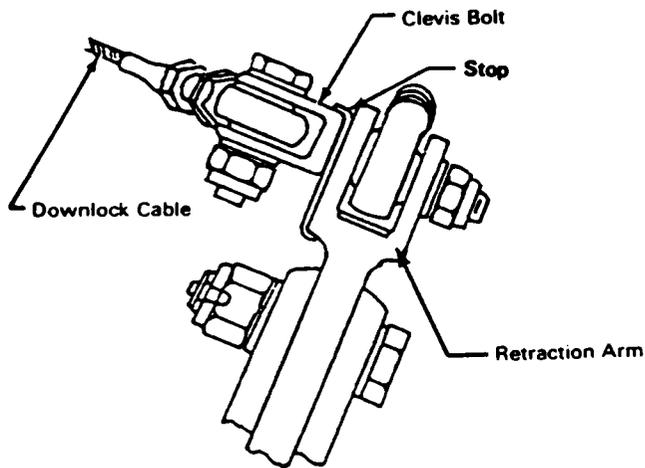
Old Configuration

PURPOSE: It has been determined that the existing anti-rotation stop used in conjunction with the main landing gear downlock cable, as installed on certain aircraft as a field retrofit or original factory installation, can allow the cable attach clevis bolt to rotate. This in effect shortens the length of the downlock cable, preventing full engagement of the downlock hook assembly. If this condition exists and is left uncorrected, a gear unsafe condition could occur.

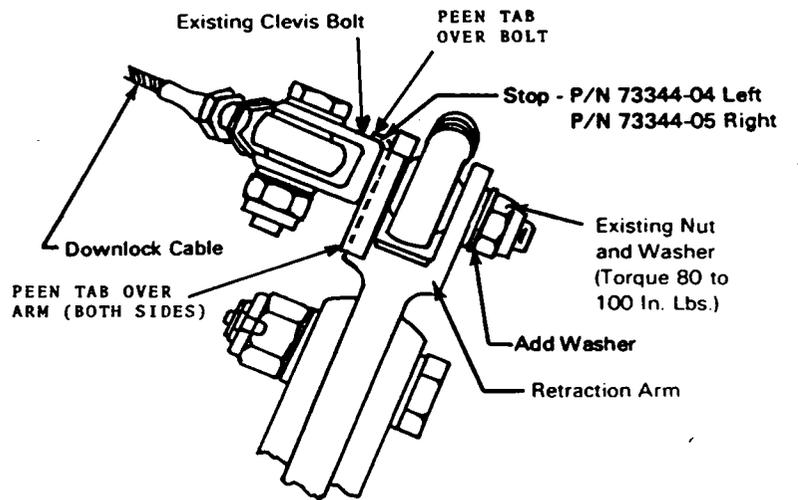
New Configuration

This Service Bulletin announces the availability of an improved anti-rotation stop which, when installed, will prevent the above described condition.

1. Place aircraft on jacks.
2. Remove nut and washer from the clevis bolt connecting the downlock cable to the retraction arm. See Sketch "A" attached.
3. Pull out the clevis bolt, remove and discard the existing anti-rotation stop, if installed.
4. Install new anti-rotation stop, Piper Part Number 73344-04 (left gear) and 73344-05 (right gear) over the bolt and reinsert bolt through the retraction arm.

5. Install an additional AN960-416 washer as well as existing washer and nut. Torque nut 80 to 100 inch pounds. See Sketch "A".
 6. Insure that tab on anti-rotation stop secures clevis bolt. See Sketch "A".
 7. Repeat procedure on opposite gear.
 8. Perform a gear function check.
 9. Remove aircraft from jacks.
 10. Make a logbook entry of compliance with PART II of this Service Bulletin.
-
