## VENDOR SERVICE PUBLICATION

SUBJECT: Bendix Service Bulletin No. 629

# SERVICE BULLETIN

Inspection and replacement of certain Bendix Aircraft Magneto Brown Distributor Blocks as used on turbocharged six (6) cylinder engines.

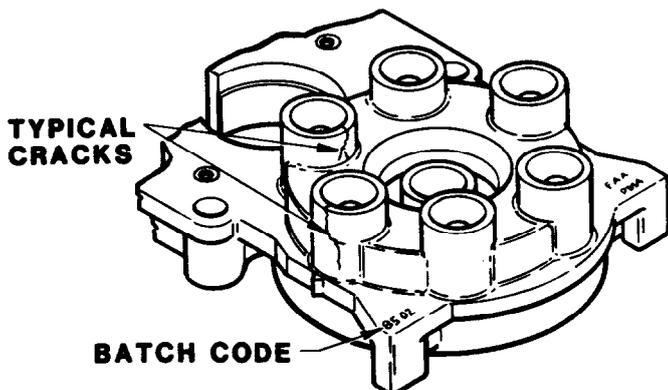
Figure 1  
D-2000/D-3000 Series  
Batch Codes 0000 through 8552

To remove from service distributor blocks that may contain outlet tower cracks. See Figures 1 through 3.

Field reports indicate some brown distributor block towers may crack (ref. Figures 1 through 3). Should the tower or towers crack the indications could be loss of ignition to the associated spark plug(s) or possible misfiring and/or cross firing of the engine.

1. Following published procedures, remove the harness cover or adapter plate from the Magneto. Using a high intensity light, inspect each distributor block tower for open cracks as shown in Figures 1 through 3.

CAUTION: BEFORE FURTHER FLIGHT, BLOCKS FOUND WITH CRACKS MUST BE REPLACED BY BLOCKS WITH BATCH CODES NOT LISTED AS AFFECTED UNDER THE "EQUIPMENT AFFECTED" SECTION OF THIS BULLETIN. FOLLOW PUBLISHED PROCEDURES.
