SERVICE LETTER

No. 755C

Piper Aircraft Corporation

SUBJECT: Landing Gear Lock Actuator Rod and Rod End Bearing Inspection/Replacement.

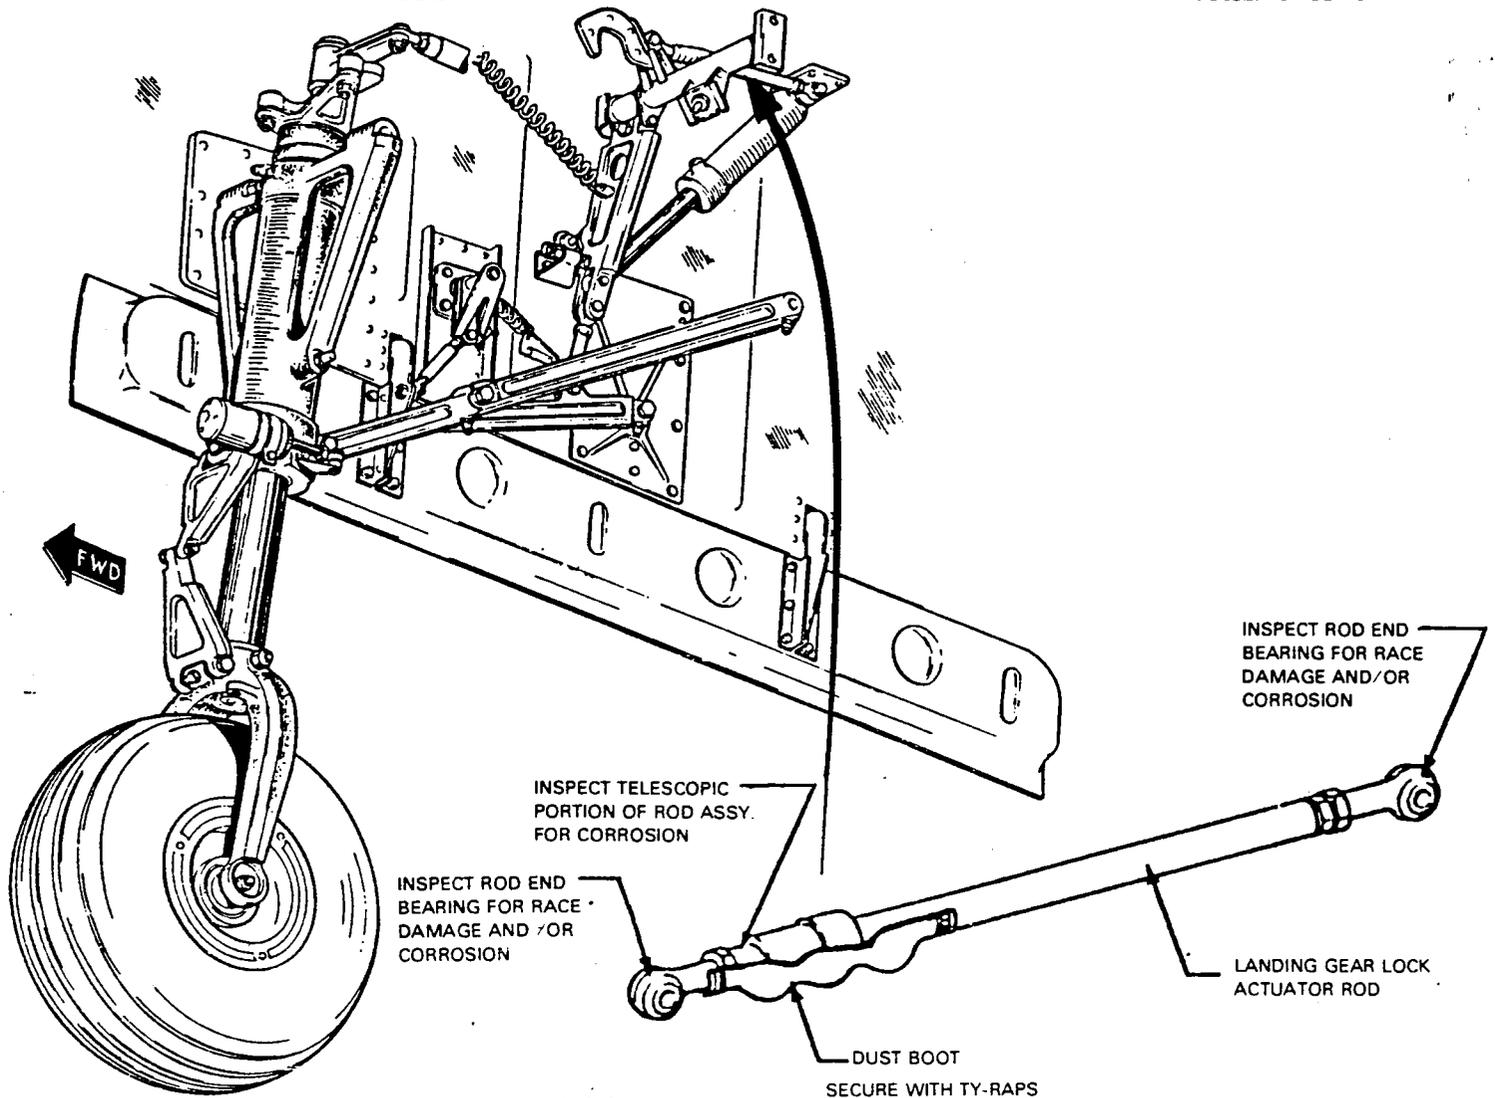
SKETCH A

Nose Gear Actuator Rod and Rod End Bearing Inspection

3. Inspect the telescopic portion of the landing gear lock actuator rod for evidence of corrosion.
 - a. If corrosion is evident, the landing gear lock actuator rod assembly should be replaced.

5. Inspect each rod end bearing for evidence of race damage and/or corrosion.
 - a. If corrosion is evident and/or ball and race of bearing shows evidence of damage (ball must rotate freely in race), it will be necessary to replace that bearing.

1. Locate and remove the nose gear lock actuator rod assembly from aircraft as shown.
2. Loosen the clamp attaching the dust boot to the landing gear lock actuator rod. Slide the dust boot back to expose the telescopic portion of the actuator rod assembly.

- b. If no corrosion exists, lubricate the telescopic portion with MIL-G-81322, 81827 or MIL-G-21164C lubricant.
4. Reposition and secure dust boot on each landing gear lock actuating rod assembly.

- b. If existing bearings show no evidence of corrosion or damage, lubricate bearings with MIL-L-7870 lubricant.
6. If a new main gear lock actuator rod assembly (assemblies) is being installed, lubricate the telescopic portion as described in 3b above, and the rod end bearings with MIL-L-7870 lubricant. Install existing dust boot on actuator rod assembly as shown.

7. Reinstall the nose gear actuator rod assembly on aircraft. Check system function and rigging; adjust as necessary using the appropriate Navajo Service Manual. Refer to Sketch "C" for the correct method of adjusting rod end bearings.

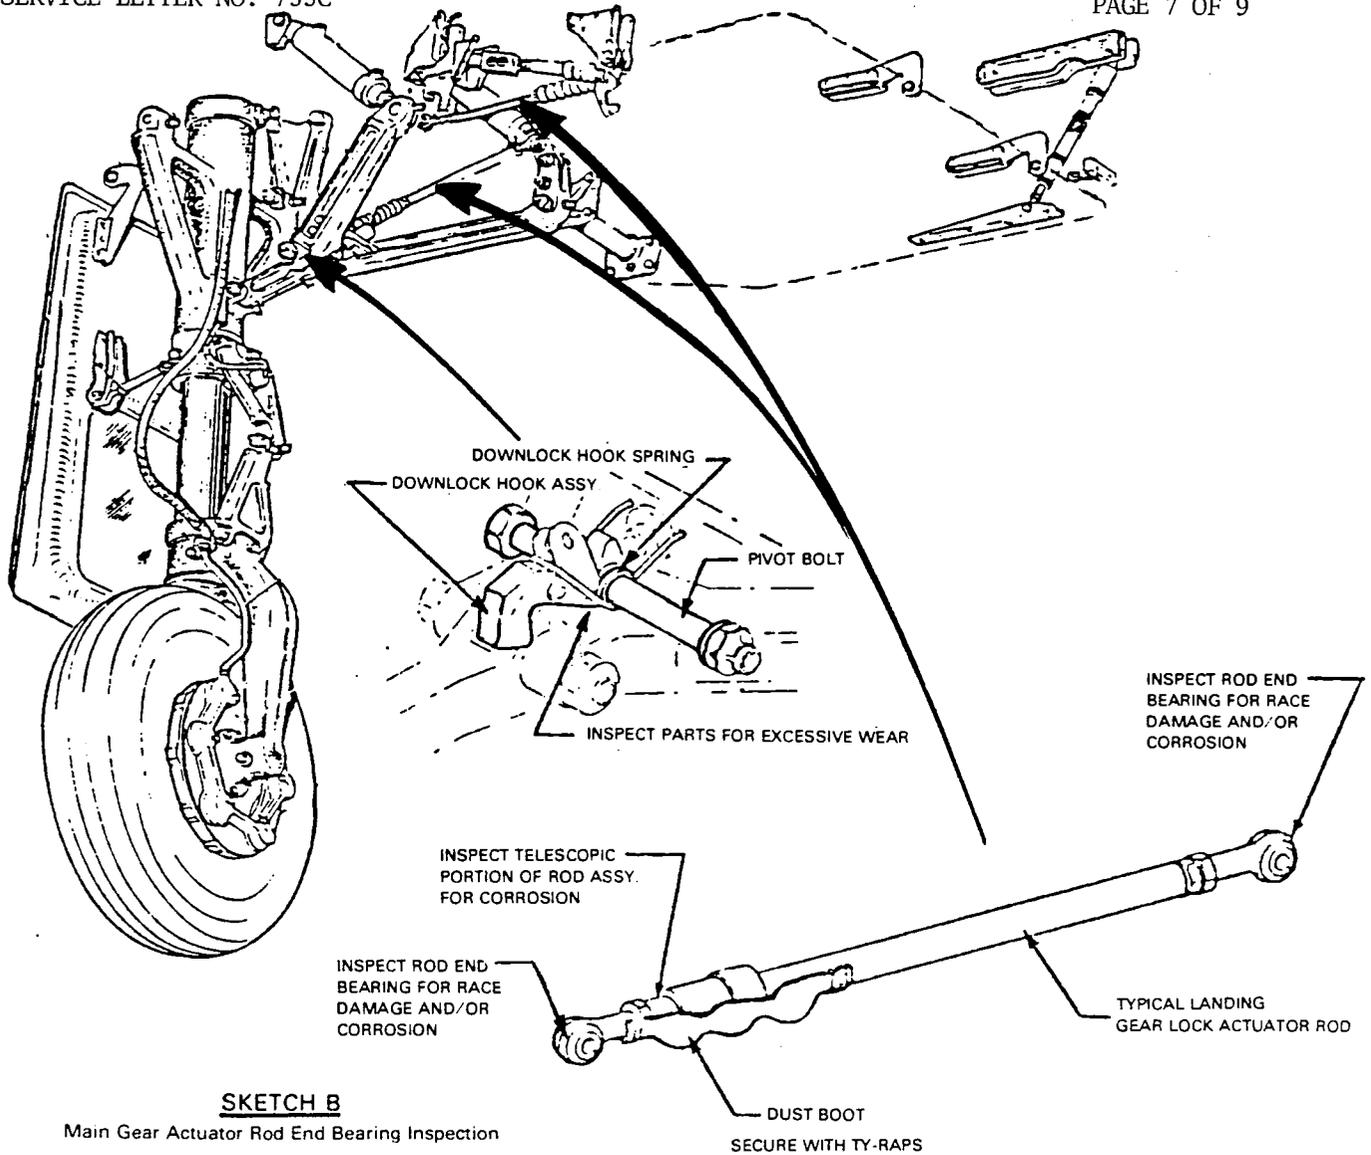
SKETCH B

Main Gear Actuator Rod End Bearing Inspection

3. Inspect the telescopic portion of each landing gear lock actuator rod assembly for evidence of corrosion.
 - a. If corrosion is evident, the landing gear lock actuator rod assembly should be replaced.

5. Inspect each rod end bearing for evidence of race damage and/or corrosion.
 - a. If corrosion is evident and/or ball and race of bearing shows evidence of damage (ball must rotate freely in race), it will be necessary to replace that bearing.

7. Remove the main gear downlock hook assembly. Thoroughly clean the downlock hook assembly, downlock hook spring and pivot bolt and inspect each part for evidence of excessive wear. If any part or parts show excessive wear, those parts should be replaced.

1. Locate and remove the main gear lock actuator rod assemblies from aircraft as shown. Accomplish on left and right main gear assemblies.
2. Loosen the clamp attaching the dust boot to the landing gear lock actuator rod assembly. Slide the dust boot back to expose the telescopic portion of the actuator rod assembly.

- b. If no corrosion exists, lubricate the telescopic portion with MIL-G-81322, 81827 or MIL-G-21164C lubricant.
4. Reposition and secure the dust boot on each landing gear lock actuating rod assembly.

- b. If existing bearings show no evidence of corrosion or damage, lubricate bearings with MIL-L-7870 lubricant.
6. If a new main gear lock actuator rod assembly (assemblies) is being installed, lubricate the telescopic portion as described in 3b above, and the rod end bearings with MIL-L-7870 lubricant. Install existing dust boot on actuator rod assembly as shown.

8. Reinstall the downlock hook assembly, spring and pivot bolt on aircraft. Lubricate pivot bolt and hook with MIL-G-81322, 81827 or MIL-G-21164C Lubricant.

9. Reinstall the main gear lock actuator rod assemblies on aircraft. Check system function and rigging; adjust as necessary using the appropriate Navajo Service Manual. Refer to Sketch "C" for the correct method of adjusting rod end bearings.

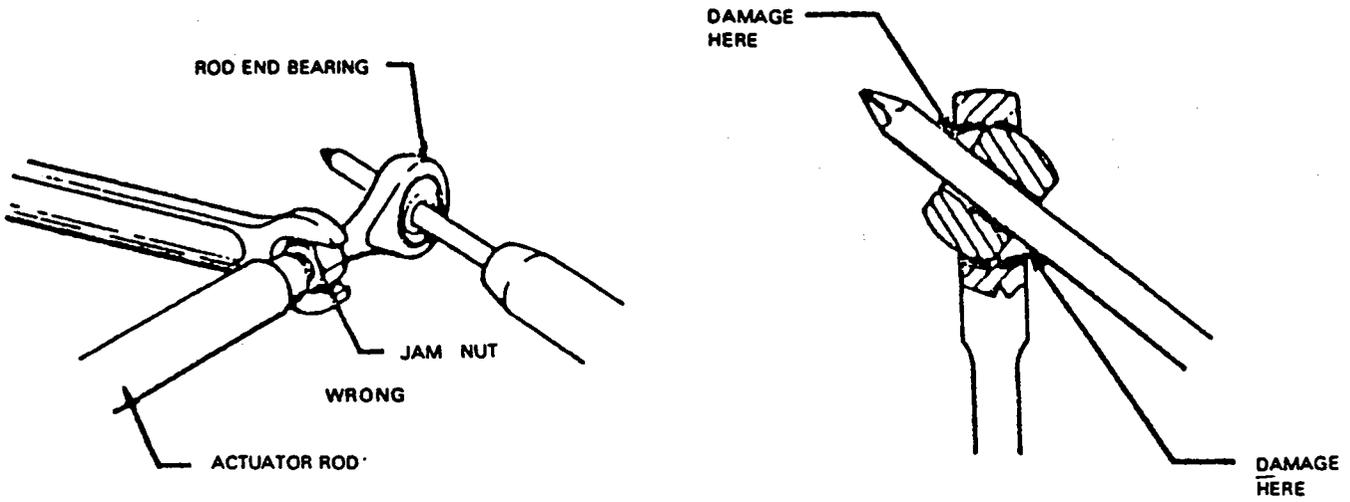
NOTE: It has been found that rod end bearings race damage - incurred during maintenance/rigging activity - has resulted in landing gear system difficulties and/or premature rod end bearing replacements. This Service Release also provides a recommended method for backholding the bearing assembly while adjusting the adjacent jam nut to prevent bearing race damage (refer to attached instruction data for details).

IMPROPER METHOD OF ADJUSTING ROD END BEARINGS
(RESULTING IN LOCKED BALL)

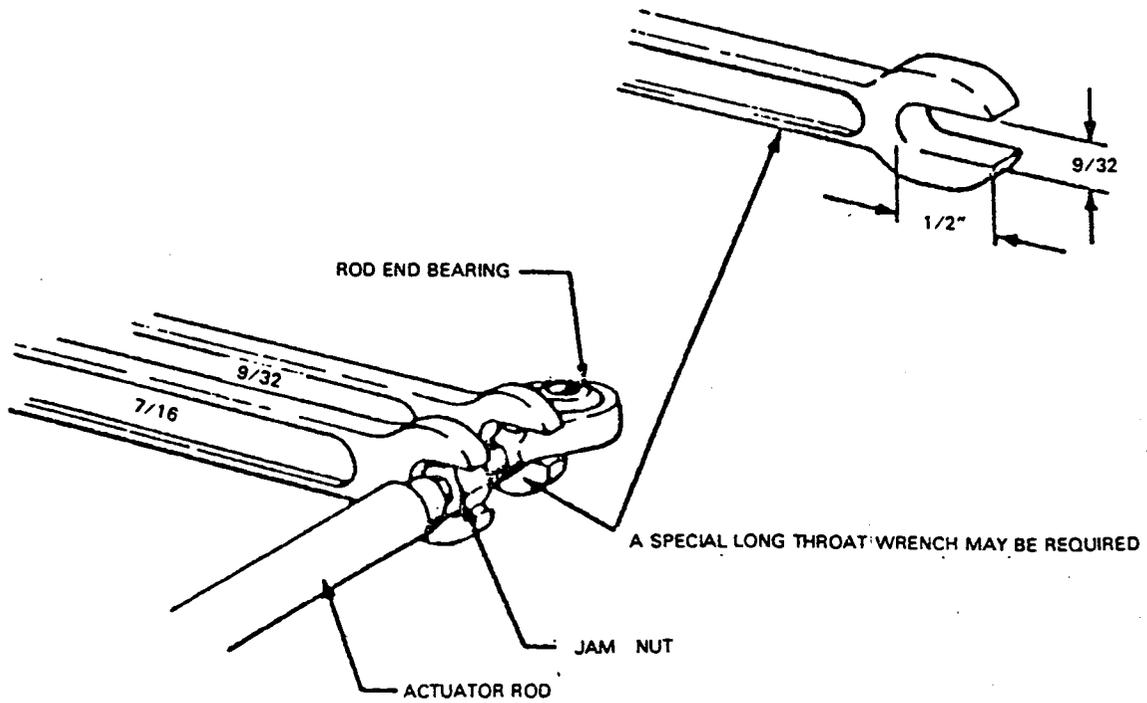
SKETCH C

CORRECT METHOD OF ADJUSTING ROD END BEARINGS

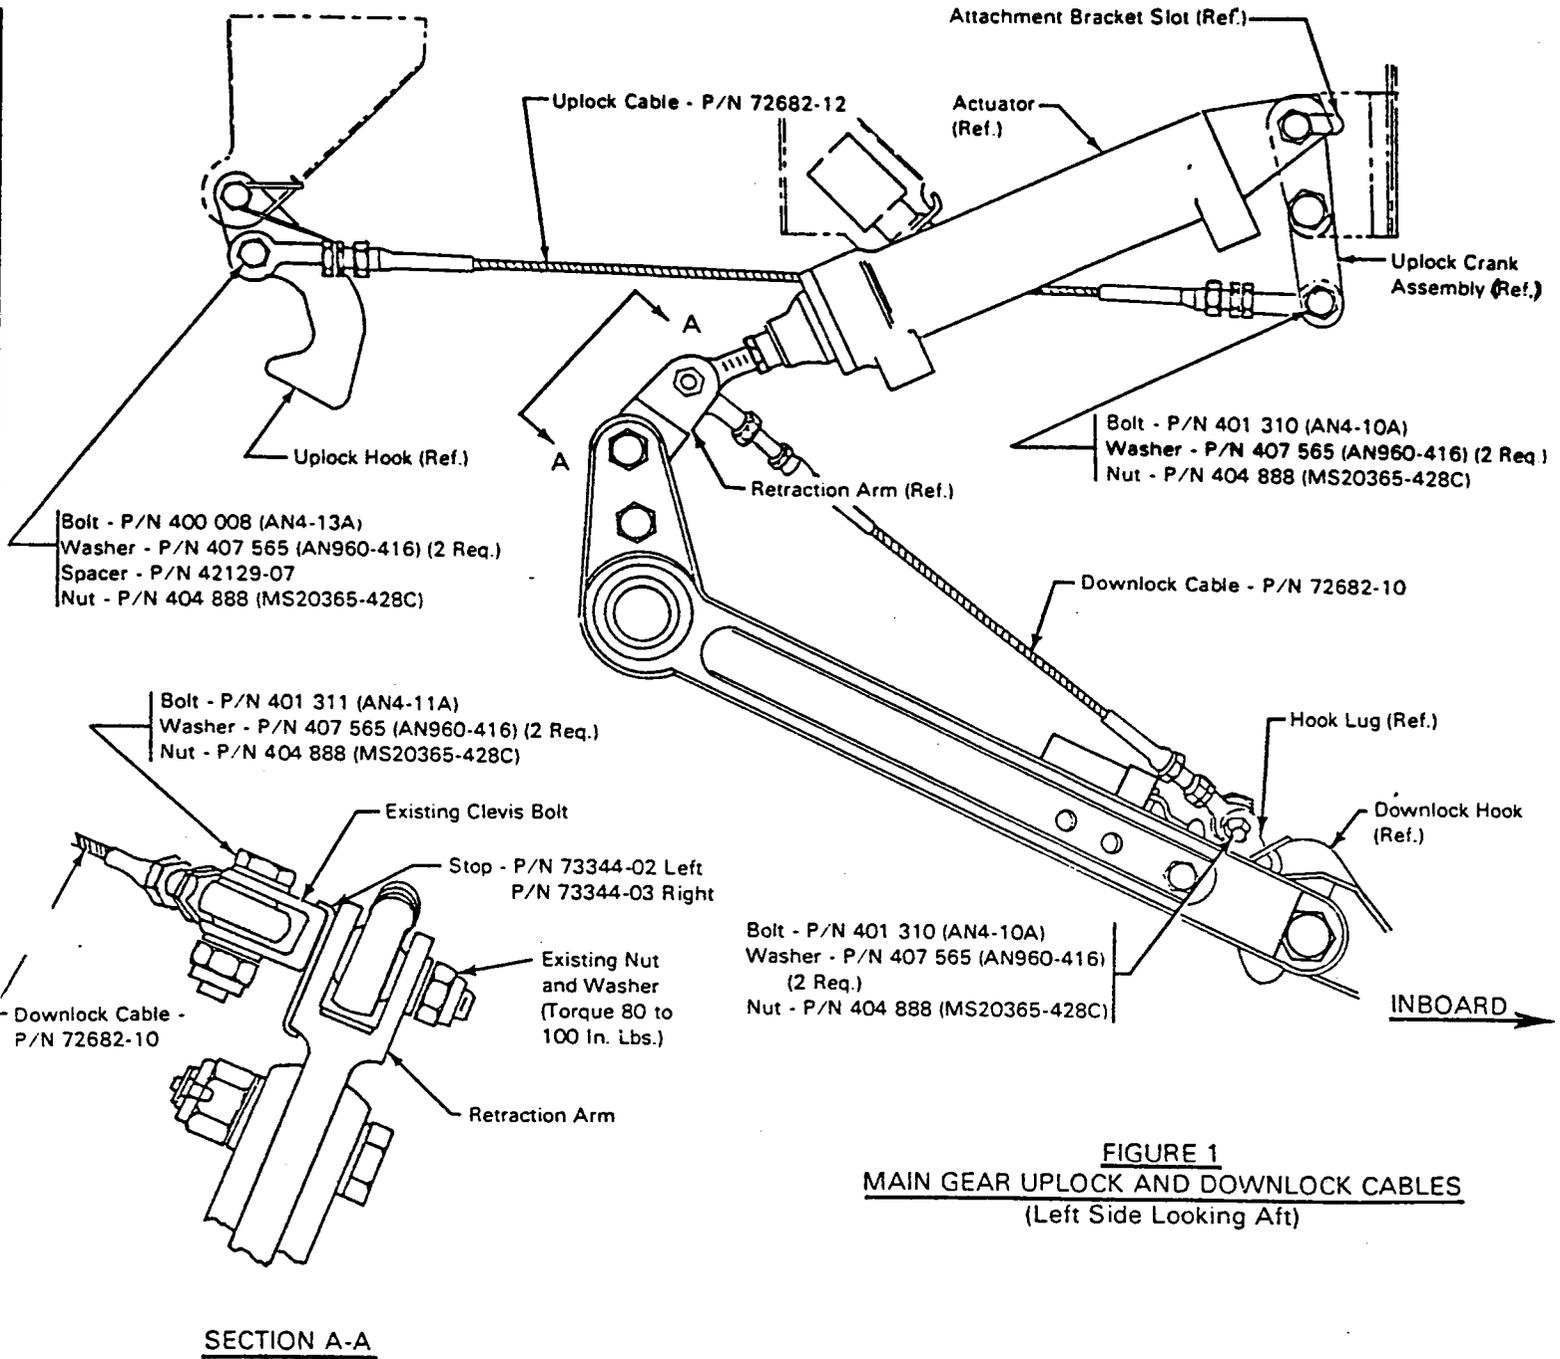
SKETCH D

PURPOSE: Above affected models and serial numbers of aircraft were delivered with the new landing gear uplock and downlock cable assemblies. Installation of these stops between the retraction arm and clevis bolt will prevent possible rotation of the downlock cables and insure safe gear indications.

FIGURE 1
MAIN GEAR UPLOCK AND DOWNLOCK CABLES
(Left Side Looking Aft)

NOTE: Refer to Sketch D, Section A-A of this Service Letter for anti-rotation stop installation.

1. Remove nut and washer from the clevis bolt (fork) connecting the down-lock cable to the retraction arm.
2. Pull out the clevis bolt and install Stop, Piper Part Number 73344-02 (left side) and 73344-03 (right side) over the bolt and reinsert bolt through the retraction arm.
3. Install washer and nut and torque 80 to 100 inch pounds.
4. Repeat procedure on the opposite gear.
5. Make proper logbook entry of compliance with PART III of this Service Letter.
