# SERVICE BULLETIN

No. 420

Piper Aircraft Corporation

Subject: Inspection of Heated Windshield

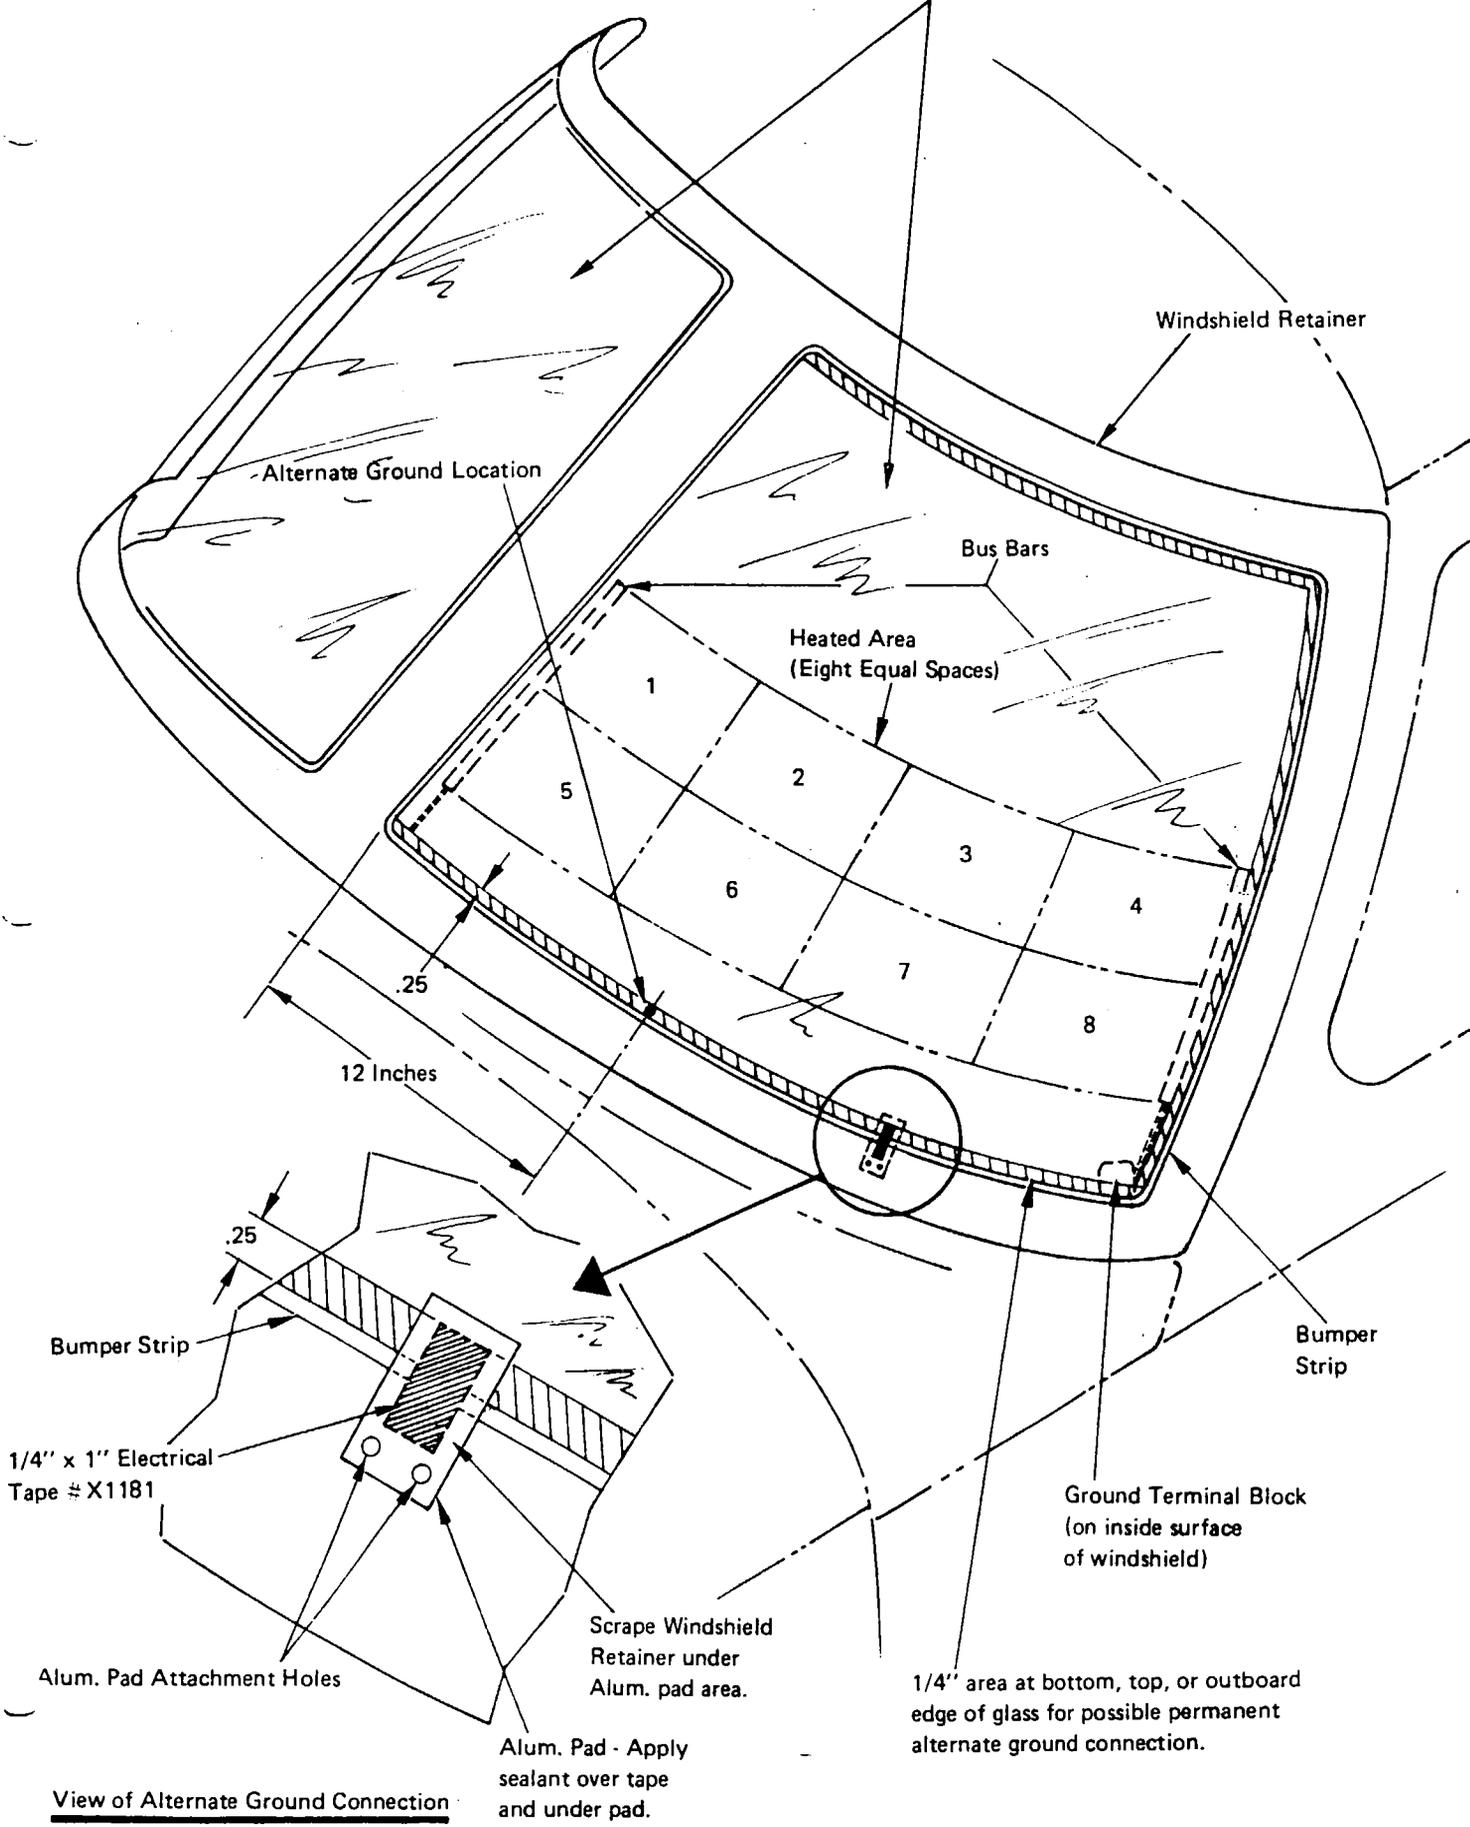
Heated Windshields - Exterior View

1. Clean the windshield to remove dust and dirt.
2. Using approximately 1/2" wide masking tape, define the windshield heated area into eight approximately equal sized areas. (See sketch.)
3. Using an ultra high sensitivity volt-ohm micro ammeter such as a Simpson 269, set the range dial to 100 K. Next, zero the meter reading. Then connect the alligator clip of one of the test leads to the windshield ground power terminal (or APU ground connection on PA-31P). Connect the alligator clip of the other test lead to the pure copper puff supplied in kit.

Disconnect the alligator clip from the ground terminal (or APU ground), and use it to contact the outer glass surface within 1/4" of the lower edge of the glass, approximately 12 inches from the centerpost. (See sketch.) With the other contact that is still connected to the copper puff, repeat the eight area check procedure defined in Step 4. If three or more of the eight areas are not acceptable, proceed to Step 9. If six or more of the eight areas are acceptable, a new ground connection can now be made as follows:

View of Alternate Ground Connection

7. For future reference, place a mark on the retainer collar, adjacent to the contact point at the lower glass edge. Scrape the paint and primer from the retainer collar at this marked position, to expose the bare metal in an area 1/4" x 1/4". (See sketch.) Apply a 1" long x 1/4" wide strip of Scotch electrical tape #X1181 (supplied with kit), 1/4" onto the glass surface and extending back across the bumper strip onto the scraped retainer collar area. The new ground connection has been made.

8. The Scotch electrical tape must be permanently protected from weathering as follows: Using the sandblasted aluminum pad (supplied with kit) locate the hole positions on the retainer collar that would completely cover the X1181 tape. Next, drill and tap the two holes in the retainer. Using RTV 106 or PR 1422 soft weather sealant, pot the pad on over the tape. Then permanently connect the pad to the retainer collar with the screws supplied with kit. The new permanent ground connection is now complete.

Alum. Pad - Apply sealant over tape and under pad.
