# SERVICE LETTER

No. 833

Piper Aircraft Corporation

Subject: Cabin Pressurization System Rupture Disc Elimination

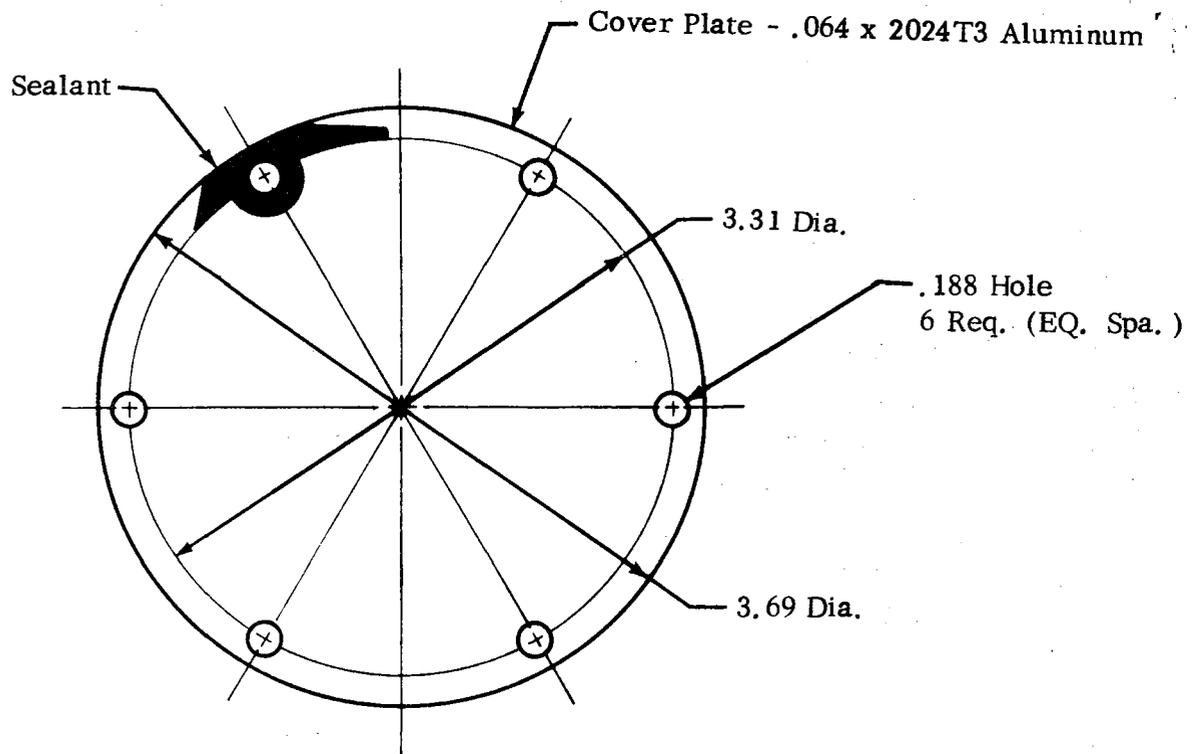
COVER PLATE DETAIL (P/N 48893-02)

Purpose: The current cabin pressurization system on the above referenced models no longer requires the rupture disc assembly (formerly installed on rear of aft fuselage pressure bulkhead, sta. 274). Further, Rupture Disc Assembly, Piper Part Number 48683-00 is no longer supplied for field replacements through the factory Customer Service Sales Division.

1. Remove left access panel, located between sta. 274 and sta. 296, from aft fuselage.
2. Locate and remove the rupture disc assembly, installed on rear of sta. 274 pressure bulkhead, by removing the six screws and washers.

3. Remove the rupture disc placards from the forward and aft sides of the pressure bulkhead by drilling out the attachment rivets.
4. Fabricate cover plate per above detail or order plate from Piper Aircraft Corp. under part number 48893-02.

5. Clean cover plate and sta. 274 bulkhead, in the area where the rupture disc assy. and rupture disc placards were removed, with a non-corrosive solvent. Let dry.

6. Apply MIL-S-7502 Sealant (Products Research Comp. PRC-1221 or equivalent) around cover plate and around each hole, as shown on above detail, to make one continuous bead of sealant.

7. Install cover plate on sta. 274 bulkhead with the six screws and washers previously removed.
8. Apply sealant under head of MS20470AD3 rivets and install in rivet holes where placards were attached. (Note: Rivets need not be formed if sealant is allowed time to cure. Check cure time on sealant label.)

9. Reinstall left access panel to aft fuselage.
10. Make proper logbook entry of Service Letter compliance.
