# SERVICE BULLETIN

No. 525

Piper Aircraft Corporation

Subject: Pilot/CoPilot Seat Latch Mechanism Modification

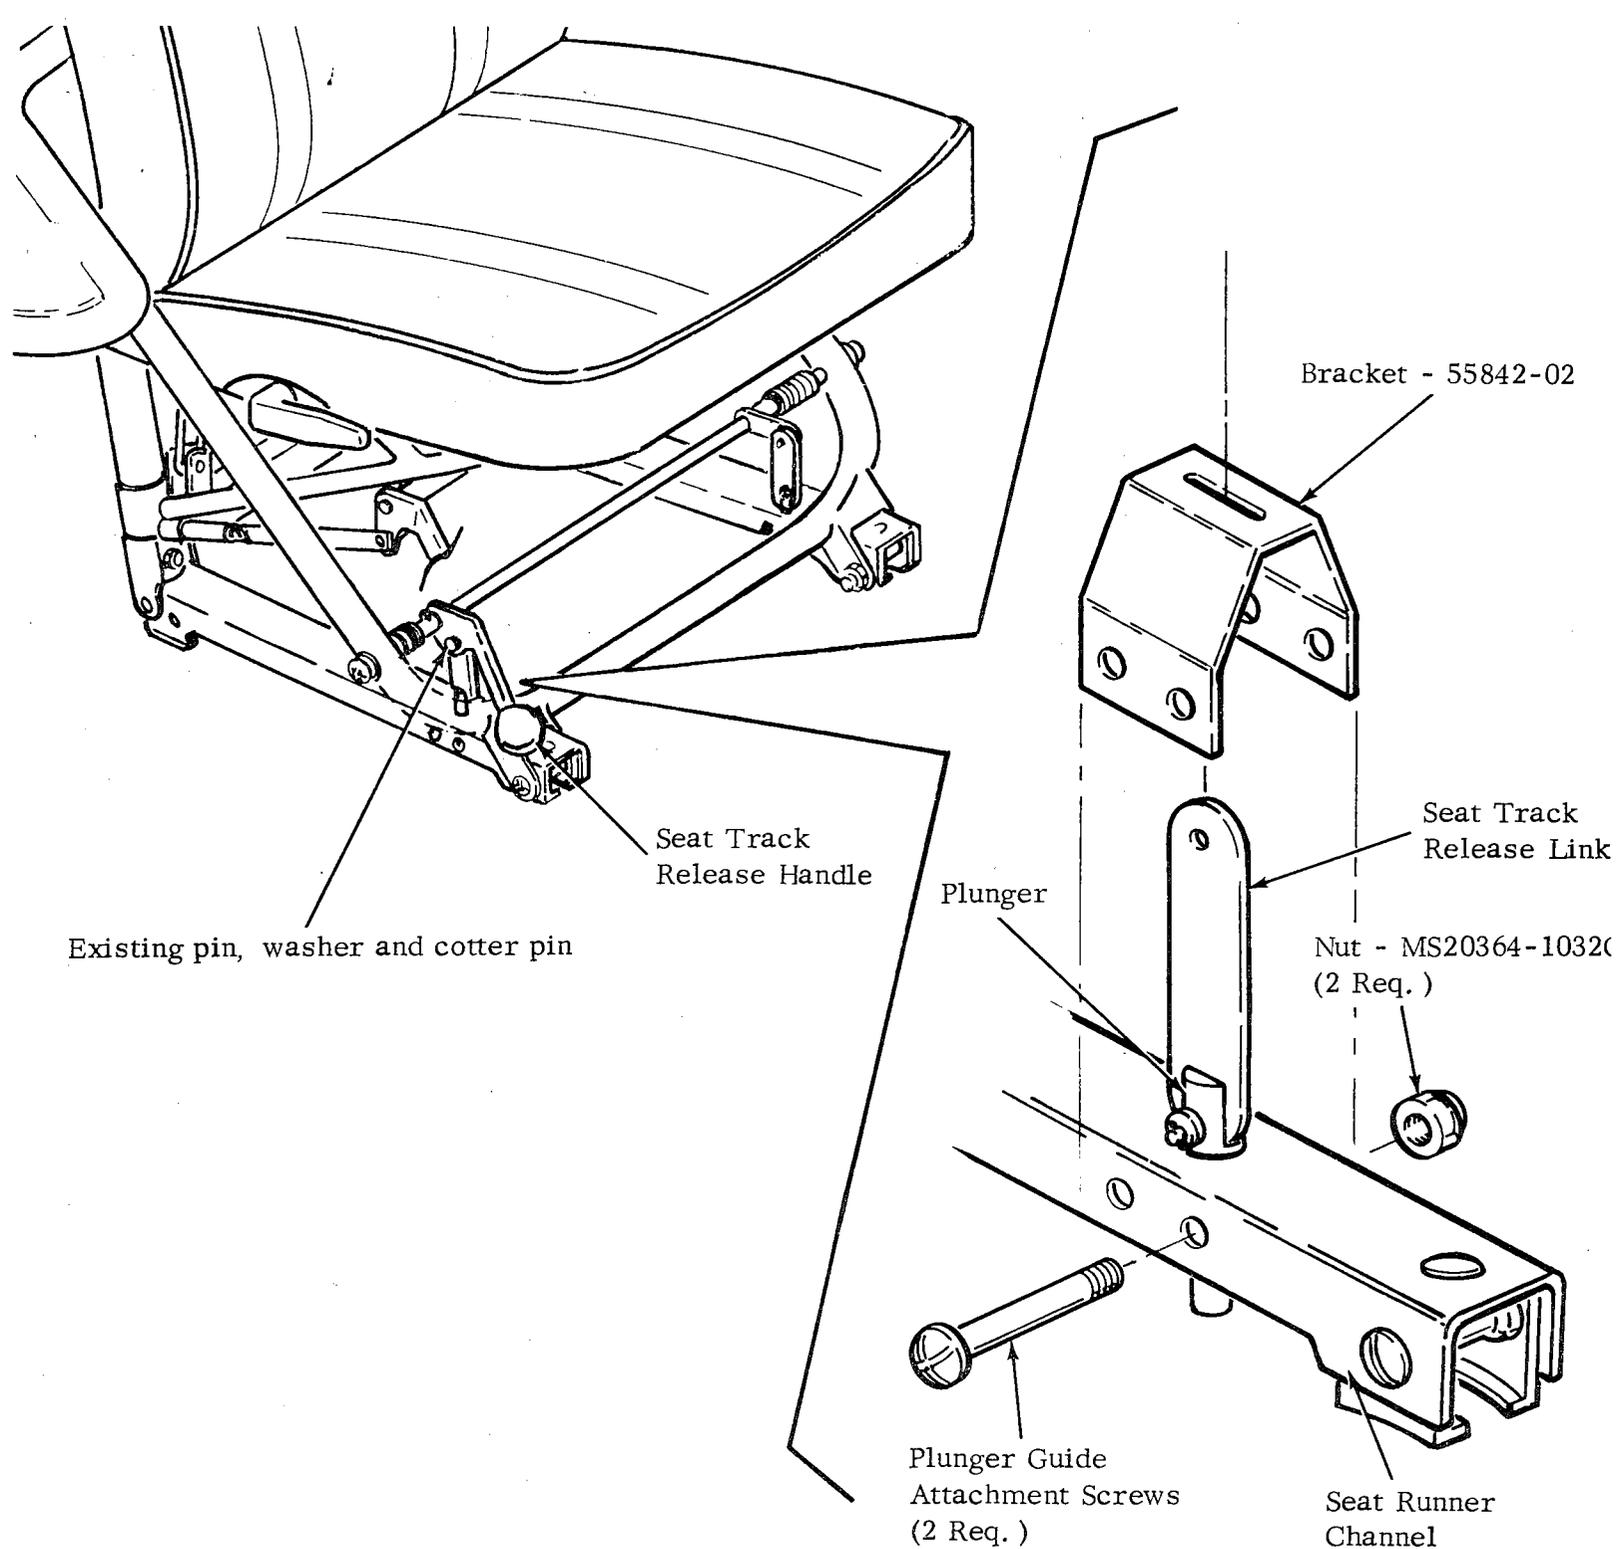
Purpose: A report has been received from the field describing a condition in which the pilot's seat latch mechanism plunger jammed in the "up" position, failing to relock upon release of the seat adjustment lever. This condition could permit inadvertent fore and aft travel of the pilot/copilot seat.

This service release provides material and instructions to install a bracket over the plunger/ seat track release link assembly to prevent excessive upward movement of the plunger, thus insuring relocking of the plunger when the seat adjustment lever is released.

1. Remove the pin, washer and cotter pin attaching the seat track release link to the seat track release handle, as shown above. Retain hardware for reinstallation. Do not remove link and plunger assembly from seat runner channel.
2. Remove the two plunger guide attachment screws as shown above. Retain screws for reinstallation and discard cap nuts.
3. Install bracket 55842-02 to seat runner channel, as shown above, using the two existing screws and two new MS20364-1032C nuts (procure nuts locally).
4. Attach seat track release link to seat track release handle using existing hardware as shown.
5. Make proper logbook entry of Service Bulletin 525 compliance.
