SERVICE *No.* 802 BULLETIN

Piper Aircraft Corporation
Vero Beach, Florida, U.S.A.

SUBJECT: Aft Bulkhead (Fuselage Station 332.0)
Inspection

PA-31P Pressurized Navajo 31P-3 through 31P-7730012

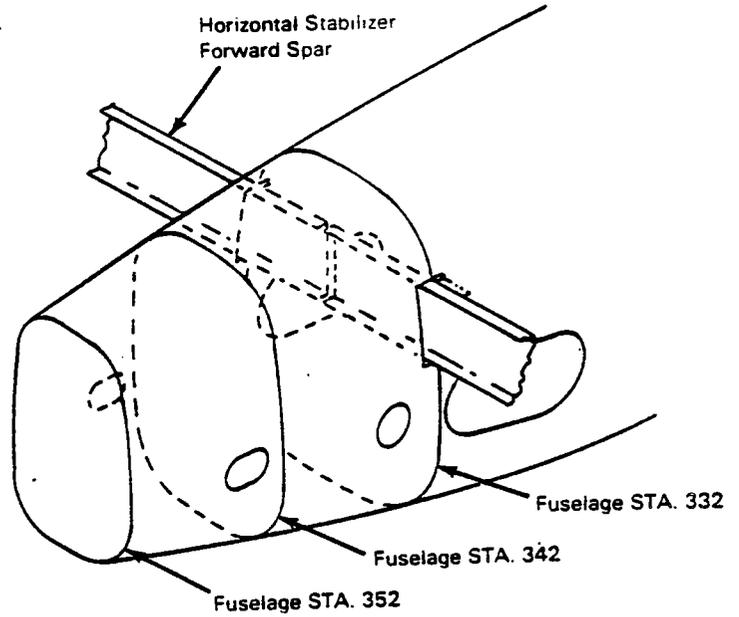
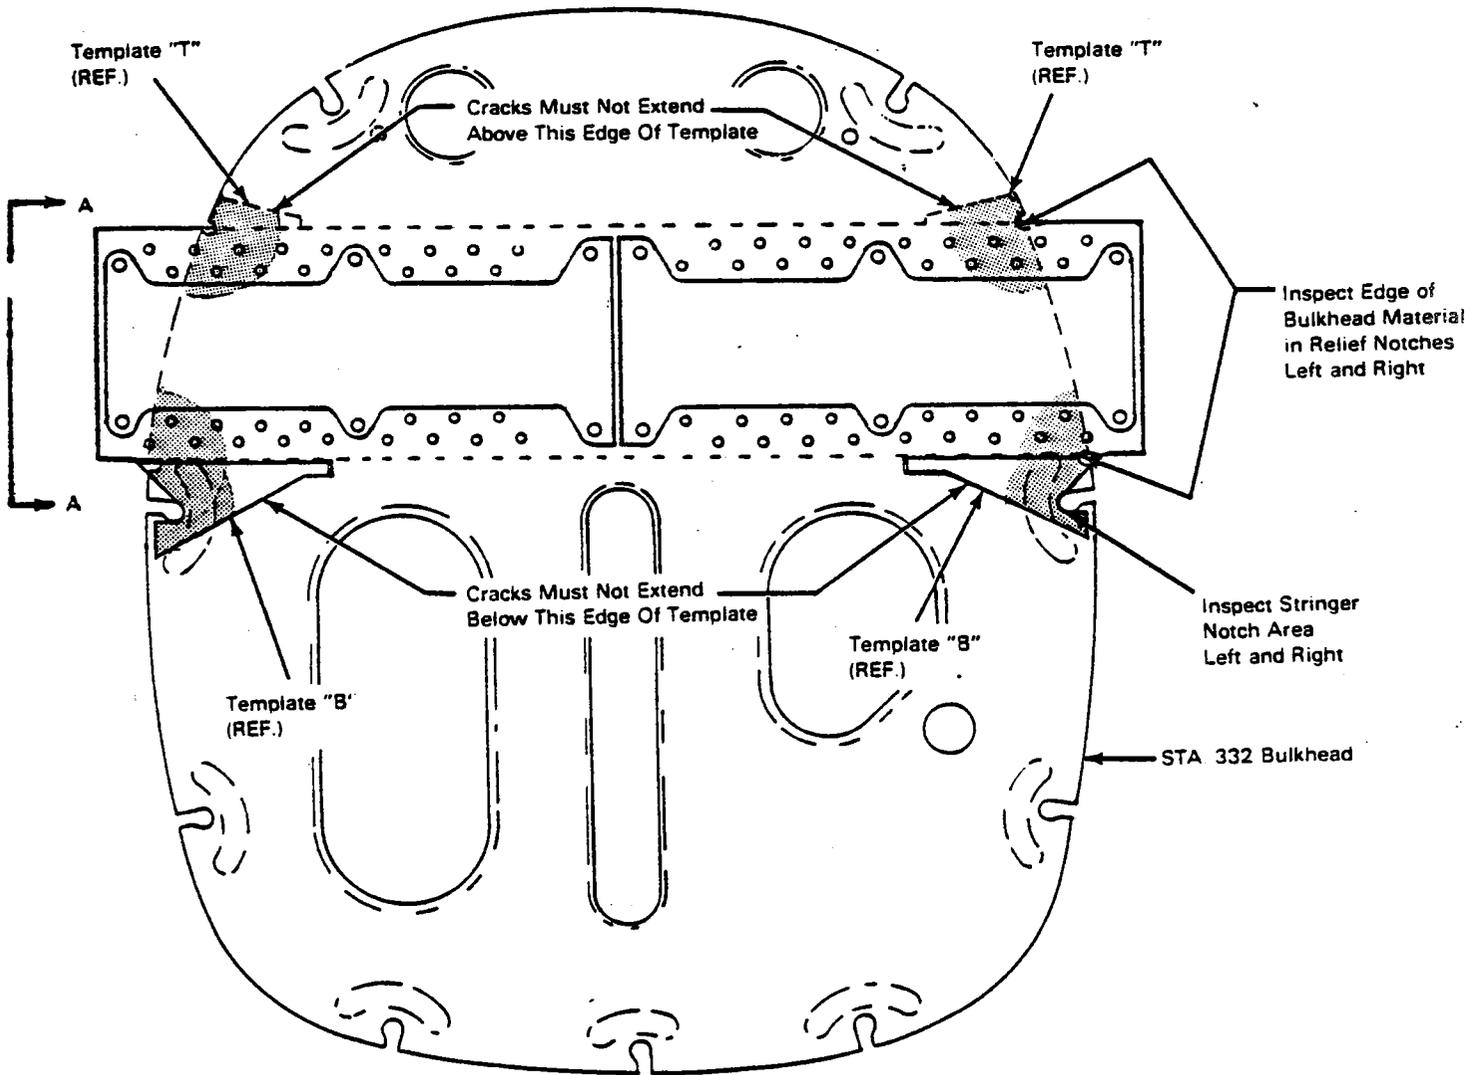
REAR VIEW OF BULKHEAD LOOKING FORWARD
(View Of Stabilizer Removed For Clarity)

PURPOSE: Field reports indicate that cracks can develop in the Fuselage Bulkhead (Part Number 45583-08) at Fuselage Station 332.0. Left uncorrected, such crack could propagate and result in a loss of structural integrity.

LIMITATIONS: Cracks which originate at the relief notches or stringer cut-outs (See Sketch A) which do not exceed 1.5 inches in length and which do not extend above the top edge of Template "T" or below the bottom of Template "B" may be repaired per Instruction 2.b.

NOTE
Bulkheads With Cracks In Areas Denoted By Shading (See Limitations) May Be Repaired Per Instruction 2b.

1. Gain access to the bulkhead area shown in Sketch A (attached) by removing the wrap-around fairings from the horizontal stabilizer to the fuselage and the access plates in the Station 332.0 area.
2. Using Dye Penetrant Inspection method, inspect the Fuselage Station 332.0 bulkhead for cracks in the areas shown in Sketch A.
 - a. If no cracks are found to exist, proceed to Instruction 3 below. A repetitive inspection is required at each 200 hours of operation.
 - b. If cracks are found, and cracks do not exceed the following limitations, cracks must be stop-drilled and Reinforcement Kit, Piper Part Number 764-983, must be installed before further flight.

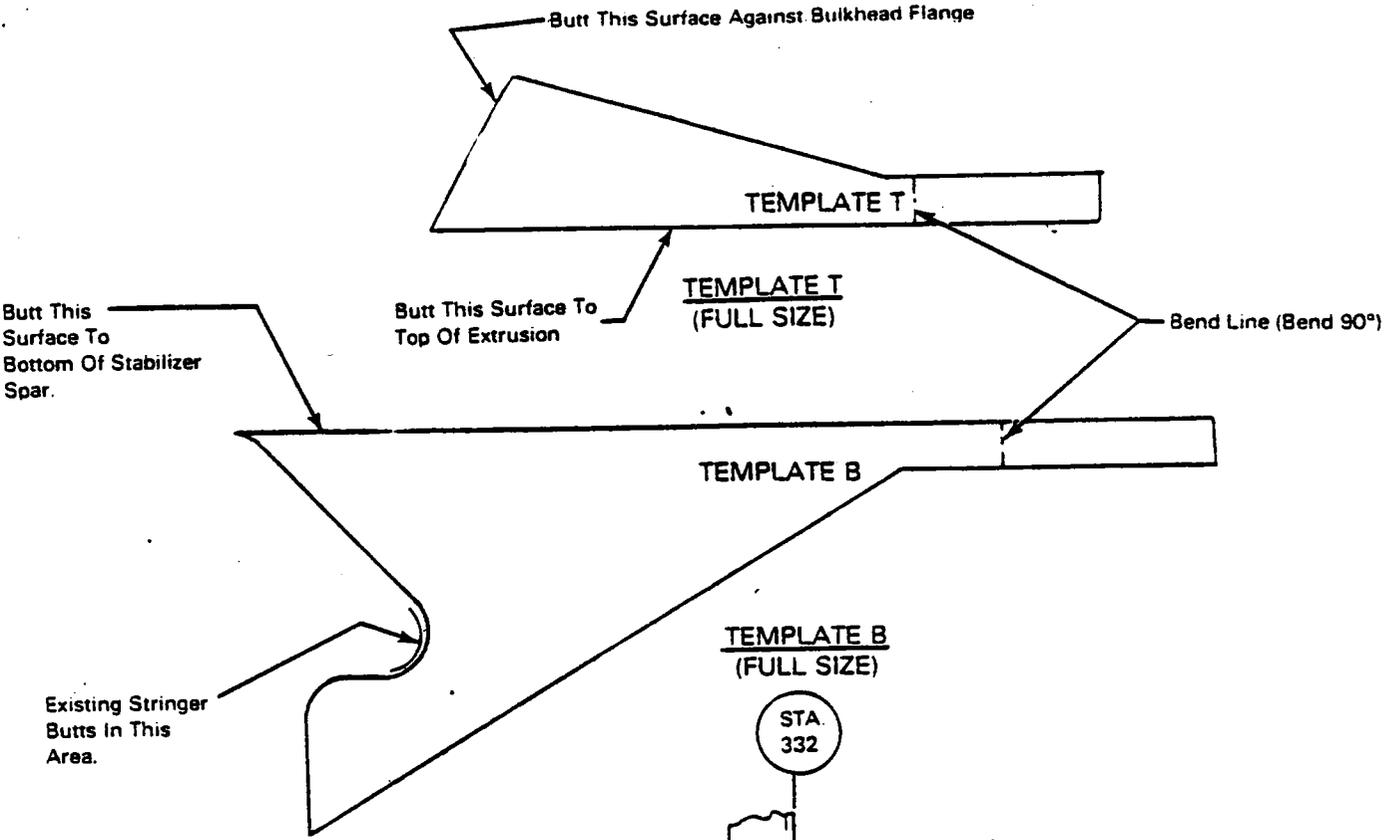
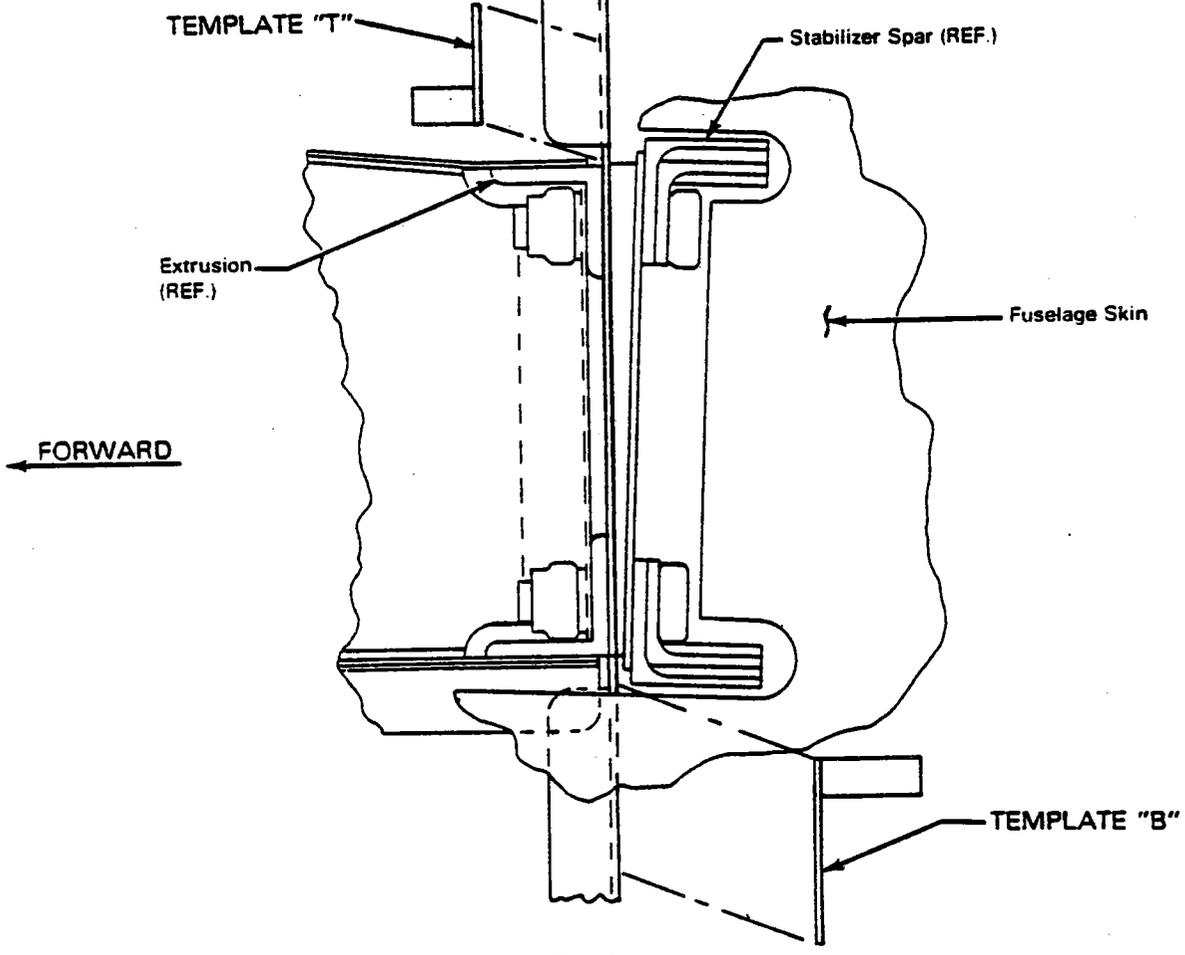
SKETCH "B"

VIEW A-A
(Left Side Shown, Right Side Opposite)
