# SERVICE BULLETIN

No. 651

Piper Aircraft Corporation

Subject: Control Shaft Roll Pin Inspection

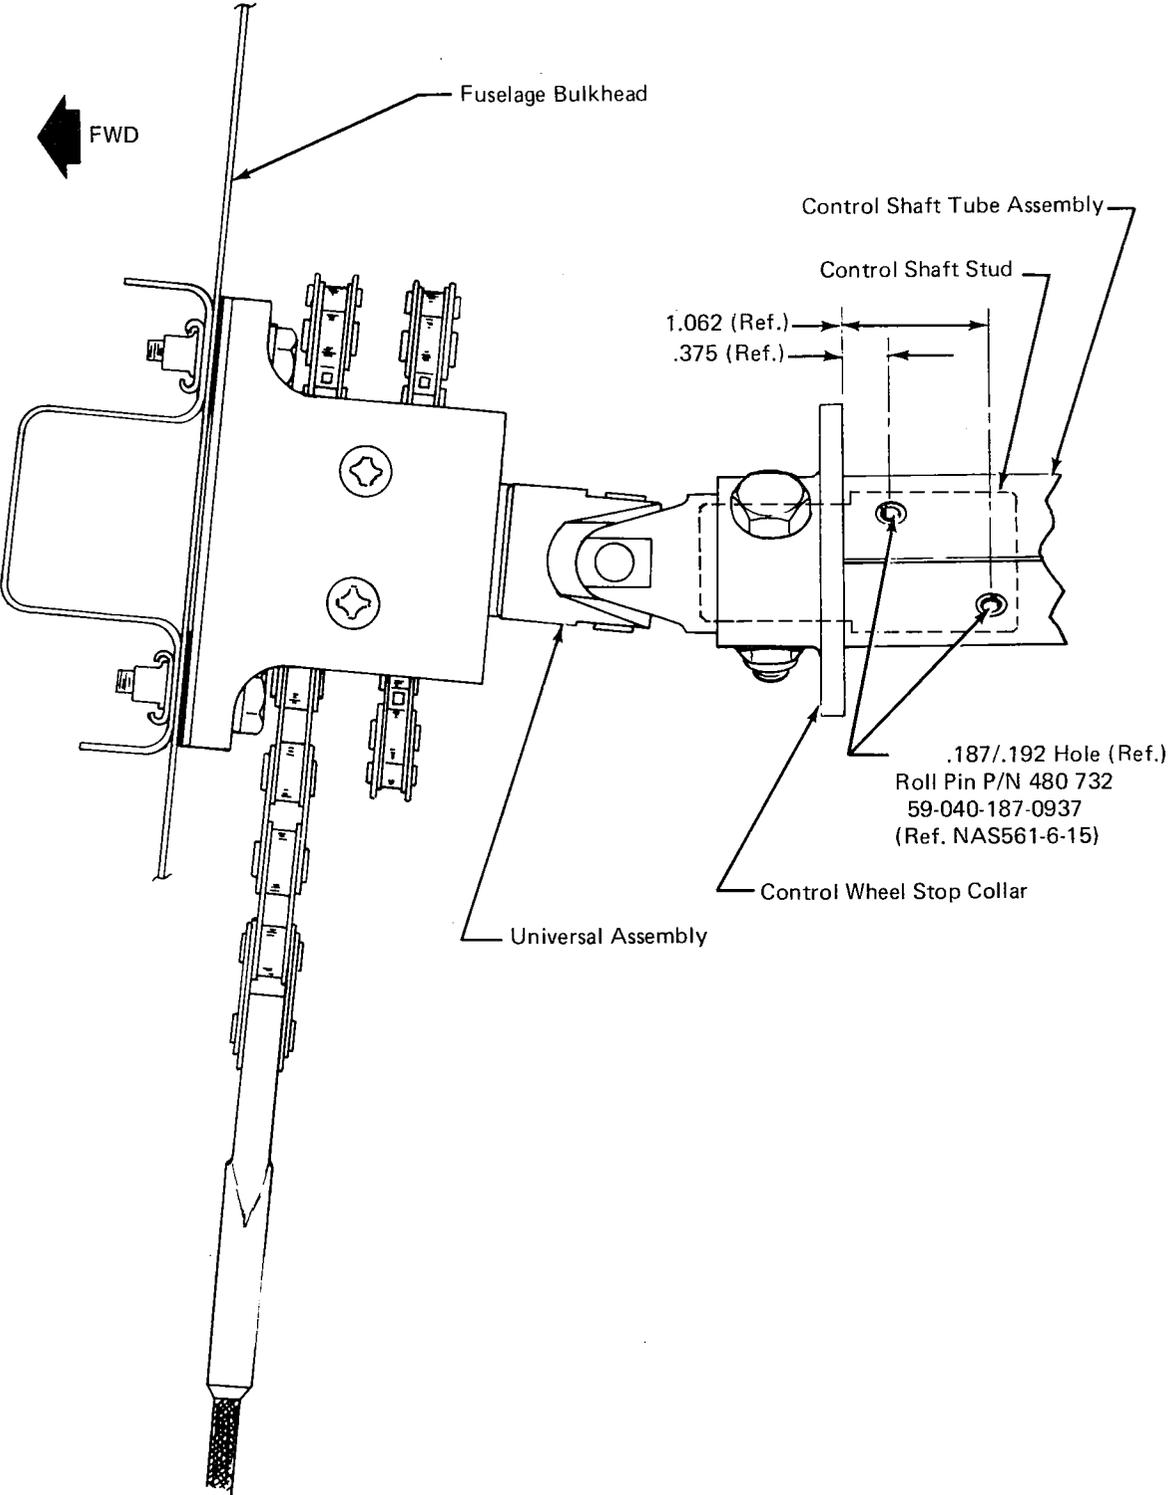
A field report has been received which indicates that the Roll Pins (Piper Part No. 480 732, two (2) per control wheel shaft) which secure the control shaft stud to the control shaft square tube may not have been installed. Absence of the subject roll pins could result in the separation of the control shaft square tube from the stud and subsequent impairment of aileron control function of the affected control wheel.

1. Secure control wheels in aft position.
2. Gain access to the control shaft square tube assembly-to-stud connection, located just aft of the control wheel stop collar. (See Sketch).
3. Deflect controls as necessary to inspect the forward end of the control shaft square tube assembly to determine that two (2) roll pins are installed.

4. If one or both roll pins are missing, replace roll pins as required.
5. If roll pin holes are not present in the shaft or the stud, insure that the shaft is fully engaged on the stud, and drill holes as shown on sketch before installing roll pins.
6. Make appropriate logbook entry of compliance with Service Bulletin No. 651.
