# SERVICE *No. 926A* BULLETIN

## PIPER CONSIDERS COMPLIANCE MANDATORY

Hartzell Service Bulletin No. 165 E,  
Inspection for Cracks in Certain  
Three Blade "Y" Shank Aluminum  
Propeller Hubs

Inspection for Cracks in Certain Three Blade "Y" Shank Aluminum Hubs

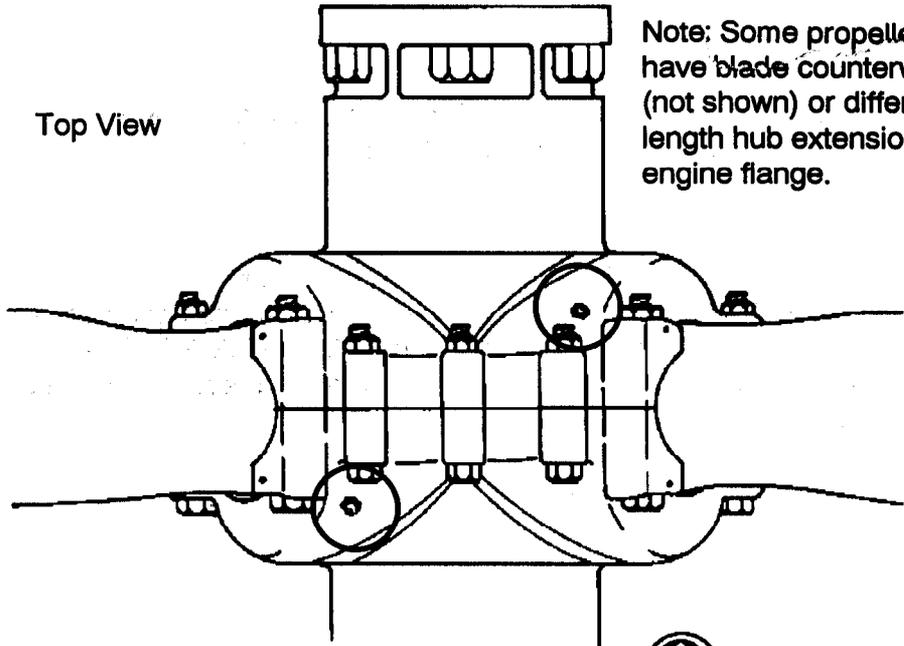
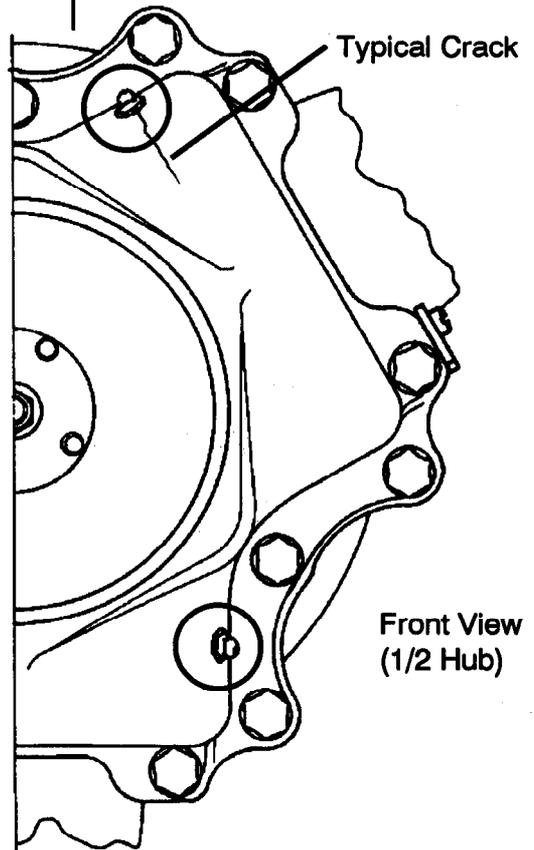
Figure 1. Hub Grease Fittings

In Hartzell three blade "compact" aluminum hub propellers, cracks typically originate in the threads of a grease fitting hole on the inside of the hub. As the cracks propagate around the blade arm of the hub, their progression accelerates and results in failure of one hub half. Several incidents have continued to progress to blade separation.

**NOTE:** Typically, cracks begin at the grease fitting and propagate perpendicular to blade around the blade arm barrel. Cracks may initiate on either hub half from any of the six (6) grease fittings.

Circled areas encompass grease fittings to be inspected at two points on each blade socket

3. Use 10X magnifying glass and light source to perform careful visual inspection of the hub for hairline cracks in the general vicinity of blade retention bearings, but primarily inspect the grease fitting areas as shown in Figure 1. Perform inspections with grease fittings installed.

- 2) Scan probe gradually around each of the six grease fittings on the propeller hub. See Figure 1, scan probe in a manner to cross typical crack indications (rather than scanning in strokes that may be parallel to typical crack indications). The center of the probe tip must pass within 1/4 inch of the grease fittings and outward from the fitting as far as practical (up to 2 inches). The initial scanning around the grease fitting should consist of a circle with the probe as close to the grease fitting hole as possible. Perform subsequent scans of concentric circles around the grease fitting with no more than 1/10 inch spacing between circles.

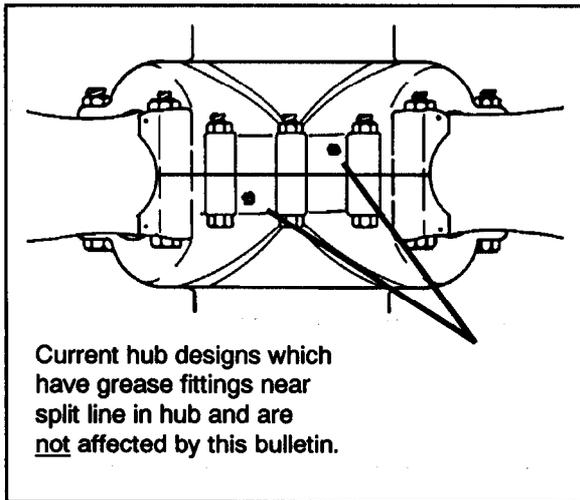
**NOTE:** During 1983, a hub design change relocated the grease fitting holes near the hub parting line (see Figure 1). The earlier-design hubs are listed as affected serial numbers, however, there may be a few hubs listed that are of the later type. Any hub found to be of the current configuration does not require compliance with this Bulletin. Any hub with the old configuration requires compliance.

Current hub designs which have grease fittings near split line in hub and are not affected by this bulletin.
