# SERVICE LETTER

No. 770

Piper Aircraft Corporation

Subject: Aileron Sprocket/Chain Inspection.

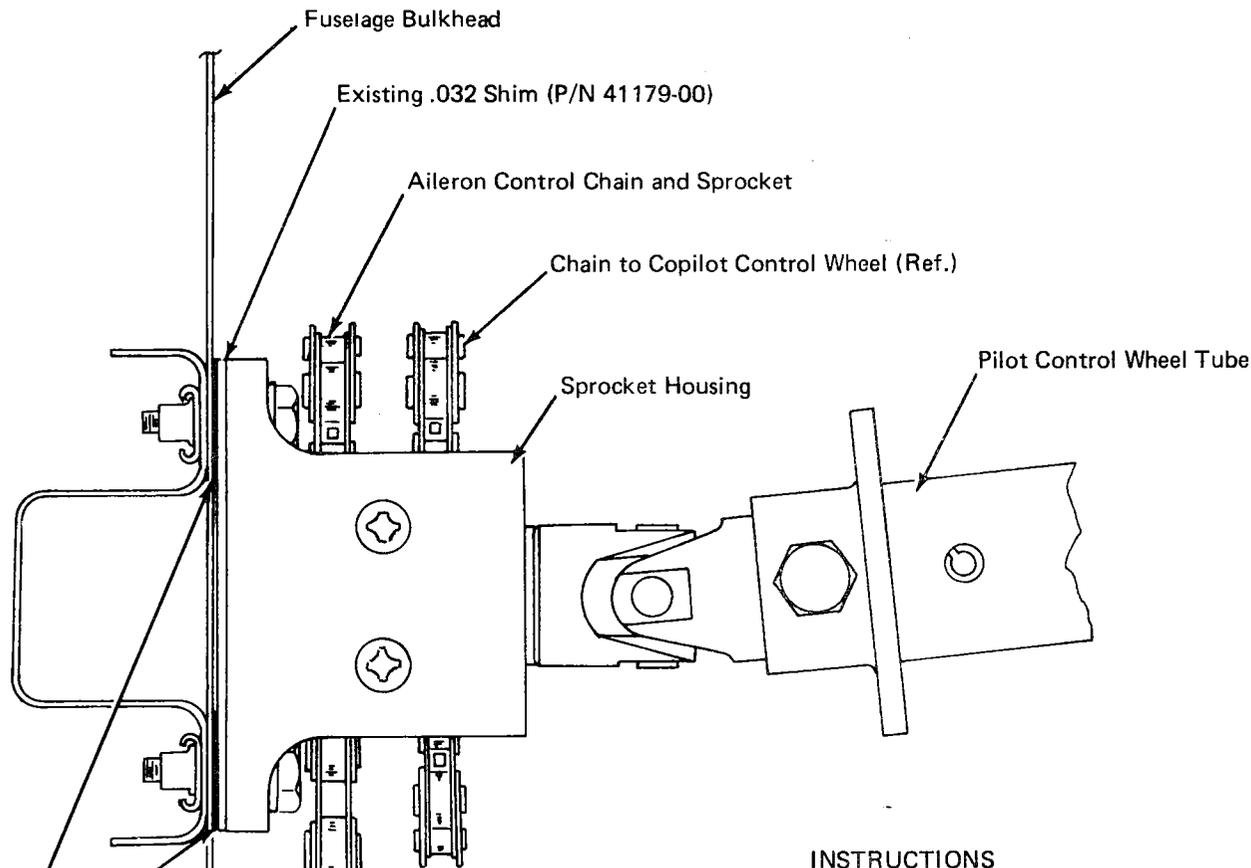
A report has been received from the field describing rough, "articulated" rotation of the pilot's control wheel. During corrective action, it was determined that the aileron sprocket and mating aileron control chain were misaligned, causing the chain to bind on the sprocket teeth. In addition to the above referenced roughness of operation, this condition, if not corrected, could cause eventual sprocket and/or chain wear.

Add new .012 shim (P/N 55817-02) as req. to attain proper vertical alignment of sprocket and aileron control chain.

- a. Inspect at outboard end of sprocket housing to determine if the .032 shim (P/N 41179-00) is installed between the offset in the housing and the bulkhead. Install shim (P/N 41179-00) if it is not present. This shim will ensure proper horizontal alignment.

- b. To attain proper vertical alignment, install new .012 shims (P/N 55817-02) between the top or bottom of the sprocket housing and the bulkhead, as required, to ensure a smooth flow of the chain links over the sprocket.
